Bridge #02735(Routine)

SH 26 - 03 - 11.76 over WOLF CREEK

Location: EAST EDGE OF DELIGHT

Team Lead: John King Inspection Date: July 06, 2021

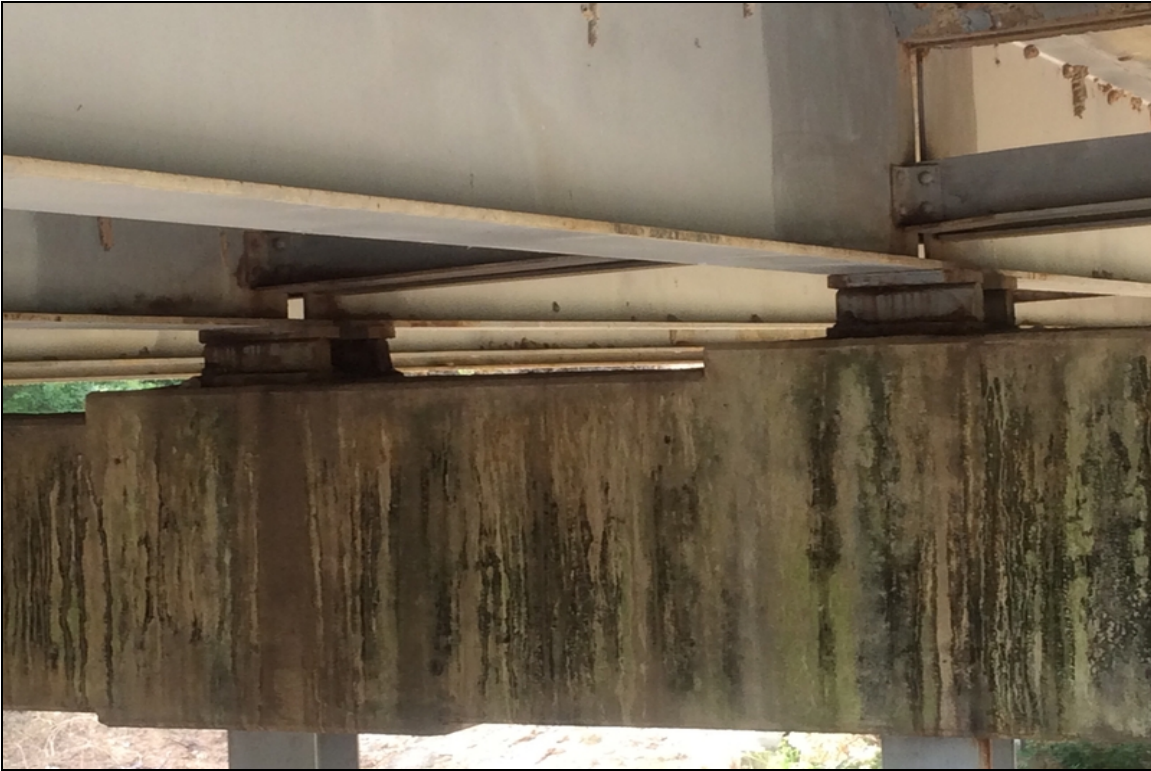
ALL BEARINGS ARE RUSTING ENTIRE BRIDGE H-PILE AND BEAMS ALSO RUSTING VARIOUS LOCATIONS.

ALL BEARINGS ARE RUSTING ENTIRE BRIDGE . BEAMS ALSO RUSTING VARIOUS LOCATIONS. 07/06/2021 bearings are starting to show signs of rust. Bent 2 steel column at top.

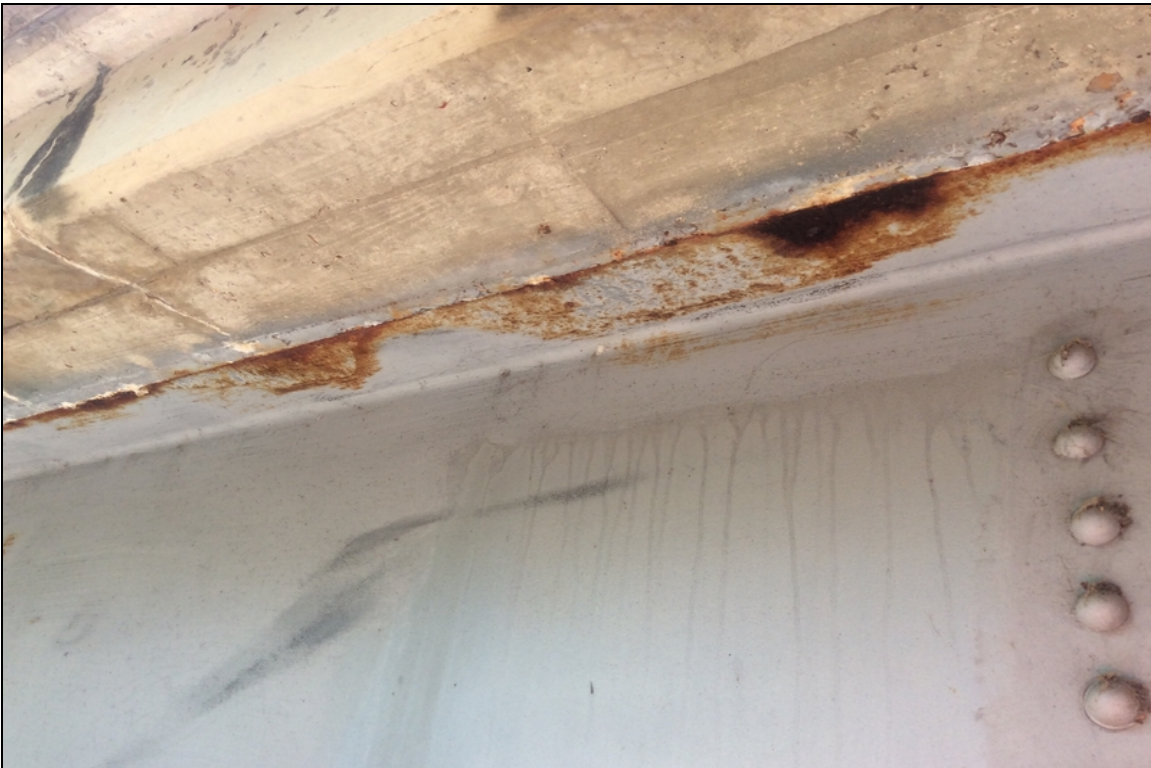
BEAMS RUSTING VARIOUS LOCATIONS

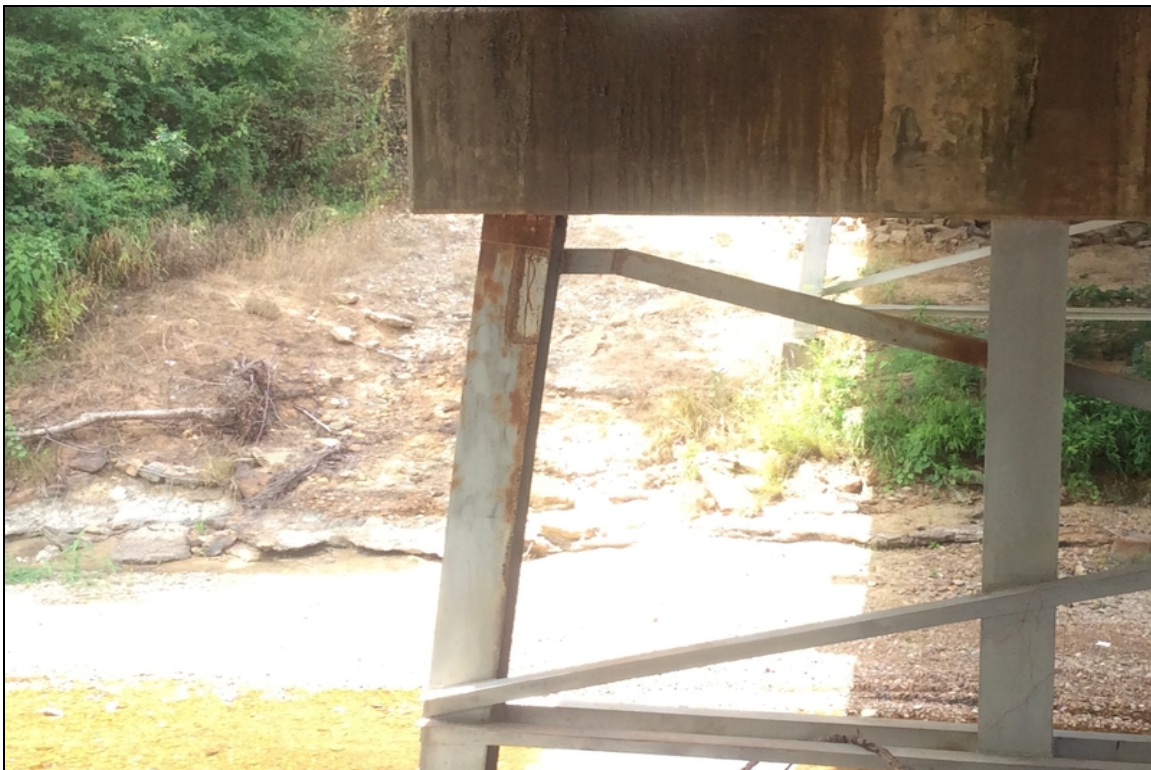
H-PILE RUSTING VARIOUS LOCATIONS

STEEL PILES AT BENTS 2,& 3 HAVE CONCRETE ENCASEMENT SOME STEEL IS EXPOSED AT CAP.STEEL PILES #1,2,3 &4 @BT. #2 AND PILES #1,2,&3 @BT. #3 HAVE BEEN REPAIRED; SEE FORM 3 09/05/2002.---PILE #5 @ BT. #2 AND PILES #4,&5 @ BT.#3 HAVE MINOR SECTION LOSS;SEE FORM 3 - 09/05/2002

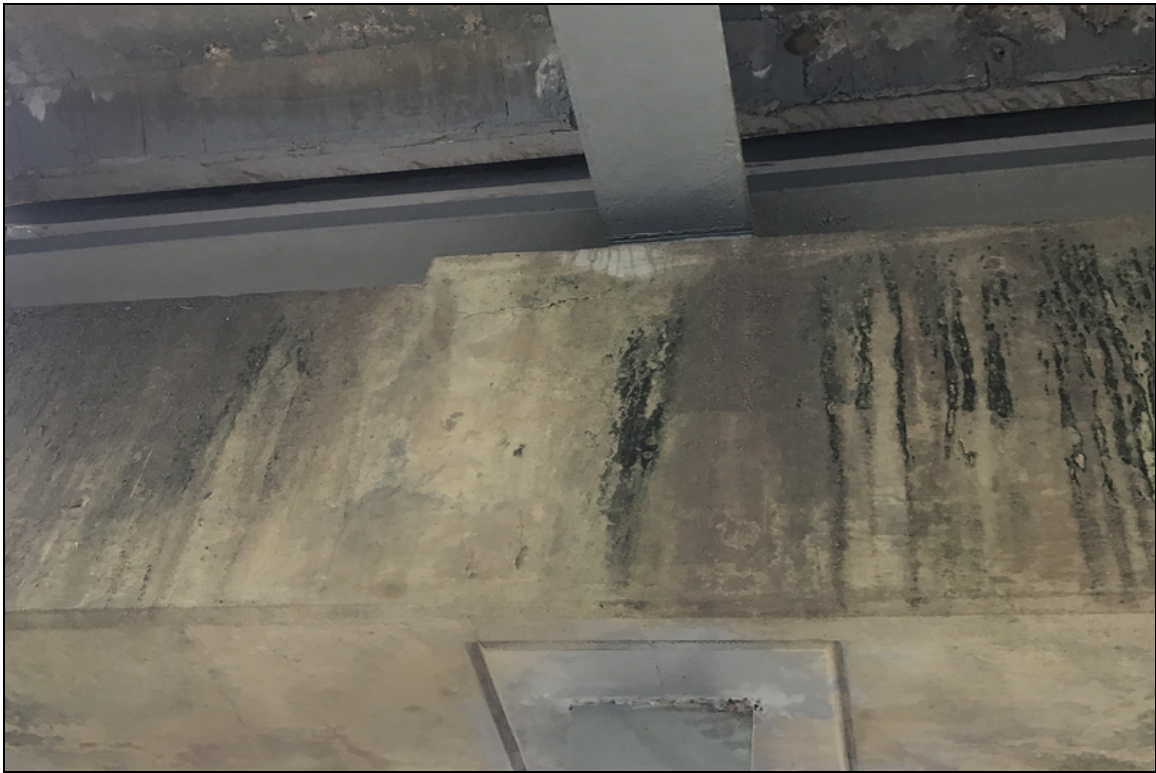
Bent 3, span 3 side above pile 4

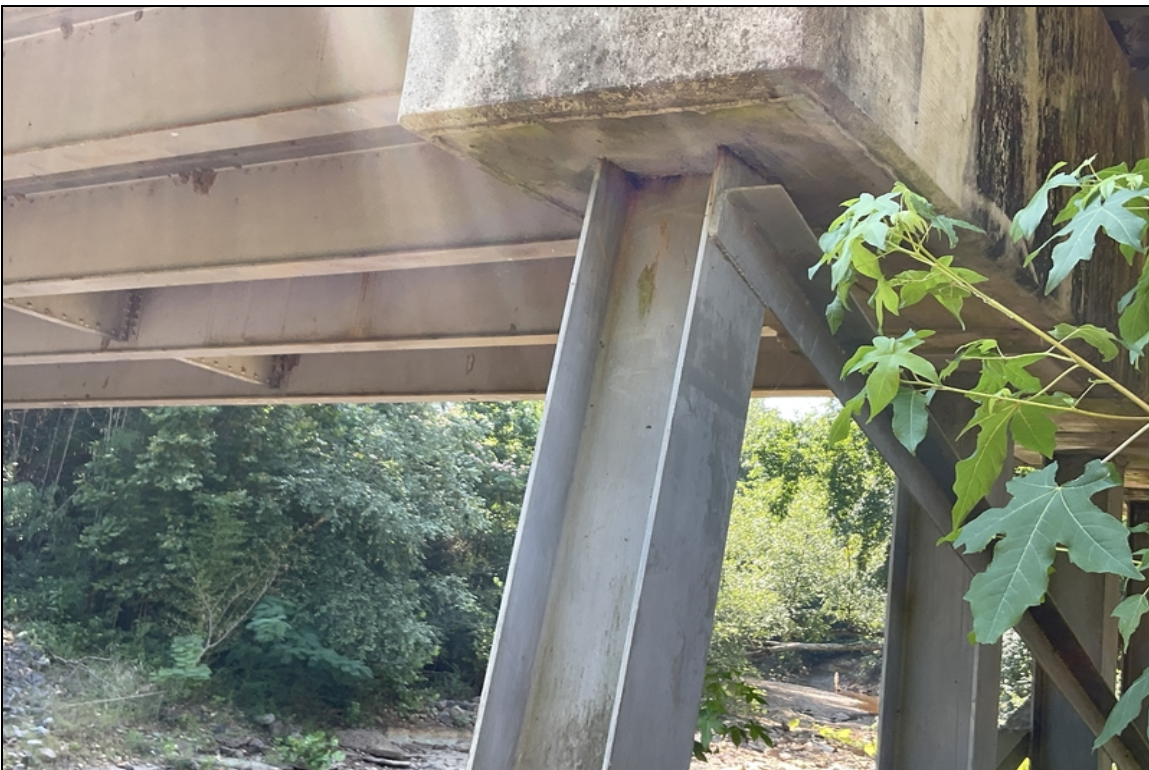
Bent 2 steel column at top

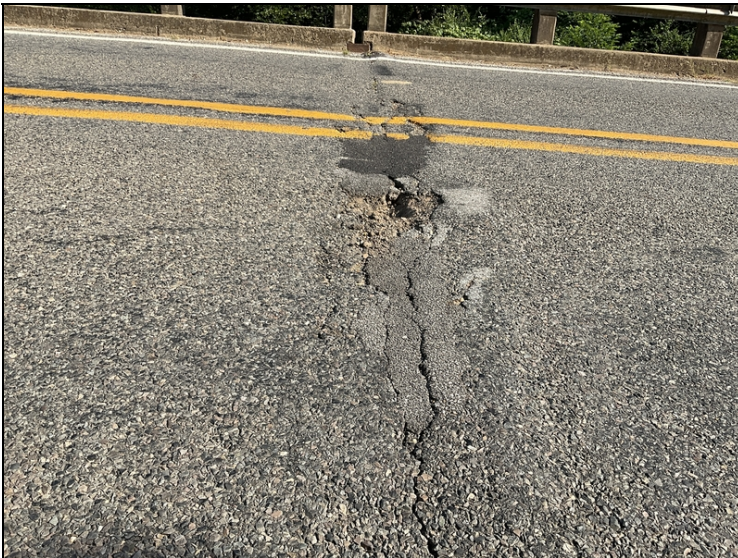
Asphalt coming apart at bent 3 joint... note asphalt is mounded up.
other joints are starting to crack also.

Asphalt coming apart at bent 3 joint... note asphalt
is mounded up

Date Reported: 07/06/2021
Priority: D- Routine
Type of Work: Repair
Status: Open
Component: Deck

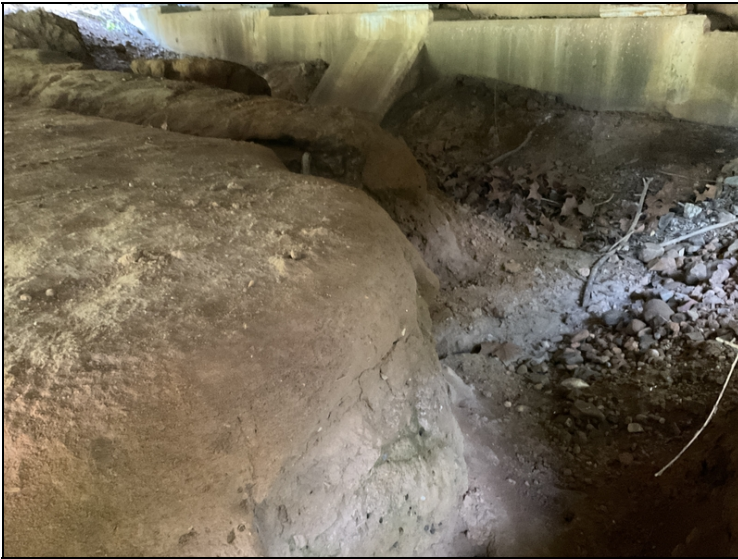
Erosion starting at end of bridge
water is coming from top side along abutment wall left to right.

Erosion starting at end of bridge

Date Reported: 07/06/2021
Priority: G - General/ Preventive maintenance
Type of Work: Repair
Status: Open
Component: Substructure
