Route:49 Section:02 Log:7.13

Bridge #03085(Routine)  
US 49-02- LM 7.13 over LOCUST CREEK  
Location: 9.63 NE JCT US 412

Team Lead: James Adams Inspection Date: November 19, 2020

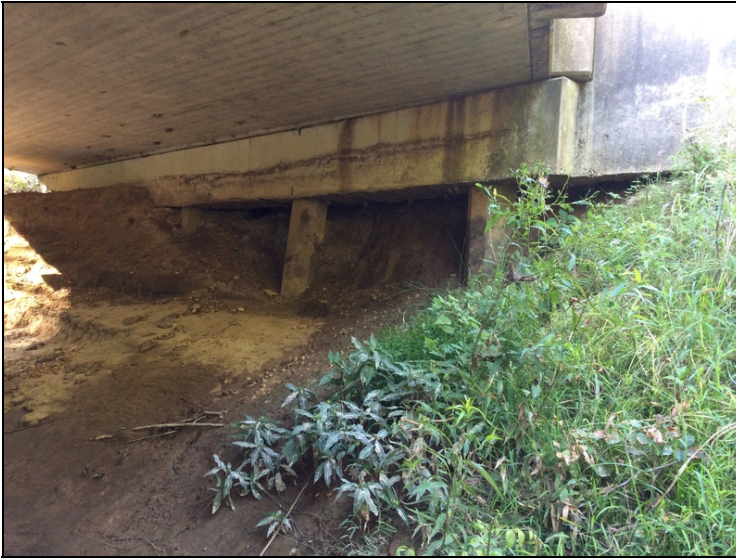
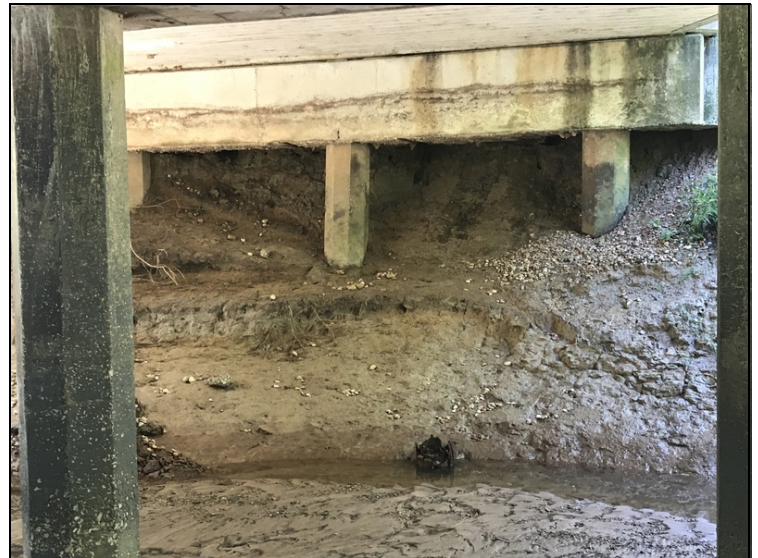
Bent 4 RT SIDE 2019

(215)	Heavy slope erosion under span 3 has undermined 20ft. on Rt. of Bt. 4 abutment, exposing up to 3ft of piles 1 & 2 and 3ft. back under abutment, slow progression of erosion continues. See photos maintenance needs						
227	Reinforced Concrete Pile	EA	13	5	5	3	0
1190	Abrasion/Wear (PSC/RC)	EA	5	0	5	0	0
6000	Scour	EA	3	0	0	3	0
234	Reinforced Concrete Pier Cap	LF	77	63	4	10	0
1080	Delamination/Spall/Patched Area	LF	4	0	4	0	0
1090	Exposed Rebar	LF	10	0	0	10	0
301	Pourable Joint Seal	LF	65	65	0	0	0
330	Metal Bridge Railing	LF	150	150	0	0	0
515	Steel Protective Coating	SF	510	510	0	0	0
3440	Effectiveness (Steel Protective Coatings)	SF	510	510	0	0	0

Bent 4 abutment is undermined for 29' on Rt end up to 4' below and 3' back under. 3 piles are exposed.

**Date Reported:** 01/09/2012  
**Priority:** B - Pressing; 6 month completion goal  
**Type of Work:** None  
**Status:** Assigned  
**Component:**

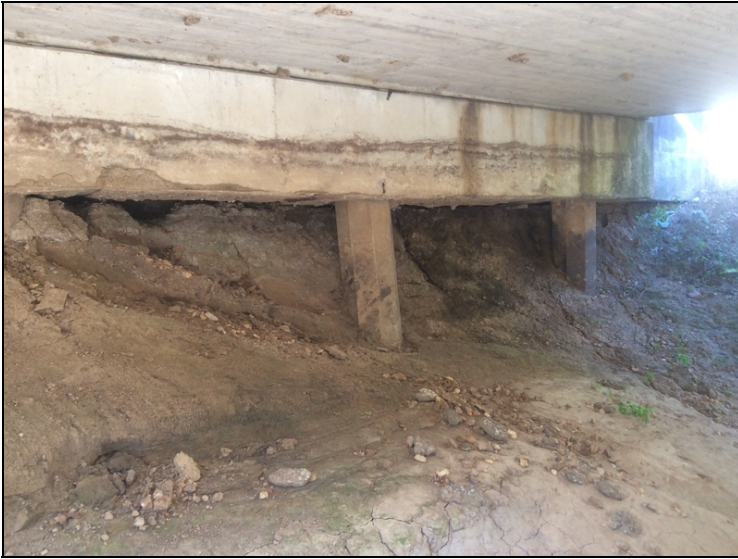
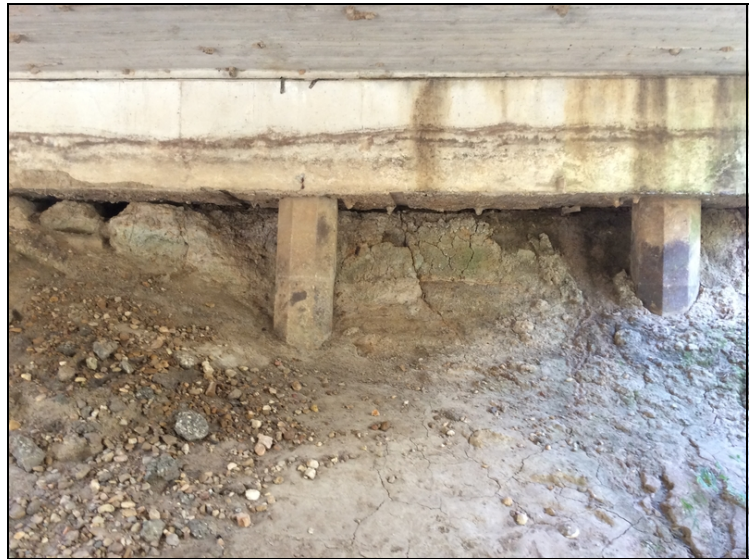
VOID

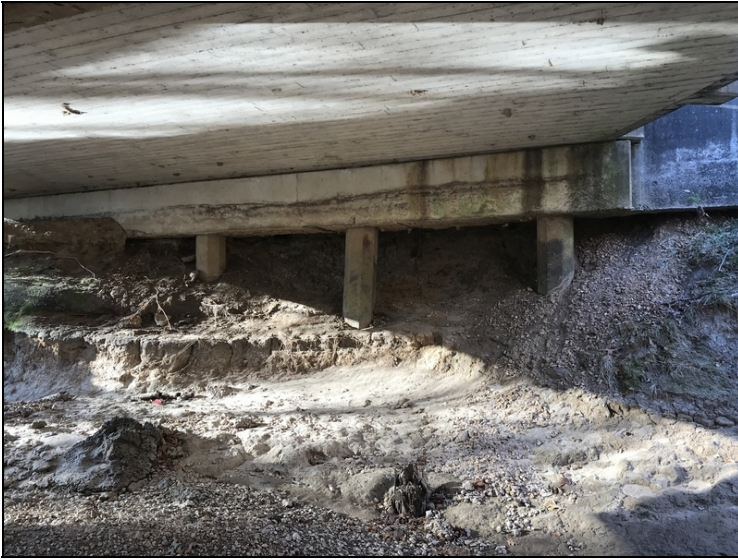
Bent 4 erosion 2020

Minor drift at bent 3. Minor localized scour under bridge around bent 3 piling. Bent 4 abutment is undermined for 29ft. on right end up to 4 ft. below and 3ft. back under cap.
