Bridge #B5025(Routine)

I-30 EB Log 91.77 over Blakley Crk, Acme Pit Rd

Team Lead: Bryan Saunders Inspection Date: February 25, 2020

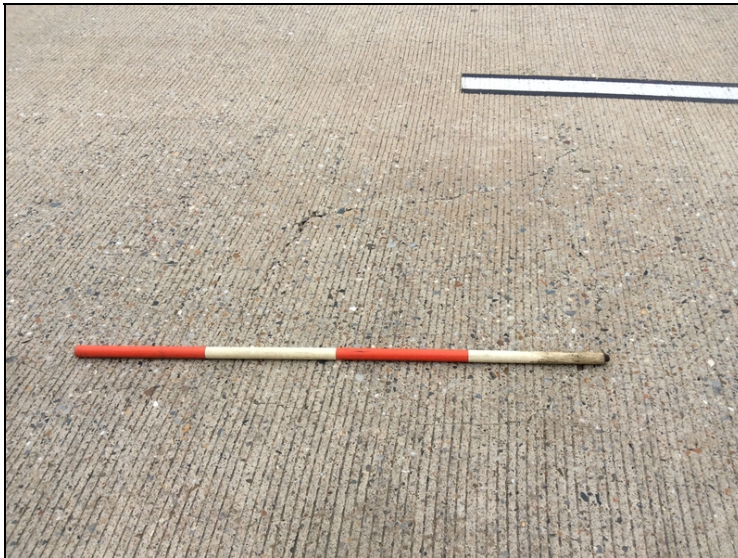
Deck all spans have unsealed cracks.

Span 6, deck cracks up to .050".

Date Reported: 03/16/2011
Priority: C - Important
Type of Work: Repair
Status: Monitor
Component: Deck

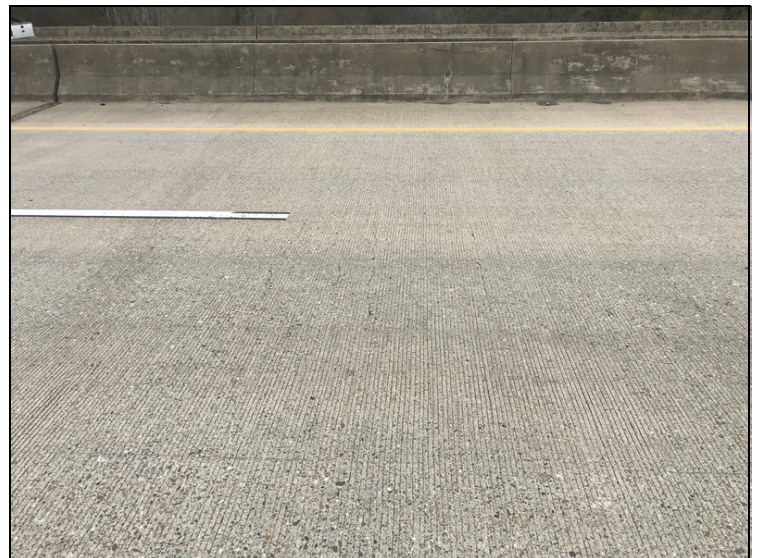
Span 4, large transverse cracks.

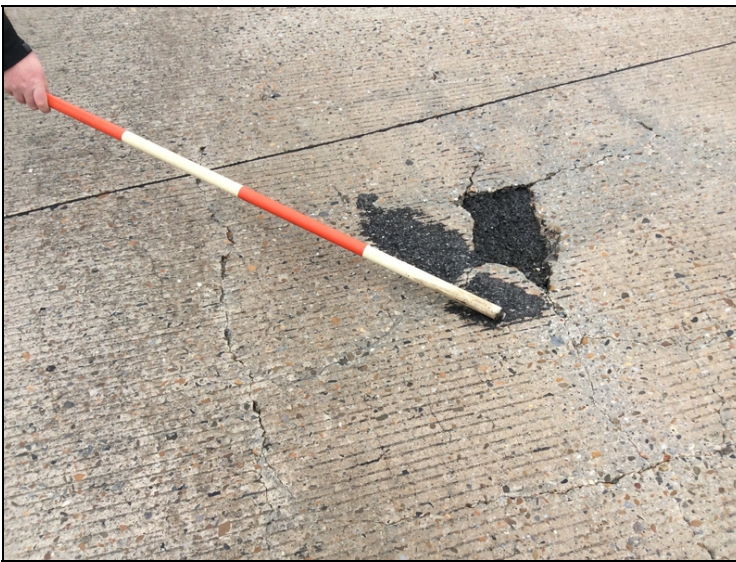
Deck span 2 has 1'x1' spall filled with asphalt.

Span 2, spall filled with asphalt.

Date Reported: 02/27/2014
Priority: C - Important
Type of Work: Repair
Status: Open
Component: Deck

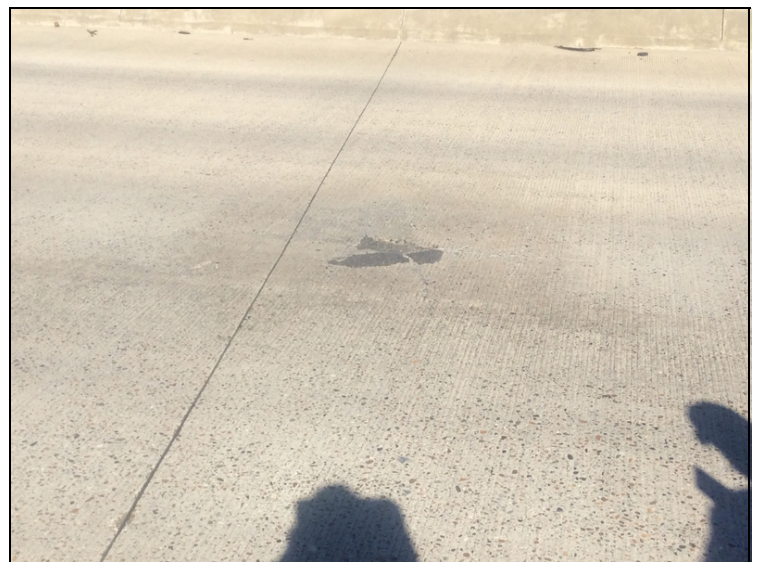
Spall filled with asphalt in deck at span 2.

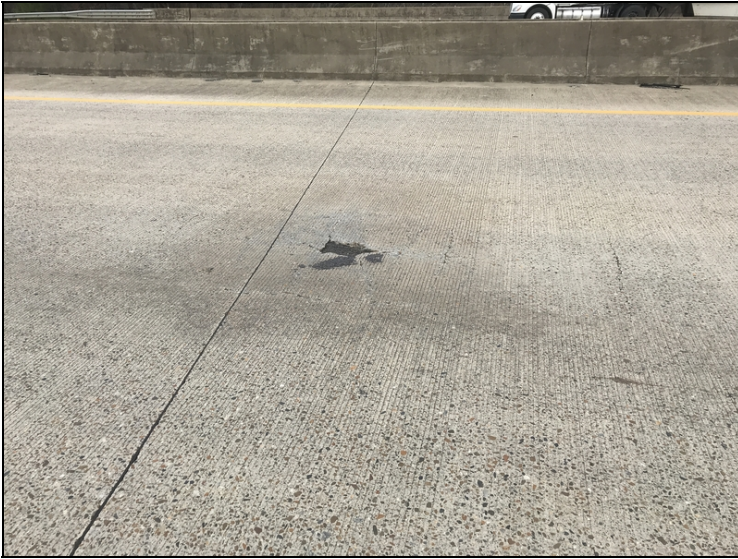
(12)	Transverse and longitudinal cracks in all spans up to and above 0.050". Pothole in span 2. . Overhangs have cracks with efflorescence.						
107	Steel Open Girder/Beam	LF	1692	1692	0	0	0
515	Steel Protective Coating	SF	12619	0	12619	0	0
3430	Oxide Film Degradation Color/Texture Adherence(Steel Protective Coatings)	SF	12619	0	12619	0	0
202	Steel Column	EA	7	0	7	0	0
1000	Corrosion	EA	7	0	7	0	0
515	Steel Protective Coating	SF	600	404	175	21	0
3440	Effectiveness (Steel Protective Coatings)	SF	196	0	175	21	0

Span 2 right lane pothole.

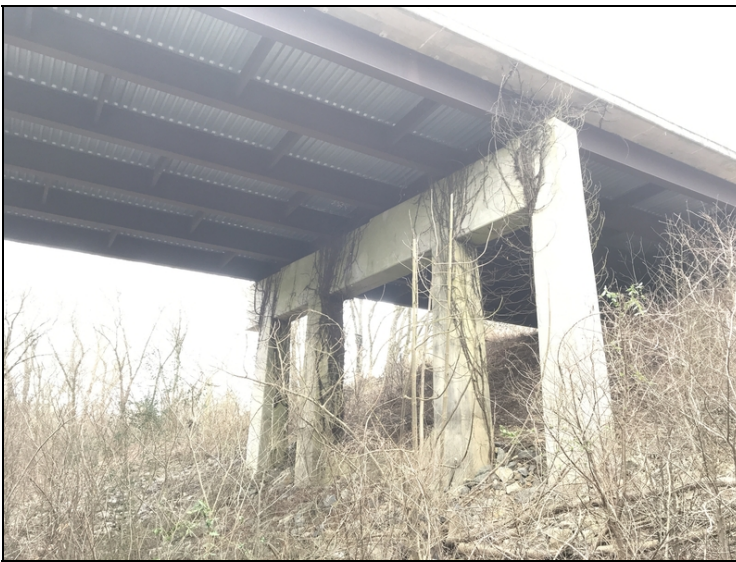
Vines growing on columns and caps on bent 2 and small trees growing under bridge in span 2.

Bent 2, vines growing on columns and cap

Date Reported: 02/25/2020
Priority: C - Important
Type of Work: Clean
Status: Open
Component:

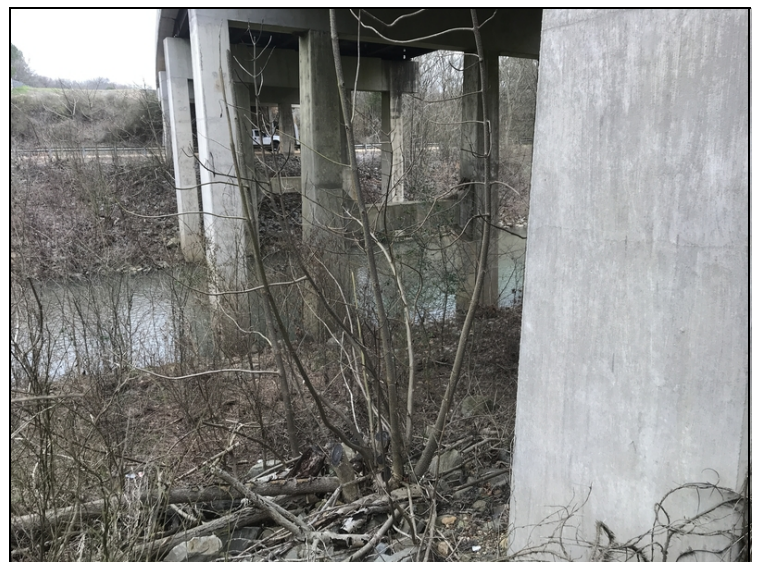
Span 2, typical of 1.
