**Bridge #B6872(Routine)**  
**I-40 EB Log 166.76 over Bayou Meto**

**Location: 2 Mi E of SH 15**

**Team Lead: Chris Doggett Inspection Date: July 09, 2019**

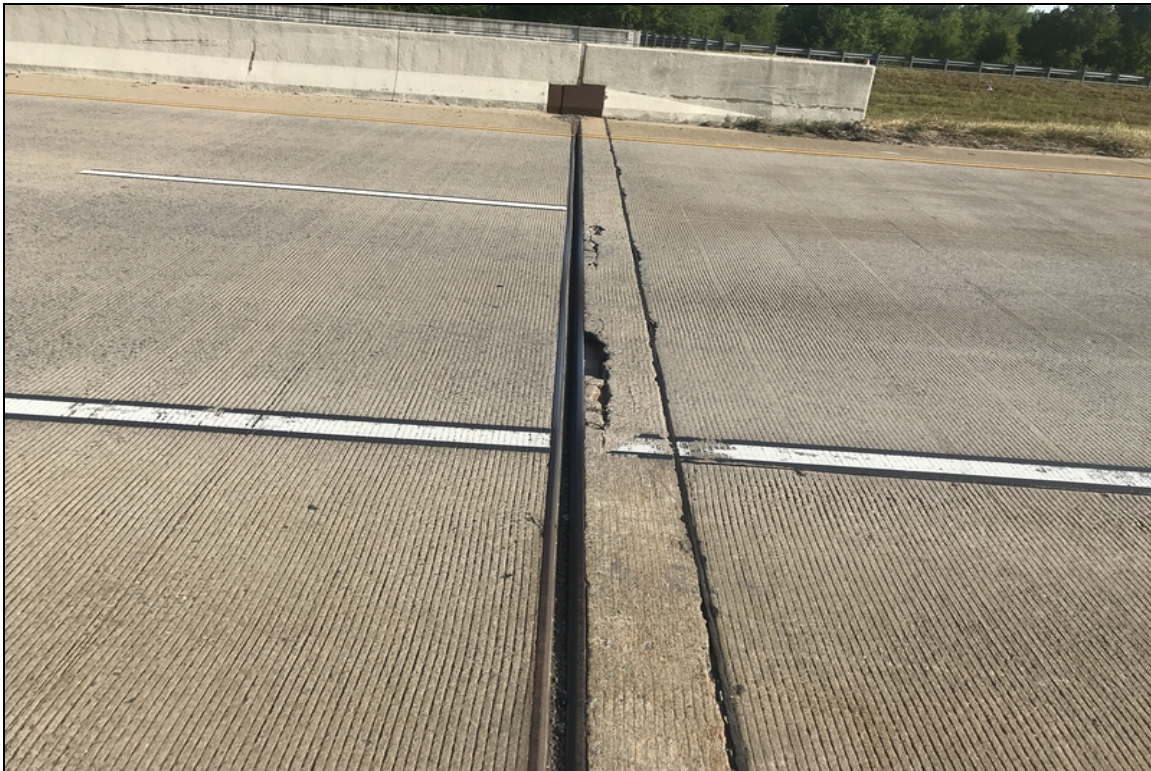
(215)	Bent 10 spalls in top of back wall at joint armor. See photo.						
227	Reinforced Concrete Pile	EA	42	41	1	0	0
1080	Delamination/Spall/Patched Area	EA	1	0	1	0	0

(300)	Spall at bent 10 along the joint armor.						
310	Elastomeric Bearing	EA	60	60	0	0	0
321	Reinforced Concrete Approach Slab	SF	1752	1704	0	48	0
1130	Cracking (RC and Other)	SF	48	0	0	48	0

Bent 10: head wall with spalls in the right lane of traffic

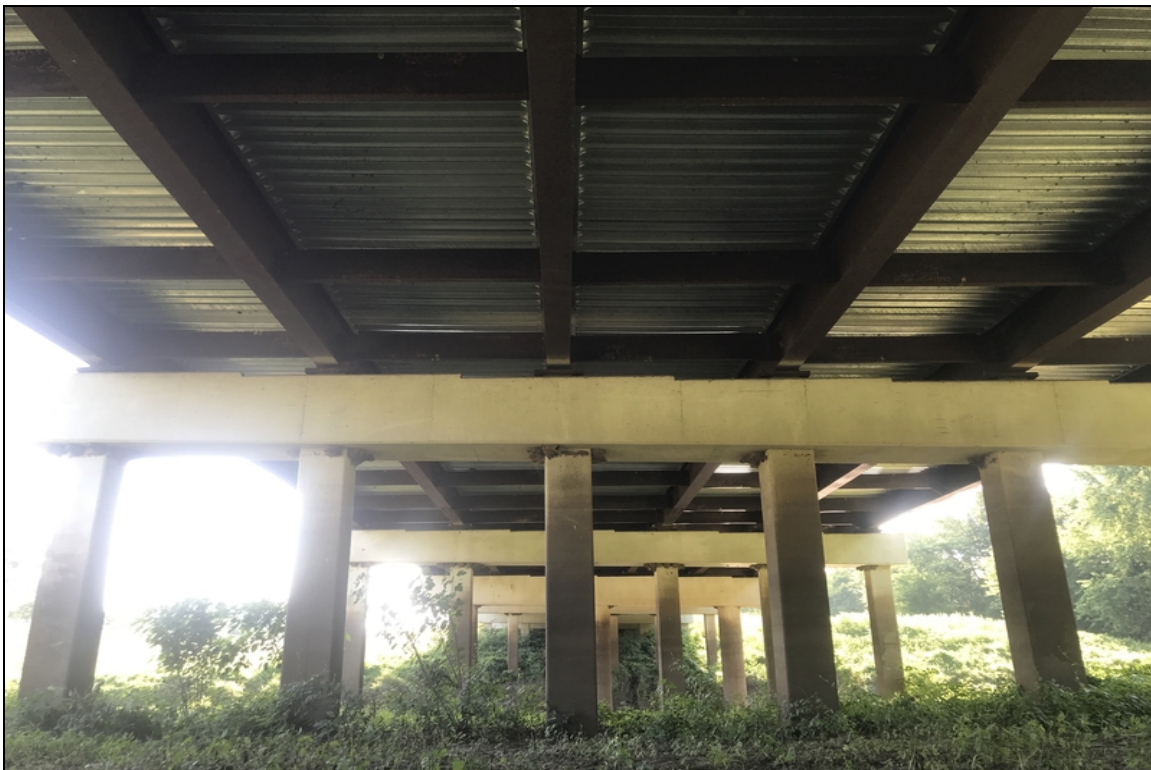
Soffit view
