Bridge #A3654(Routine)

I-40 WB Log 180.68 over RICKETY BRANCH

Location: 2 MI W SH 13-WESTBOUND

Team Lead: Keith Harris Inspection Date: March 16, 2021

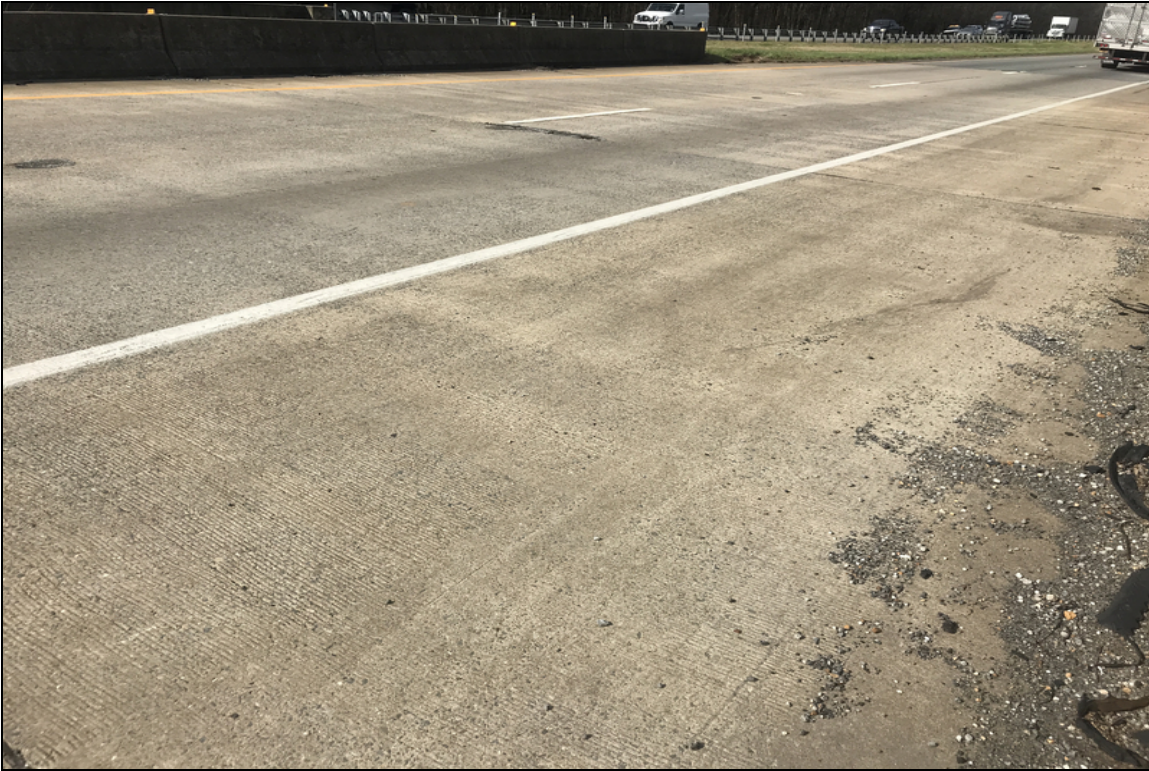
Deck overview

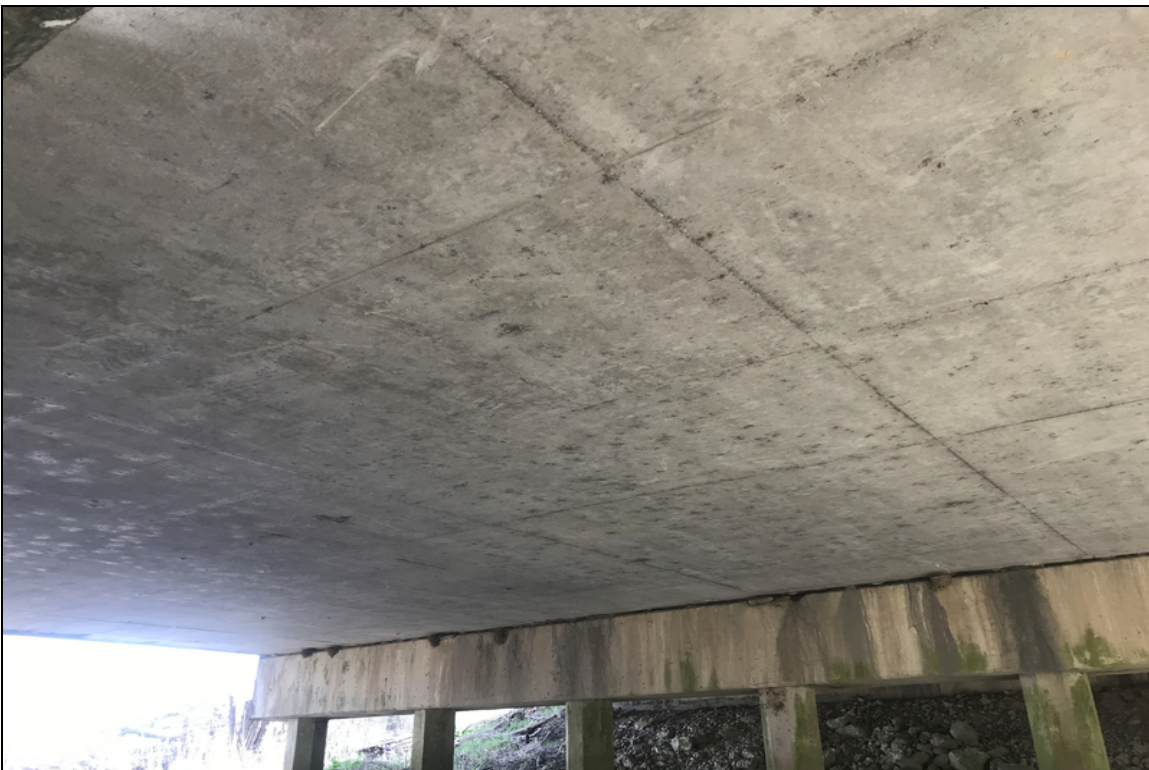
Slab under view Span 2

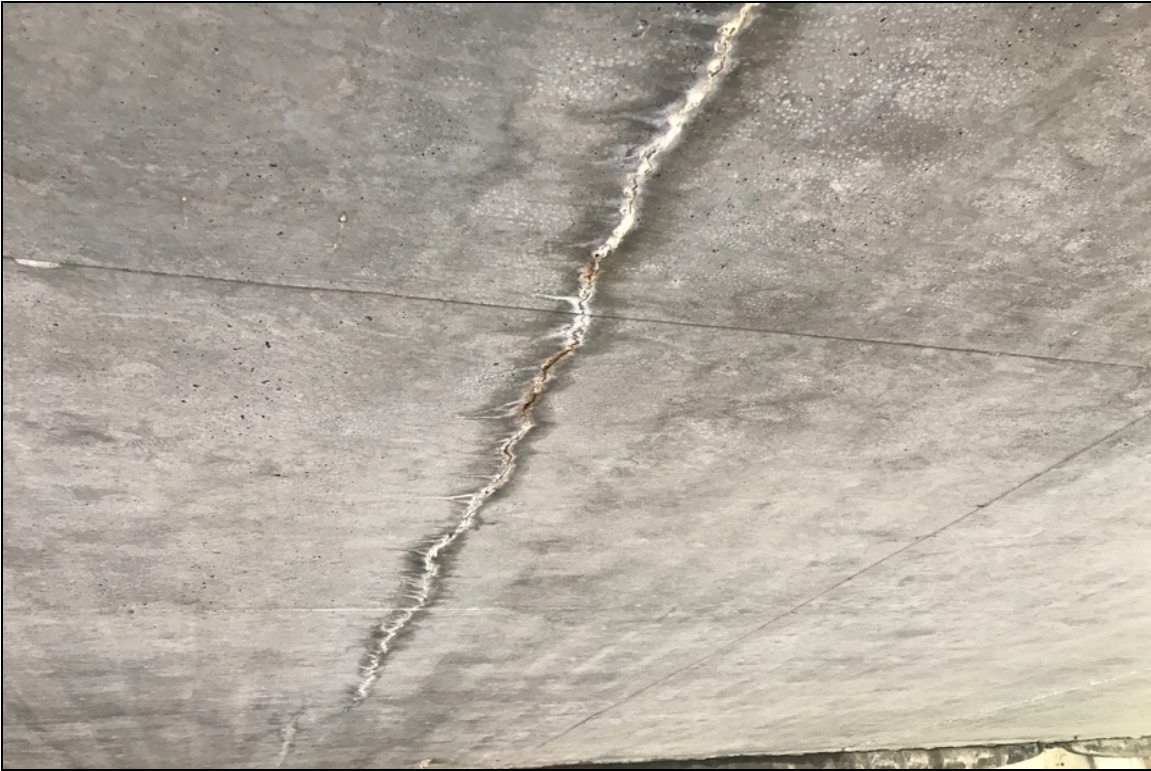
(38)	Spall filled with asphalt in the end of span 2. All three spans have longitudinal cracks near centerline. (0.035 inch width avg.) Span 3 has longitudinal cracks up to 1/8" wide.						
215	Reinforced Concrete Abutment	LF	94	94	0	0	0
227	Reinforced Concrete Pile	EA	14	14	0	0	0
234	Reinforced Concrete Pier Cap	LF	89	82	0	7	0
1090	Exposed Rebar	LF	7	0	0	7	0

Cracks with efflorescence at centerline of span 3.

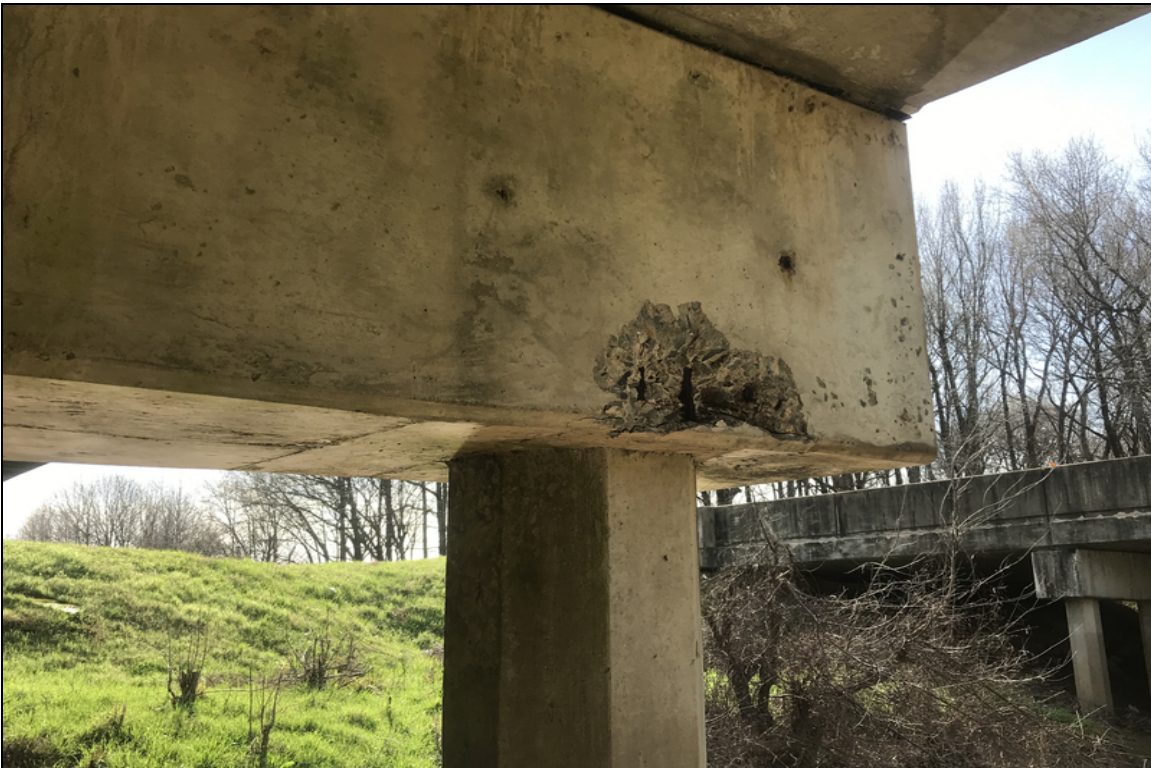
(234)	Bent 2 right end of cap back above pile 7 spall with exposed rebar. Bent 3 small spalls with rebar on bottle of cap						
301	Pourable Joint Seal	LF	89	0	89	0	0
2320	Seal Adhesion	LF	89	0	89	0	0
321	Reinforced Concrete Approach Slab	SF	2788	2704	12	72	0
1130	Cracking (RC and Other)	SF	84	0	12	72	0

Spall with exposed rebar on bent 2 cap

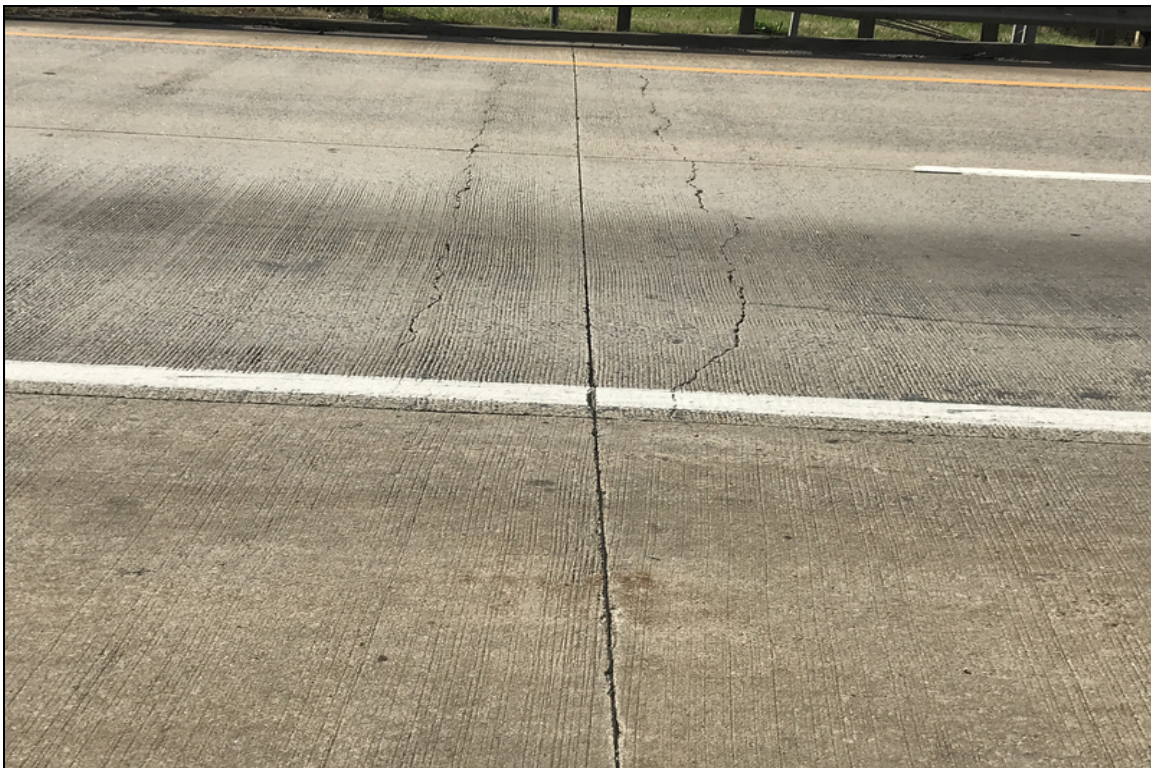
(321)	Both approach slabs have transverse cracks.						
331	Reinforced Concrete Bridge Railing	LF	150	147	0	3	0
1130	Cracking (RC and Other)	LF	3	0	0	3	0

Large cracks in East approach slab

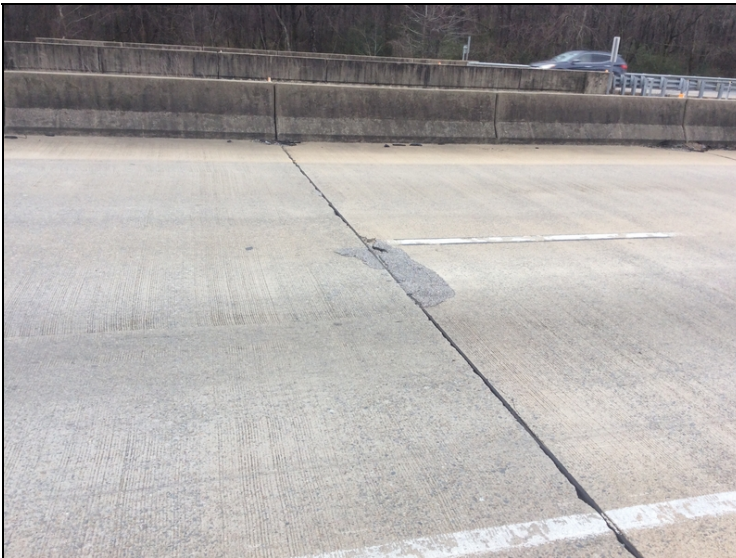
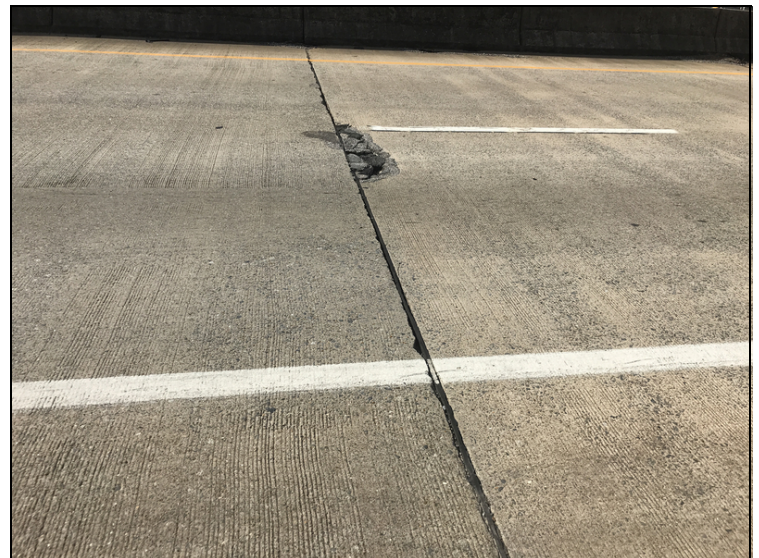
**Date Reported:** 03/06/2013  
**Priority:** C - Important  
**Type of Work:** None  
**Status:** Monitor  
**Inspection Direction** W to E  
**Component:**

Span # 2 deck spall right lane west bound.

Span 2 at bent 3: large spall that has an asphalt patch.

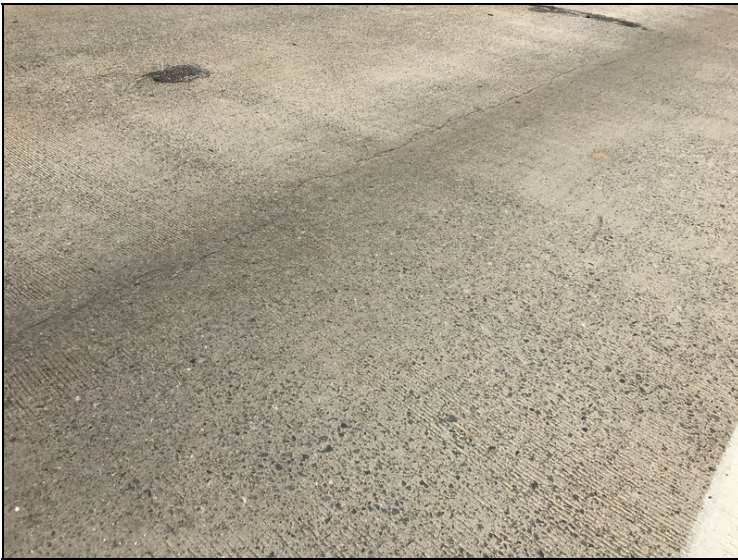
Date Reported: 03/20/2017  
Priority: C - Important  
Type of Work: None  
Status: Monitor  
Inspection Direction W to E  
Component:

Span 3 large unsealed cracks.

Span 3 unsealed crack at centerline
