Bridge #B3654(Routine)

I-40 EB Log 180.68 over RICKETY BRANCH

Location: 2 MI W SH 13-EASTBOUND

Team Lead: Keith Harris Inspection Date: March 16, 2021

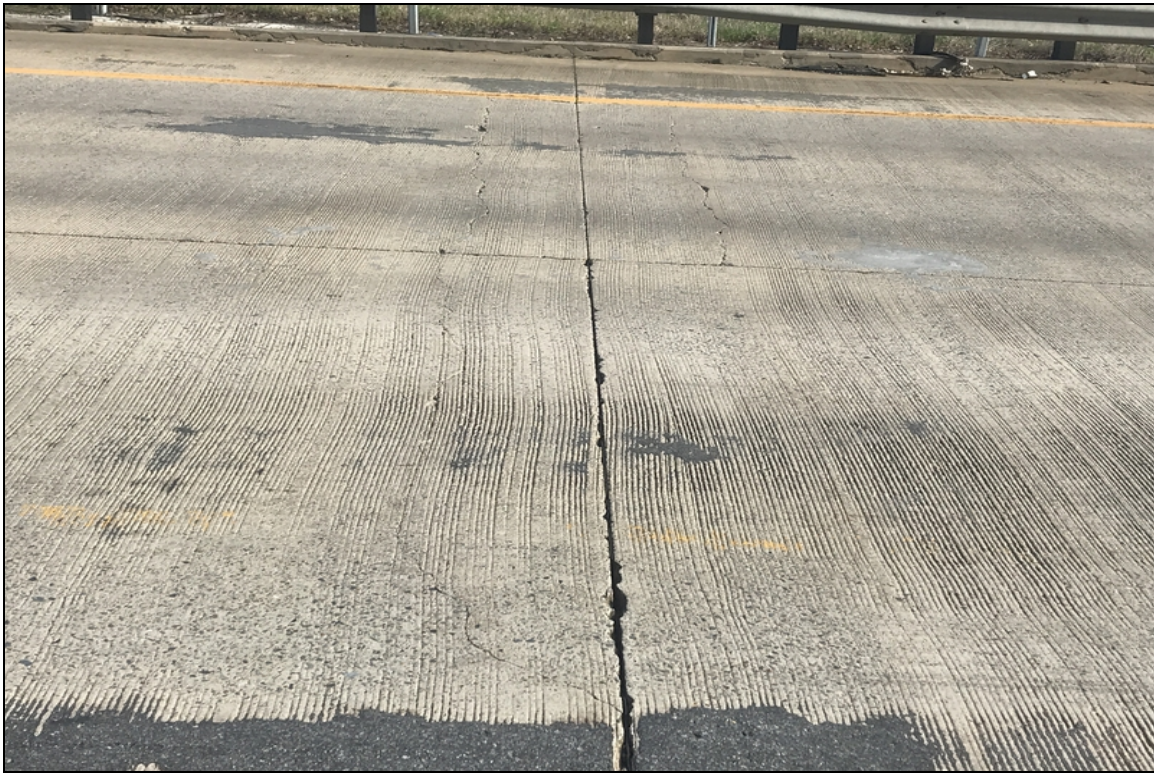
| ELEM | DESCRIPTION | UNITS | TOTAL | CS1 | CS2 | CS3 | CS4 |
|---|---|---|---|---|---|---|---|
| (321) | Both approach slabs have cracks. | | | | | | |

Cracks in West approach slab

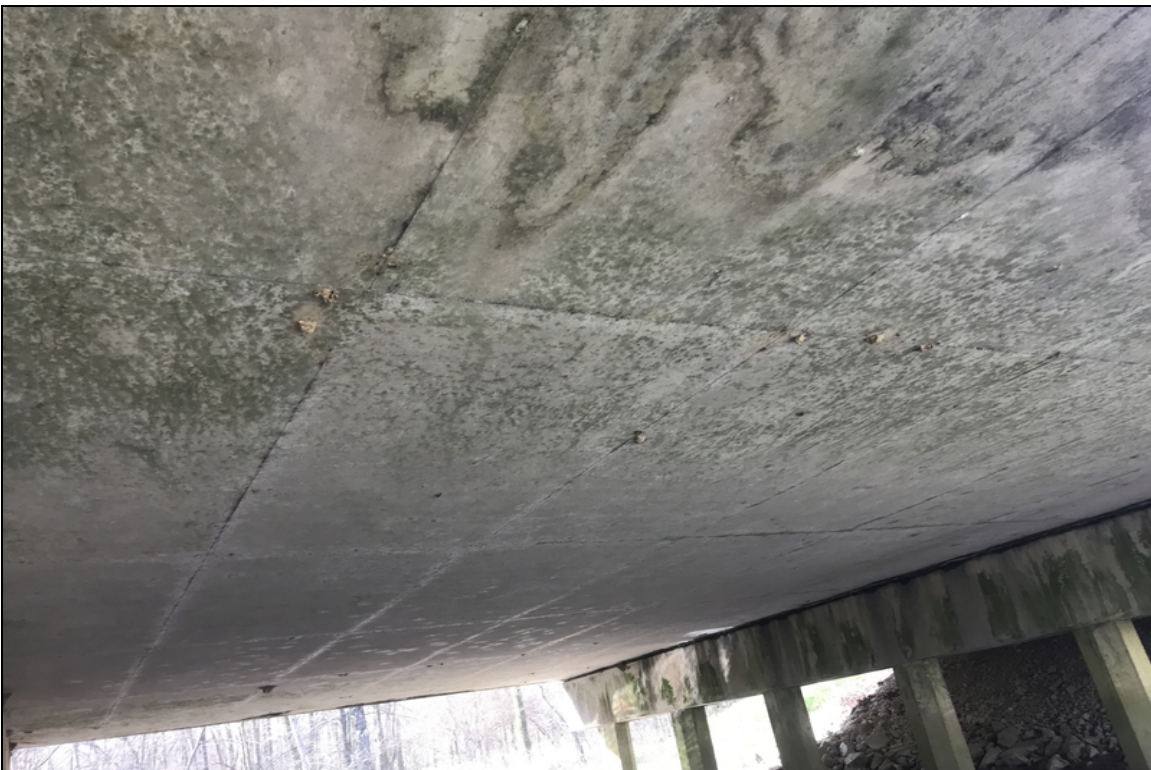
Slab under view span 2

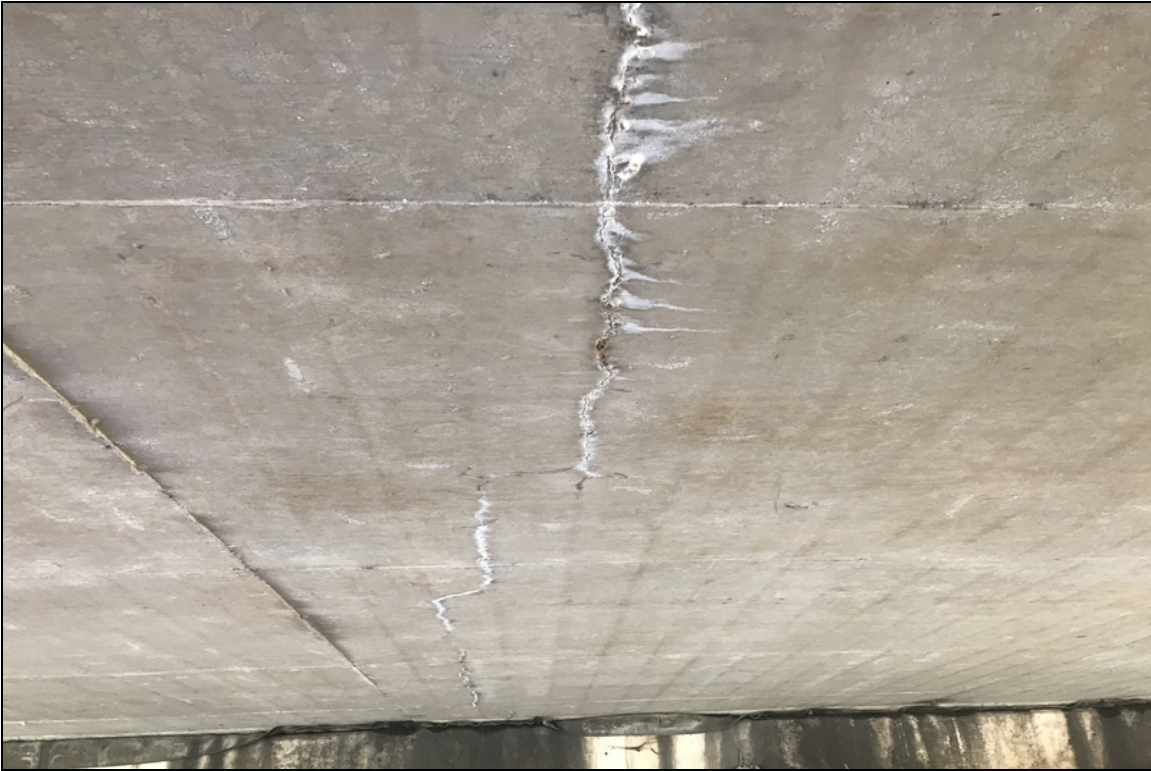
| ELEM | DESCRIPTION | UNITS | TOTAL | CS1 | CS2 | CS3 | CS4 |
|---|---|---|---|---|---|---|---|
| (38) | Longitudinal crack near centerline of all three spans up to 1/8" wide. Small spalls at bent 2. | | | | | | |

Cracks with efflorescence at centerline in Span 3.

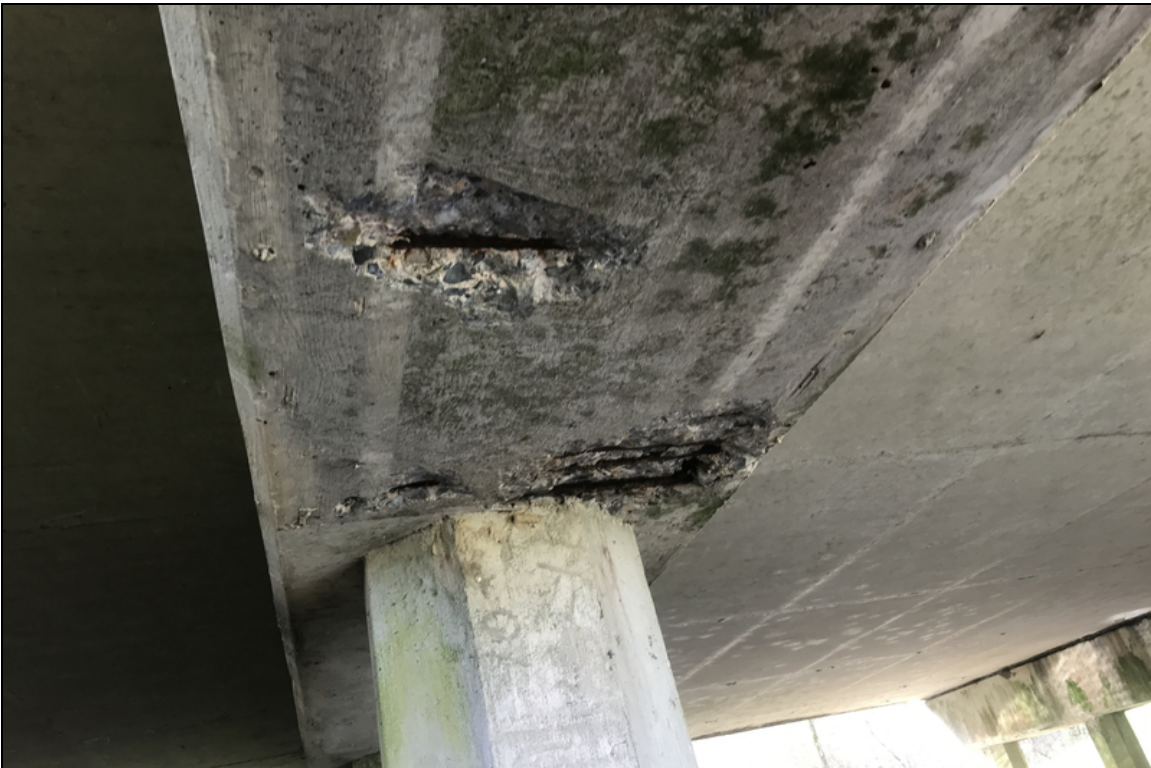
| ELEM | DESCRIPTION | UNITS | TOTAL | CS1 | CS2 | CS3 | CS4 |
|---|---|---|---|---|---|---|---|
| (234) | Spalls with exposed rebar to bottom of caps at bents 2&3 | | | | | | |

Spalls with exposed rebar at Bent 3 bottom of cap.

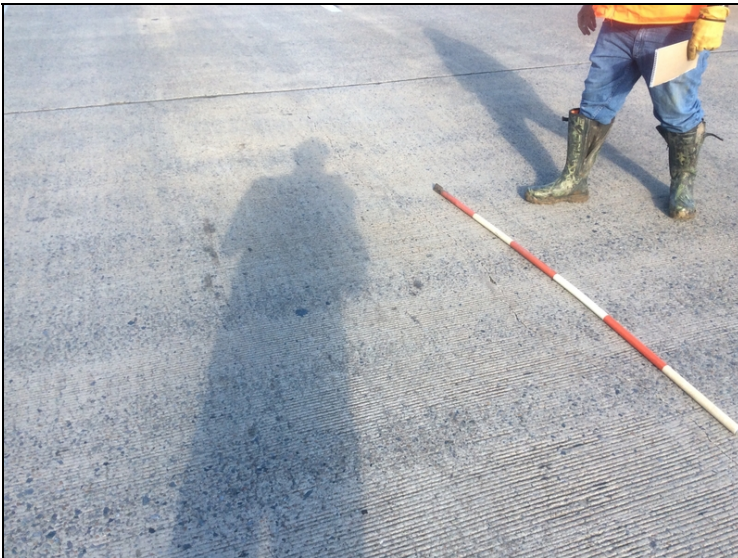
Deck all spans large unsealed longitudinal cracks.

Longitudinal crack span 3 common span 1

Date Reported: 03/20/2017
Priority: C - Important
Type of Work: None
Status: Monitor
Inspection Direction W to E
Component:

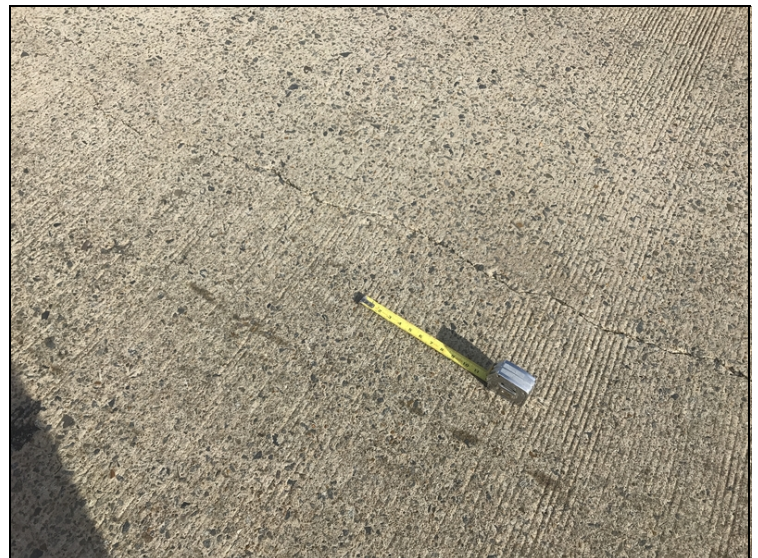
Span 1 longitudinal cracks
