Bridge #A3689(Routine)
I-30 WBS-14LM69.8 over BIG DECIPER CREEK

Location: .53 MI E JCT SH 26

Team Lead: Rickie Bratton Inspection Date: December 17, 2019

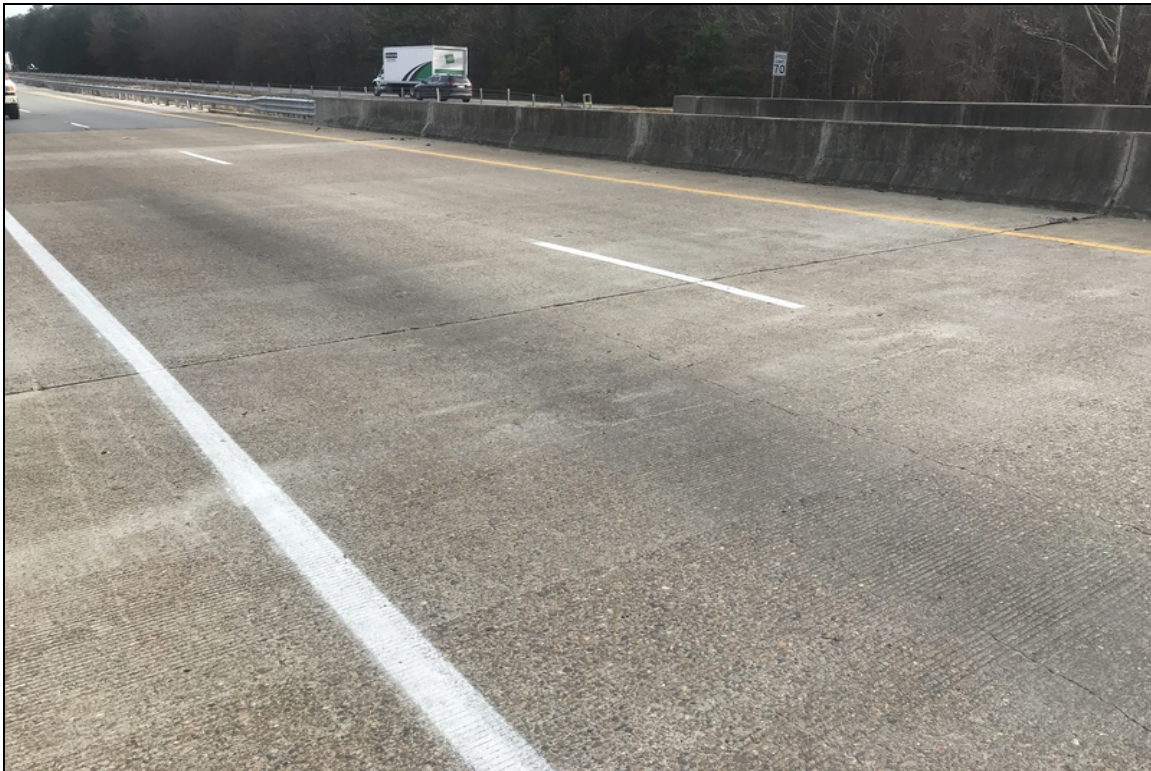
Deck overview.

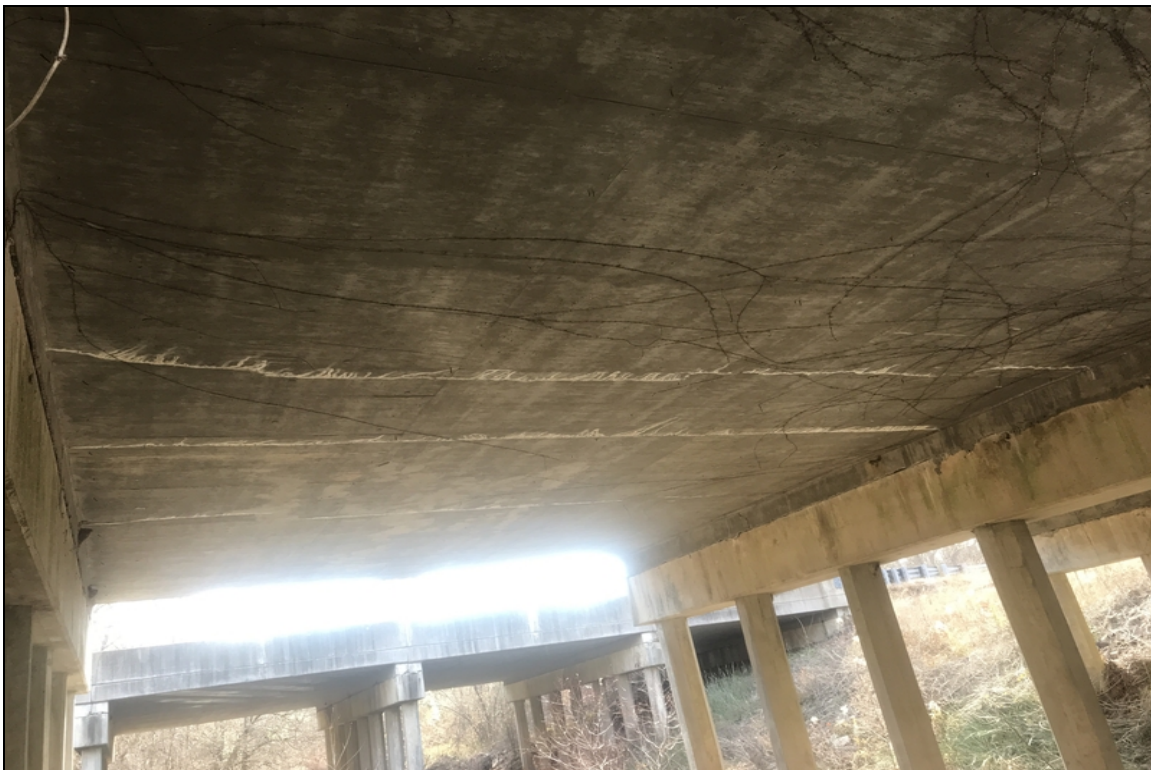
ELEM	DESCRIPTION	UNITS	TOTAL	CS1	CS2	CS3	CS4
38	RC Slab	SF	4450	3567	758	125	0
1120	Efflorescence/Rust Staining	SF	325	0	325	0	0
1130	Cracking (RC and Other)	SF	558	0	433	125	0
(38) Longitudinal cracks. Soffit has corresponding efflorescent cracks. 12/27/17 JPR -- there is 1 full length longitudinal crack + 1 more on span 4 that are #3 crack, the rest are #2 cracks.							
215	Reinforced Concrete Abutment	LF	80	80	0	0	0
227	Reinforced Concrete Pile	EA	21	21	0	0	0
234	Reinforced Concrete Pier Cap	LF	133	133	0	0	0
301	Pourable Joint Seal	LF	200	0	140	60	0
2320	Seal Adhesion	LF	140	0	140	0	0
2330	Seal Damage	LF	60	0	0	60	0
(301) Losing bond and leaking. 12/27.2017 JPR -- some of the joint material is missing.							
331	Reinforced Concrete Bridge Railing	LF	200	200	0	0	0

Soffit span 3, cracks with light efflorescence.

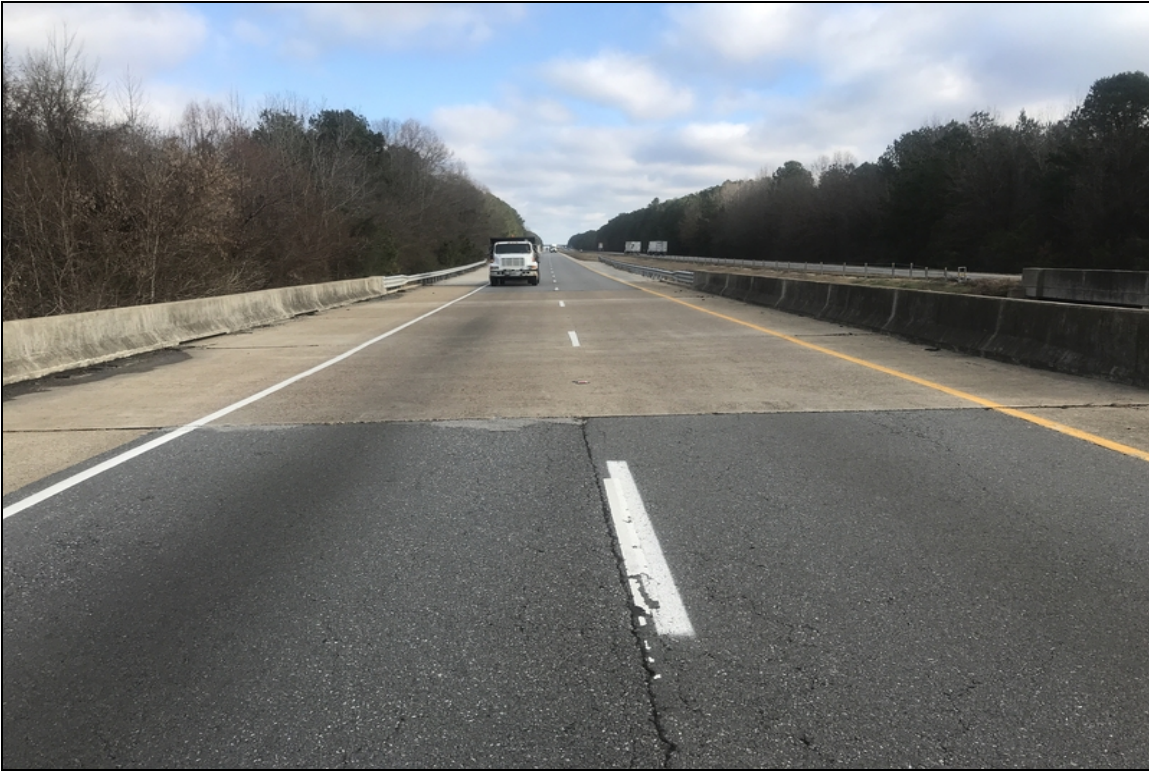
Approach roadway.

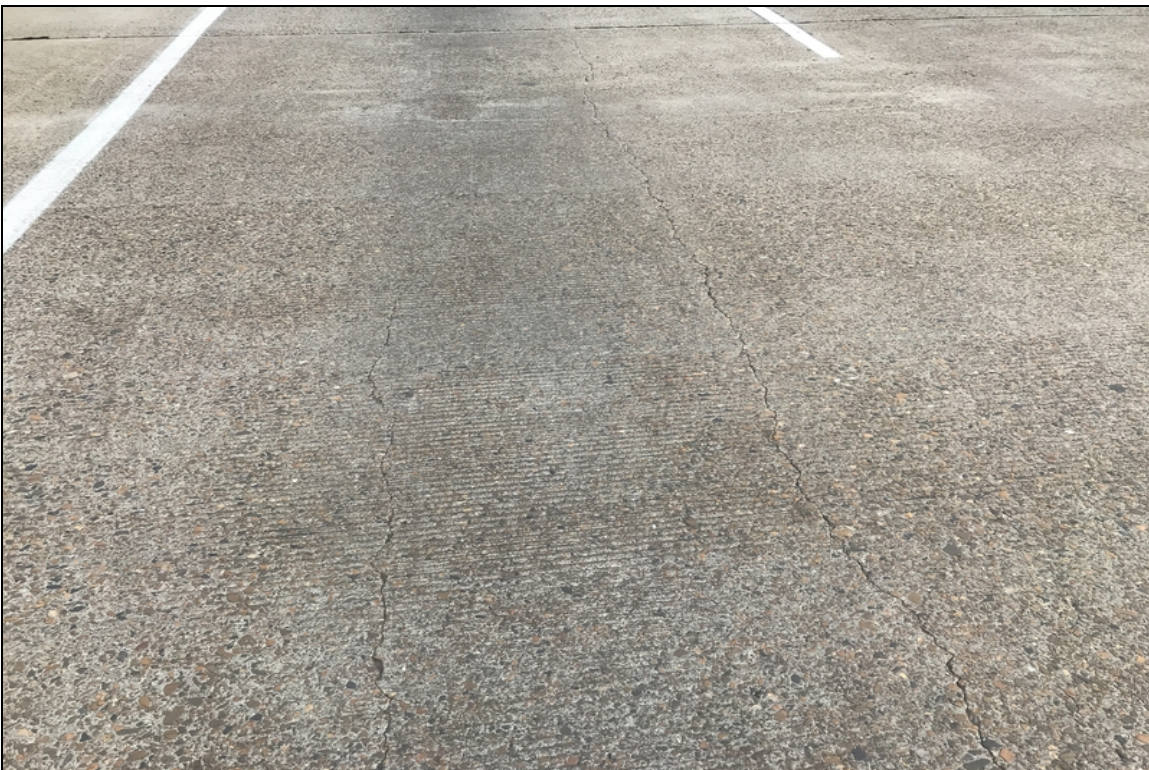
Cracks Span 1.

Surface crkg all spans esp. longit. crks in Lt lane(Rt lane for traf.) sealable 12/16/2013 JPR Longitudinal crack span 4 in deck, Lt. of C/L or (Rt. of C/L of RML with flow of traffic), this crack has opened up and is allowing water road salts and debris to get down into the concrete and reinforcing steel. There are several more longitudinal cracks in the deck but span 4 is the worst. 12/27/17 JPR -- there is 1 full length longitudinal crack + 1 more on span 4 that are #3 crack, the rest are #2 cracks.
