DESIGN RE-EVALUATION

ARDOT JOB 100512
FAP NHPP-0076(178)
WALNUT RIDGE – MISSOURI STATE LINE (FUTURE I-57) P.E.
CLAY, GREENE, LAWRENCE, AND RANDOLPH COUNTIES

Preliminary Wetland Delineation

Corning Bypass (Future I-57)

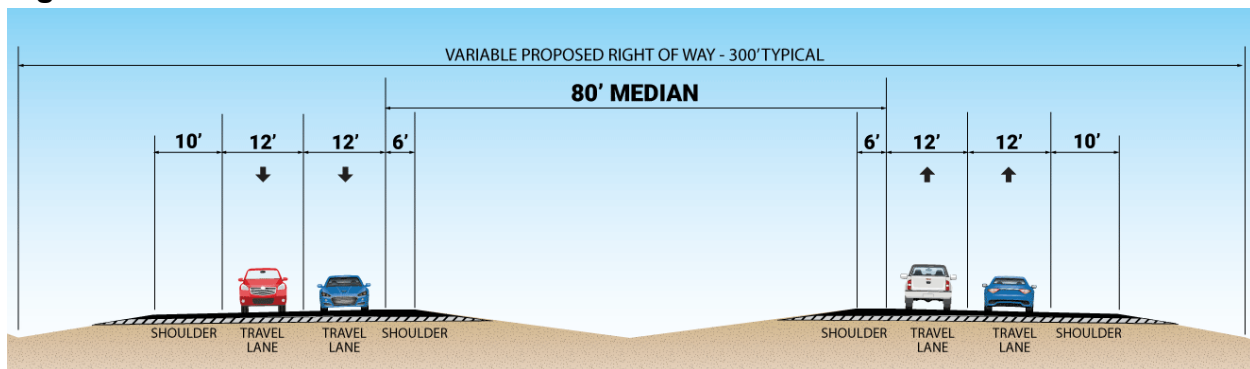
Figure 2: Cross Section

constructed. At the Highway 67 interchange north of Corning, only the northbound exit ramp and the southbound entrance ramps are being constructed. North of Corning, additional right of way would be purchased east of Highway 67 in anticipation of a future section of the Future I-57 project (i.e., ARDOT Job 101173; Section 7 in **Figure 1**). The Corning Bypass would be a fully-controlled access facility designed to interstate standards. The proposed roadway would be a 4-lane divided highway with a depressed 80-foot median and an approximately 300-foot-wide right of way (**Figure 2**). The roadway would have four 12-foot-wide driving lanes with 6-foot-wide inside shoulders, 10-foot-wide outside shoulders, and a proposed speed limit of 75 miles per hour. An overpass at County Road (CR) 139 is included to provide continued access for local users. CR 143 would be severed and include cul-de-sacs on each side of the proposed roadway. Culverts and drainage improvements are also incorporated into the project to ensure proper drainage.

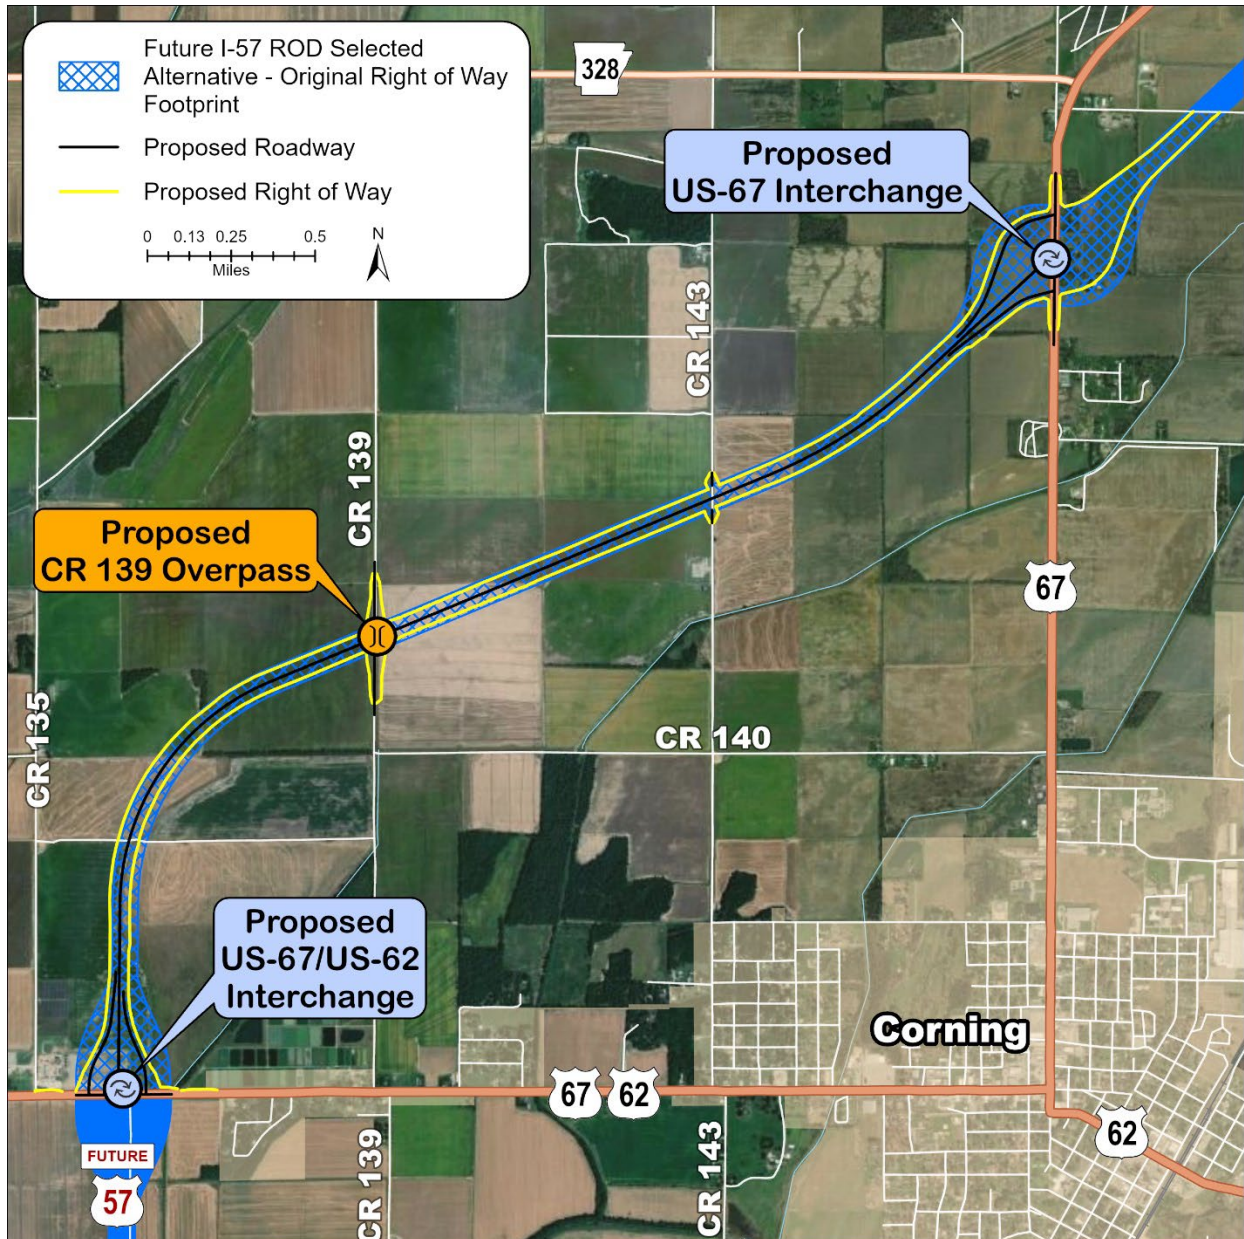
Figure 3: Original Footprint and Proposed Design Modifications

Design modifications to the Corning Bypass include an overpass and cul-de-sacs. These changes resulted in additional right of way required for the Corning Bypass portion of the Future I-57 project, which resulted in the need to re-evaluate the Corning Bypass segment. Additionally, the uplisting of the Northern Long-eared Bat (*Myotis septentrionalis*) from threatened to endangered also triggered the need for a re-evaluation.

Design changes resulted in three additional landowners being impacted by right of way acquisition and two other landowners no longer being impacted. The total number of landowners impacted by right of way acquisition for the Corning Bypass is 15.

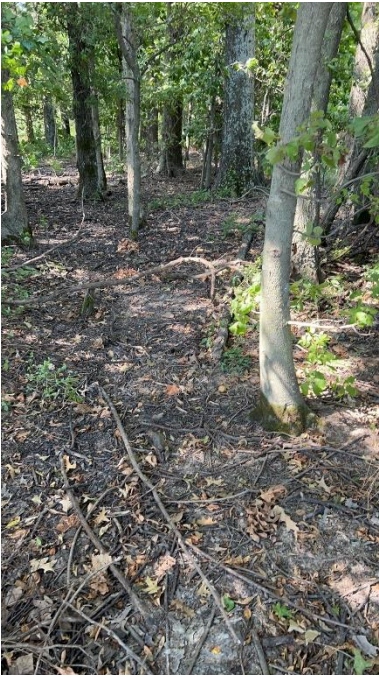
1	
Wetland 21

Description	Wetland 21 facing north.
2	
DP 37

Wetland 21 is classified as a PFO1E (Palustrine, Forested, Broad-Leaved Deciduous, Seasonally Flooded/Saturated Wetland). Observed hydrology indicators included drift deposits, water-stained leaves, moss trim lines, geomorphic position, and FAC-Neutral Test. Dominant vegetation included green ash, parsley hawthorn (*Crataegus marshallii*), and sugar-berry. Soils at DP 37 were considered hydric (depleted below dark surface and depleted matrix). A total of 0.06 acre of Wetland 21 occurs within the study area.

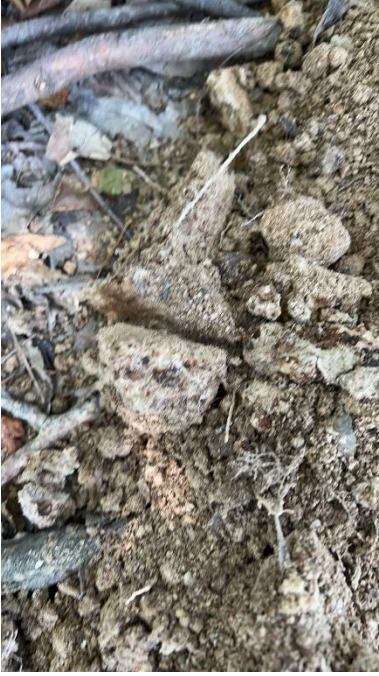
Description	View of hydric soils at DP 37.

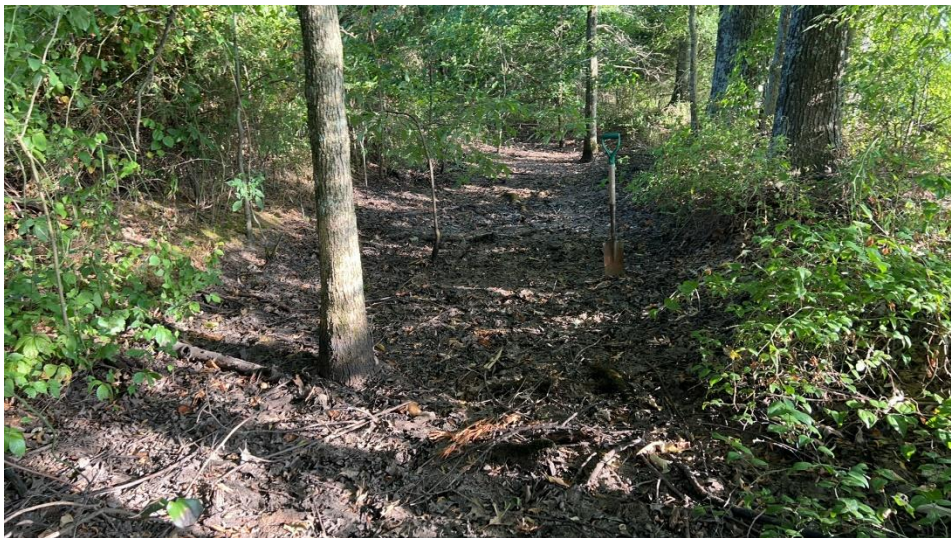
Description	View of Wetland 21.3 facing north.
--------------------	------------------------------------

Wetland 21.3 is classified as PFO1E. Observed hydrology indicators included water-stained leaves, geomorphic position, and FAC-Neutral Test. Dominant vegetation included green ash, water oak, and sugar-berry. Soils at DP 39 were considered hydric (depleted matrix). A total of 0.86 acre of Wetland 21.3 occurs within the study area.

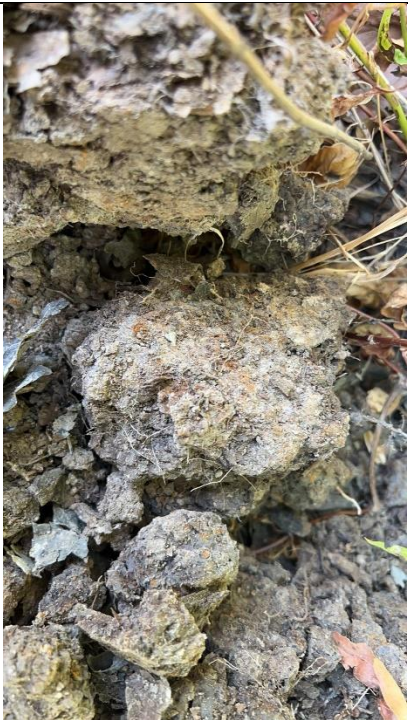
DP 39

Description	View of hydric soils at DP 39.
--------------------	--------------------------------

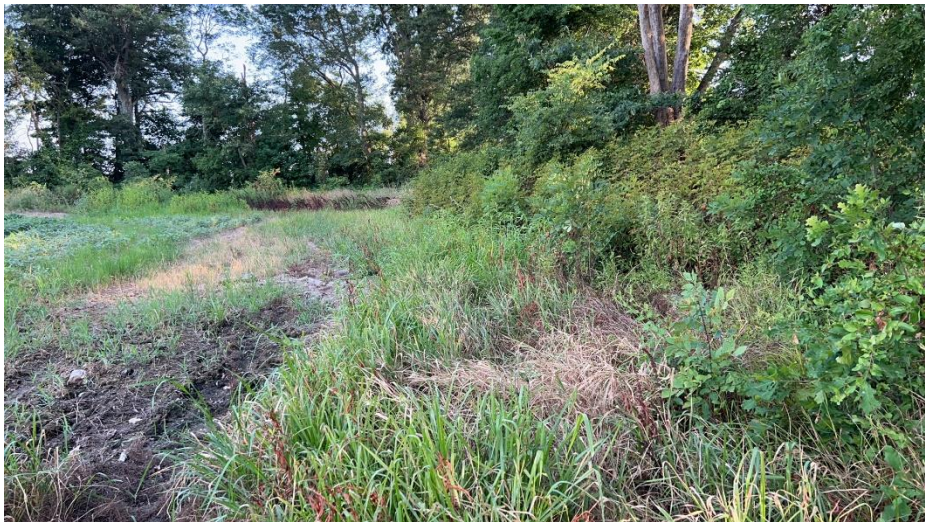
Description	View of Wetland 21.5 facing south.
--------------------	------------------------------------

Wetland 21.5 is classified as a PEM1E (Palustrine, Emergent, Persistent, Seasonally Flooded/Saturated Wetland). Observed hydrology indicators included sediment deposits, surface soil cracks, geomorphic position, and FAC-Neutral Test. Dominant vegetation included Frank's sedge, rice cut grass, sugar-berry, and cherry bark oak (*Quercus pagoda*). Soils at DP 40 were considered hydric (depleted matrix). A total of 0.17 acre of Wetland 21.5 occurs within the study area.

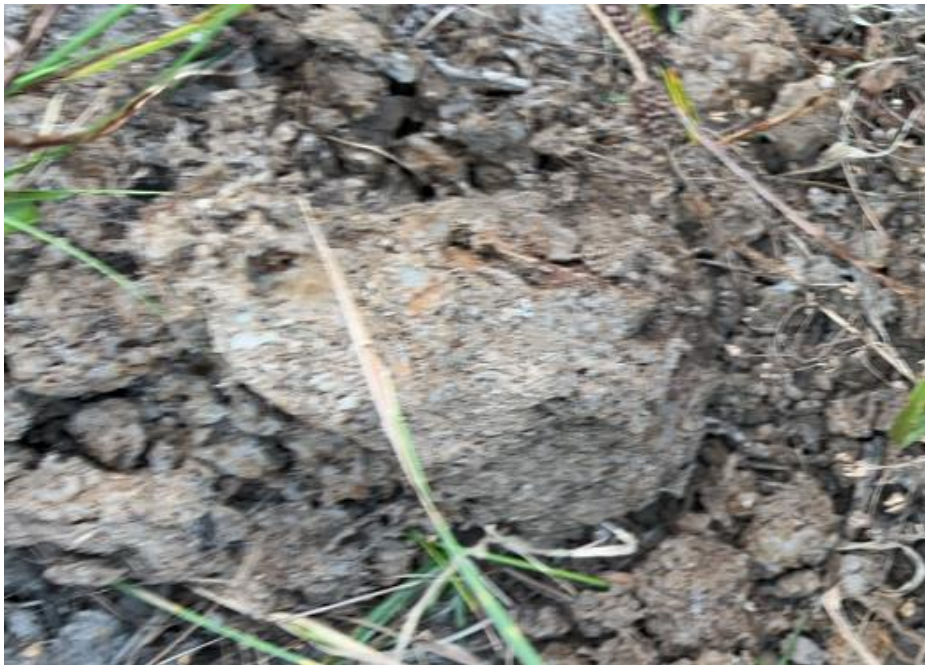
DP 40

Description	View of hydric soils at DP 40.
--------------------	--------------------------------

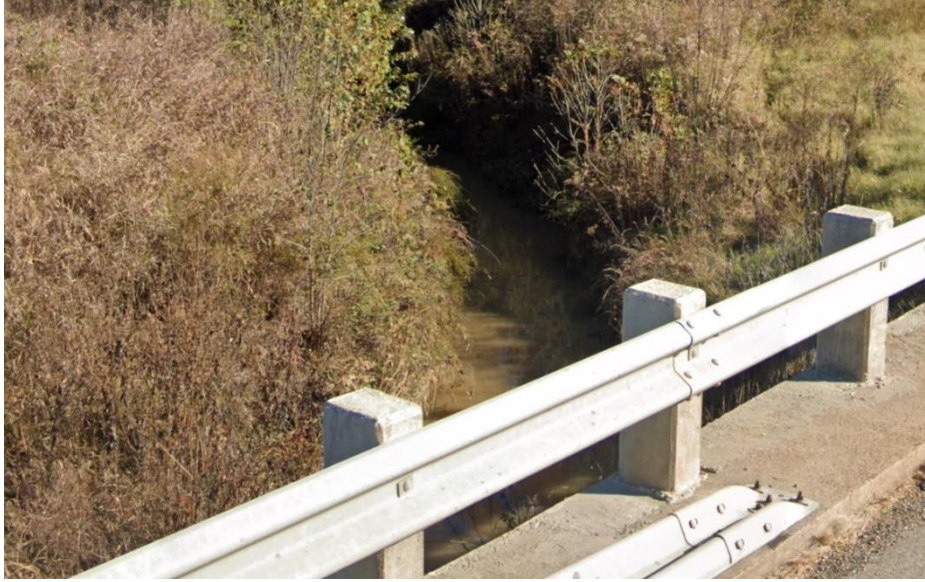
OW 105 (Oak Creek Ditch) - Upstream

Description View of OW 105 facing upstream. This reach will be spanned by fencing but will not be impacted within the ordinary high water marks. **Photo Credit:** Google Street View.

Other Water 105 (OW 105; Oak Creek Ditch) is a tributary of the Black River and a USGS-mapped intermittent stream that flows southwest through the study area. OW 105 was flowing during the site visit and the substrate consisted primarily of silt and gravel. On average, OHWMs were observed to be 10 ft. wide and 1 ft. deep. Approximately 87 LF of OW 105 occurs within the study area.

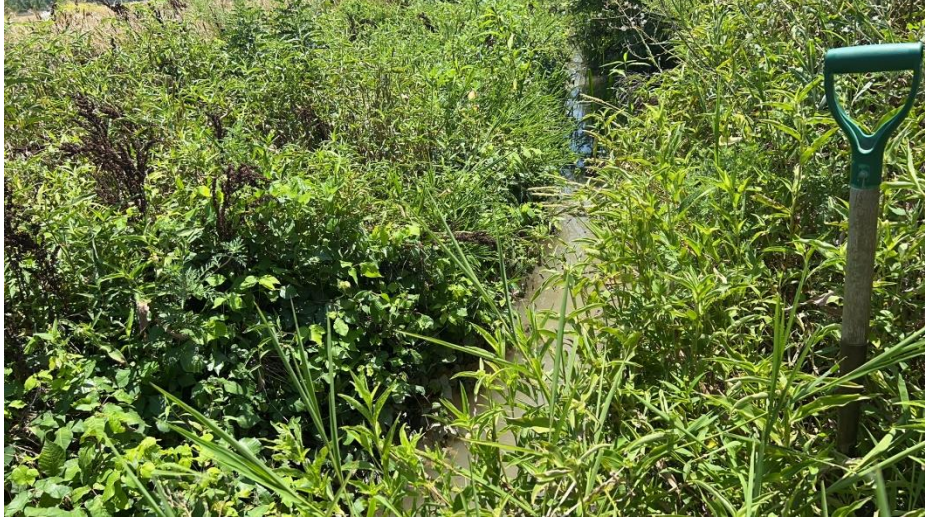
OW 108 - Downstream

Description View OW 108 facing downstream to the south. This intermittent stream was flowing at the time of the site visit.

Other Water 108 (OW 108) is a USGS-mapped intermittent stream which flows south through the project area to Oak Creek Ditch. This low gradient stream was flowing at the time of the field visit and the substrate consisted primarily of silt. On average, OHWMs were observed to be 5.5 ft. wide and 0.75 ft. deep. Approximately 1,473 LF of OW 108 occurs within the study area.

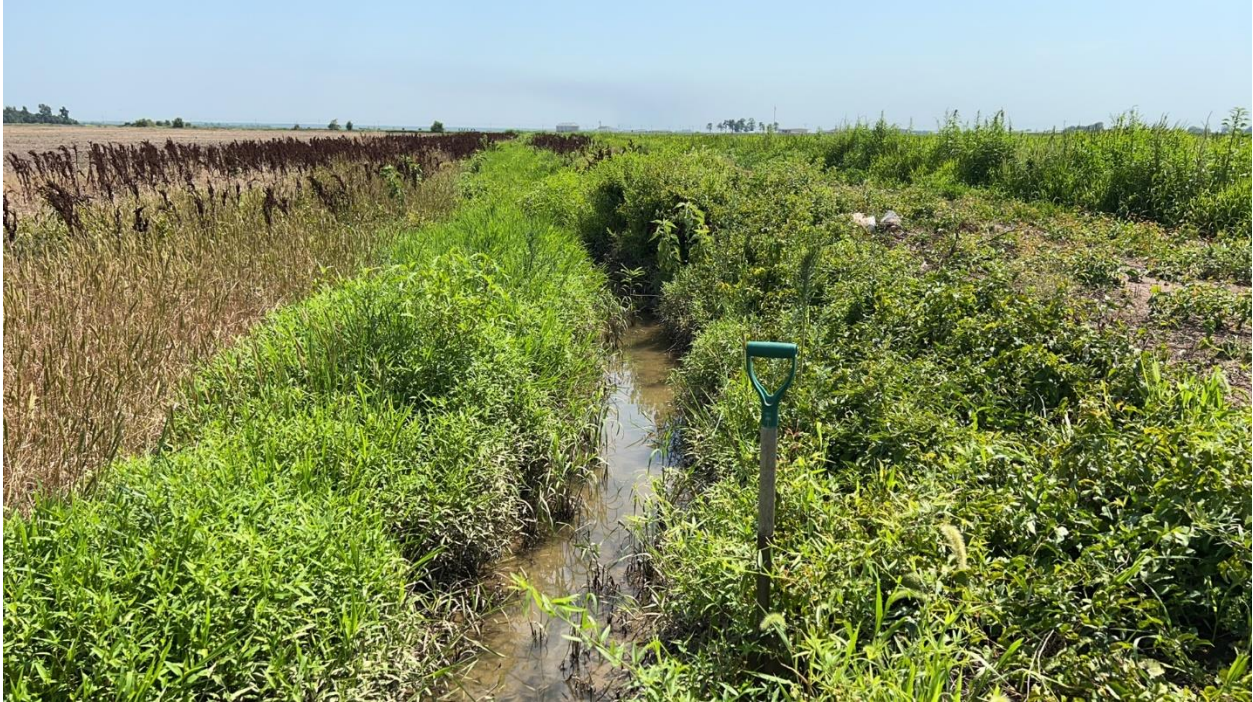
OW 110 - Downstream

View of OW 110 facing downstream to the south. This is an upper reach of the same stream which makes up OW 108.

Other Water 110 (OW 110) is an upper reach of the same stream that is OW 108. It is a USGS-mapped intermittent stream that flows south through the project area to Oak Creek Ditch. This low gradient stream was flowing at the time of the field visit and the substrate consisted primarily of silt. On average, OHWMs were observed to be 3 ft. wide and 0.5 ft. deep. Approximately 2,281 LF of OW 110 occurs within the study area.

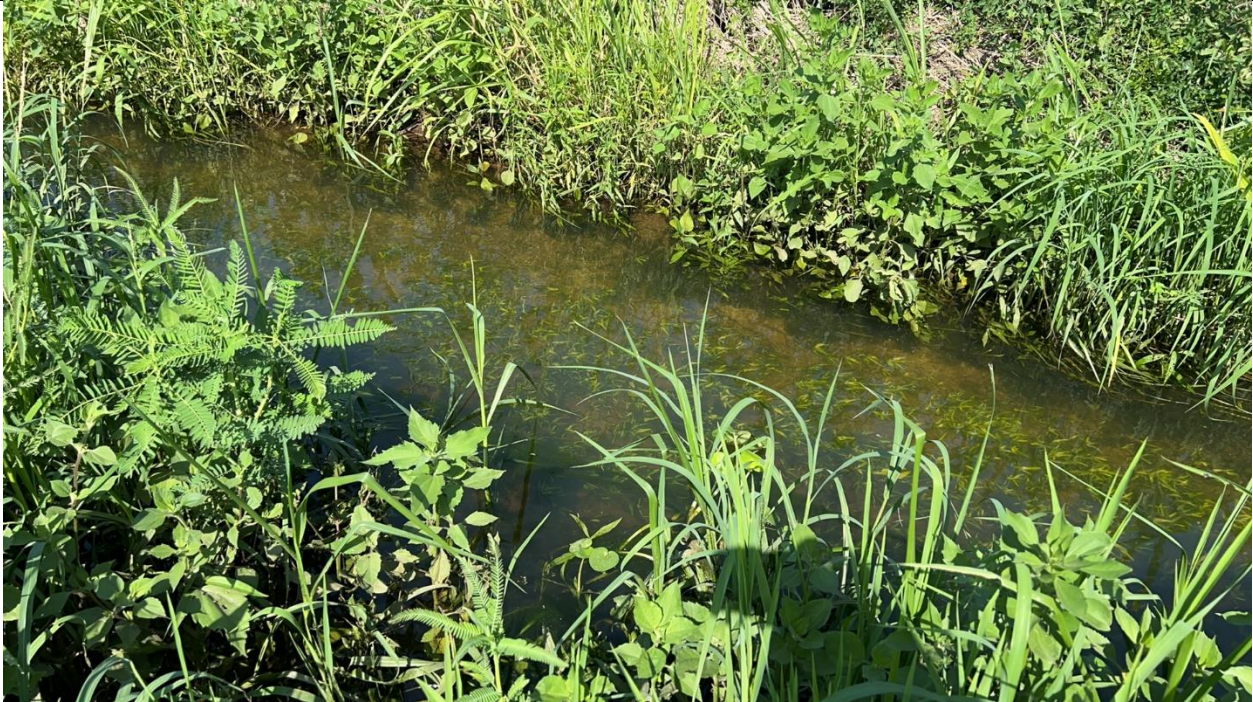
OW 111 (Oak Creek Ditch)

View of OW 111 facing northeast. This reach of Oak Creek Ditch flows south through the study area.

Other Water 111 (OW 111; Oak Creek Ditch) is an upper reach of the same stream that is OW 105. It is a USGS-mapped intermittent stream which flows south through the project area. This low gradient stream was flowing at the time of the field visit and the substrate consisted primarily of silt. On average, OHWMs were observed to be 12 ft. wide and 2 ft. deep. Approximately 1,976 LF of OW 111 occurs within the study area.

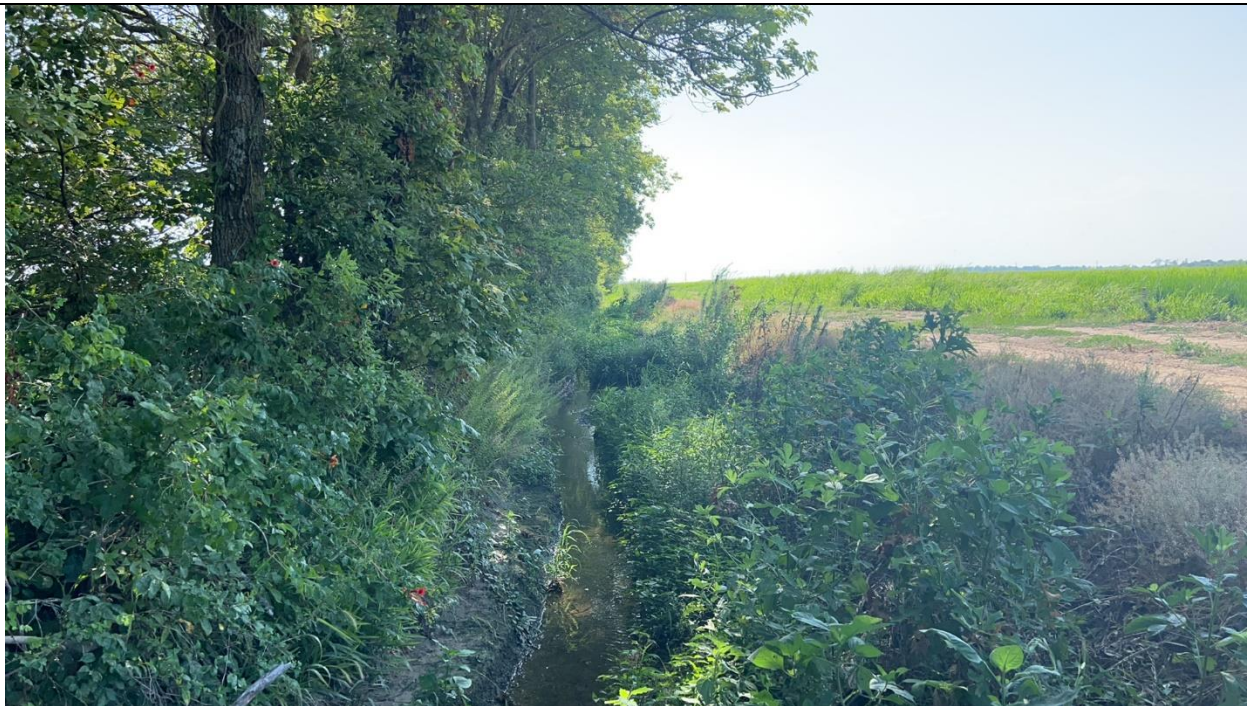
OW 113 – Downstream

View OW 113 facing downstream to the south.

Other Water 113 is a USGS-mapped intermittent stream which flows east and then south through the project area to Middle Creek Ditch. This low gradient stream was flowing at the time of the field visit and the substrate consisted primarily of silt. On average, OHWMs were observed to be 5 ft. wide and 0.8 ft. deep. Approximately 603 LF of OW 113 occurs within the study area.

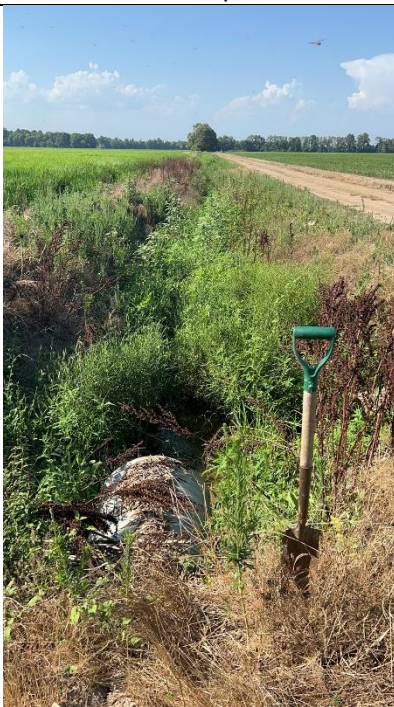
OW 114 - Upstream

View of OW 114 facing upstream to the west.

Other Water 114 (OW 114) is a USGS-mapped intermittent stream which flows south through the project area to OW 113. This low gradient stream was flowing at the time of the field visit and the substrate consisted primarily of silt. On average, OHWMs were observed to be 6 ft. wide and 1 ft. deep. Approximately 381 LF of OW 114 occurs within the study area.

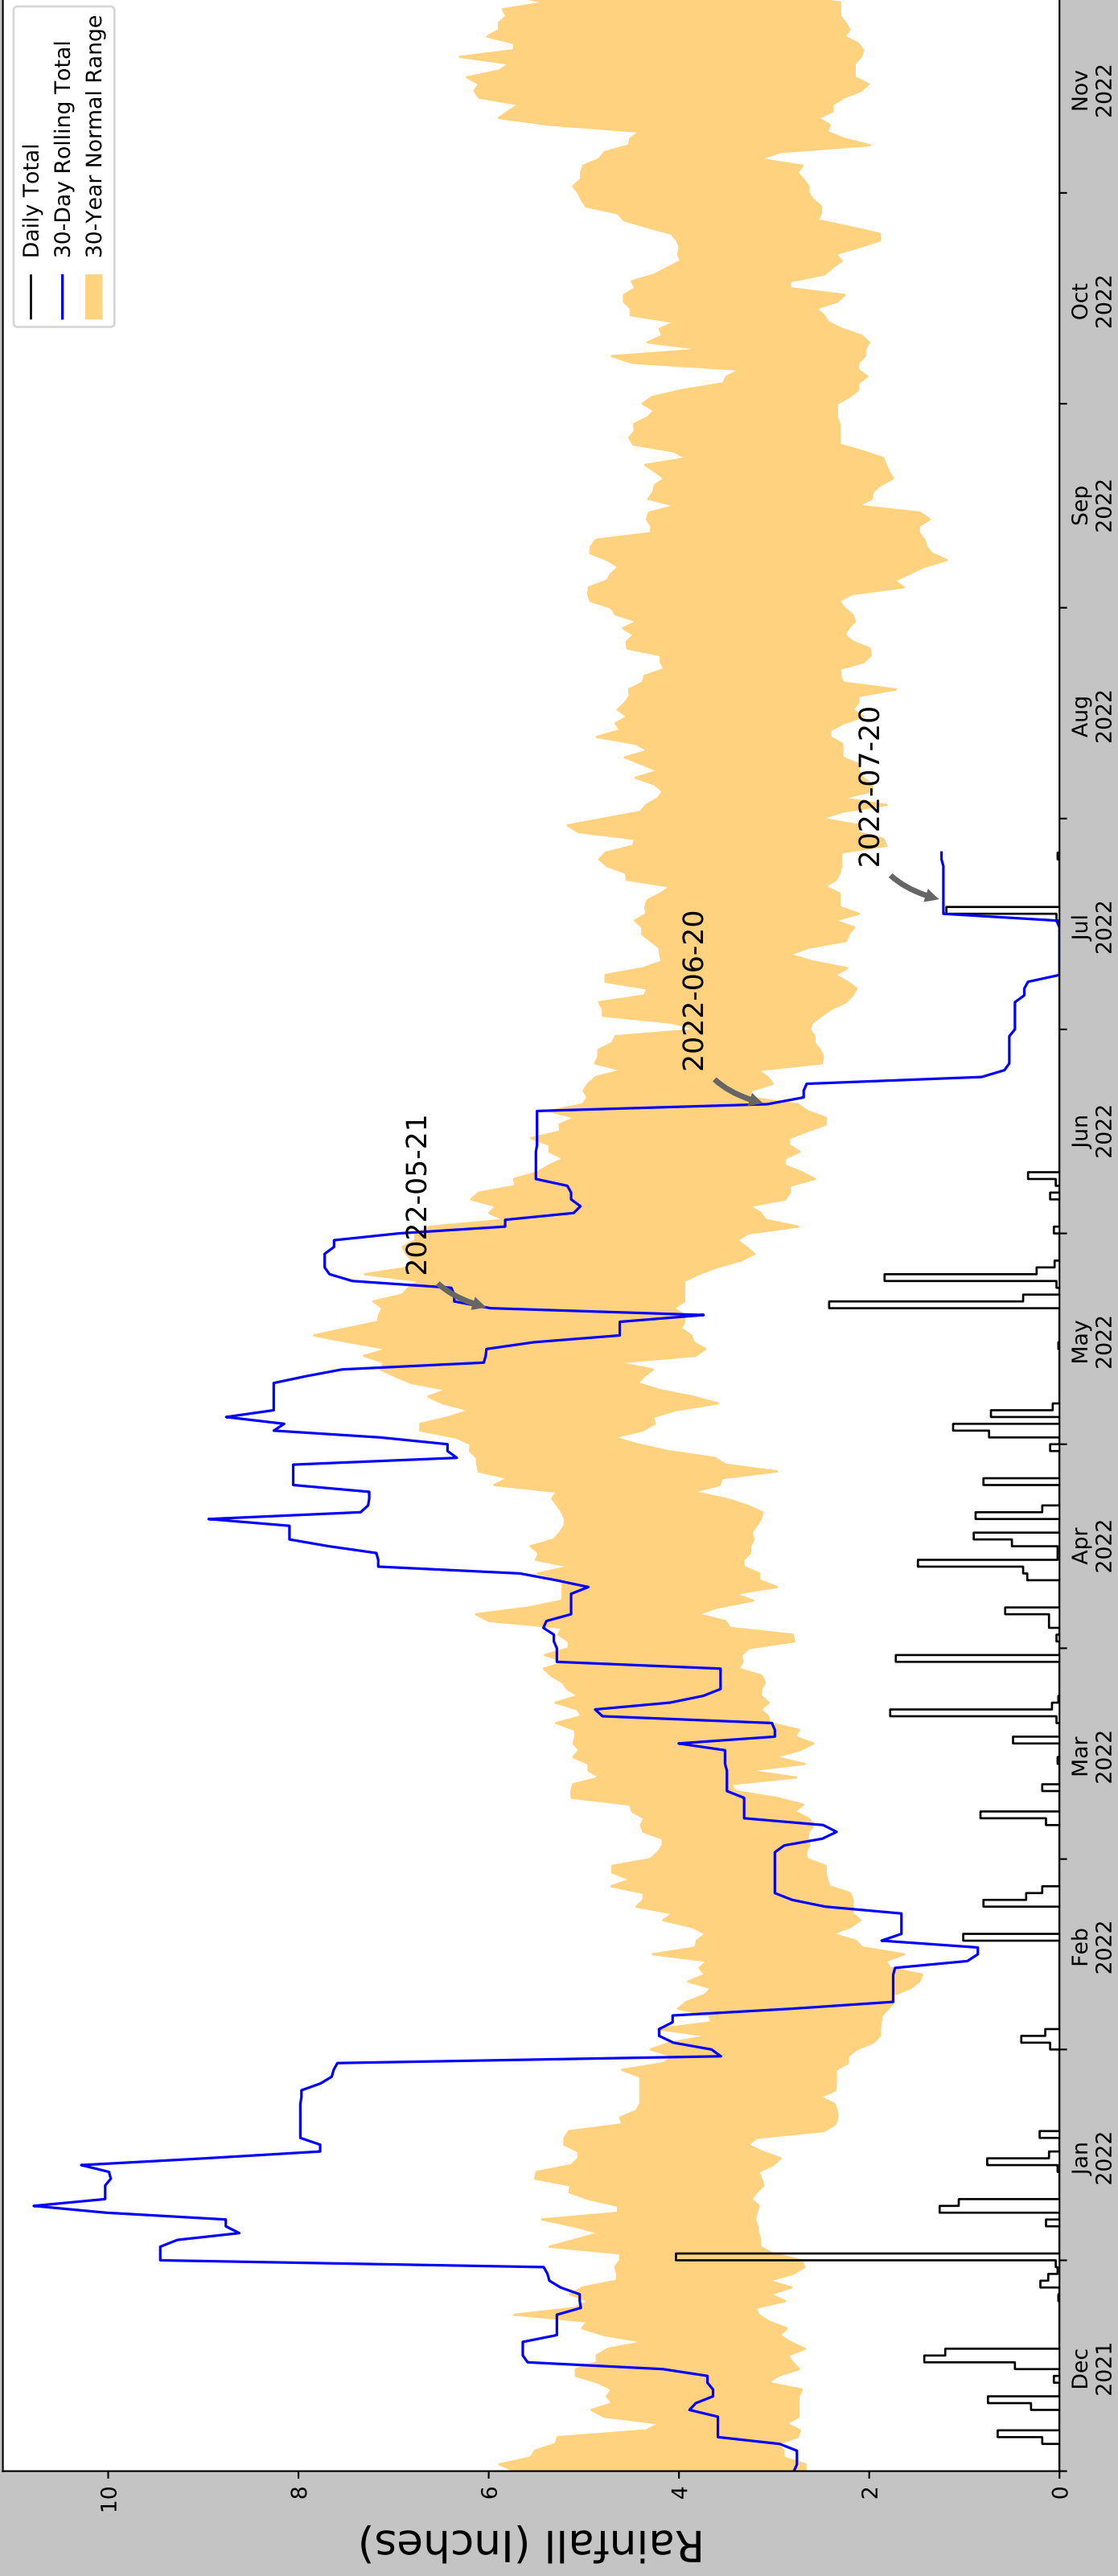
Antecedent Precipitation vs Normal Range based on NOAA's Daily Historical Climatology Network

Coordinates	36.321338, -90.776862
Observation Date	2022-07-20
Elevation (ft)	287.46
Drought Index (PDSI)	Incipient wetness (2022-06)
WebWIMP H ₂ O Balance	Dry Season

30 Days Ending	30 th %ile (in)	70 th %ile (in)	Observed (in)	Wetness Condition	Condition Value	Month Weight	Product
2022-07-20	2.312598	4.331496	1.220472	Dry	1	3	3
2022-06-20	2.750787	5.009055	3.070866	Normal	2	2	4
2022-05-21	4.055906	7.114961	5.980315	Normal	2	1	2
Result							Drier than Normal - 9

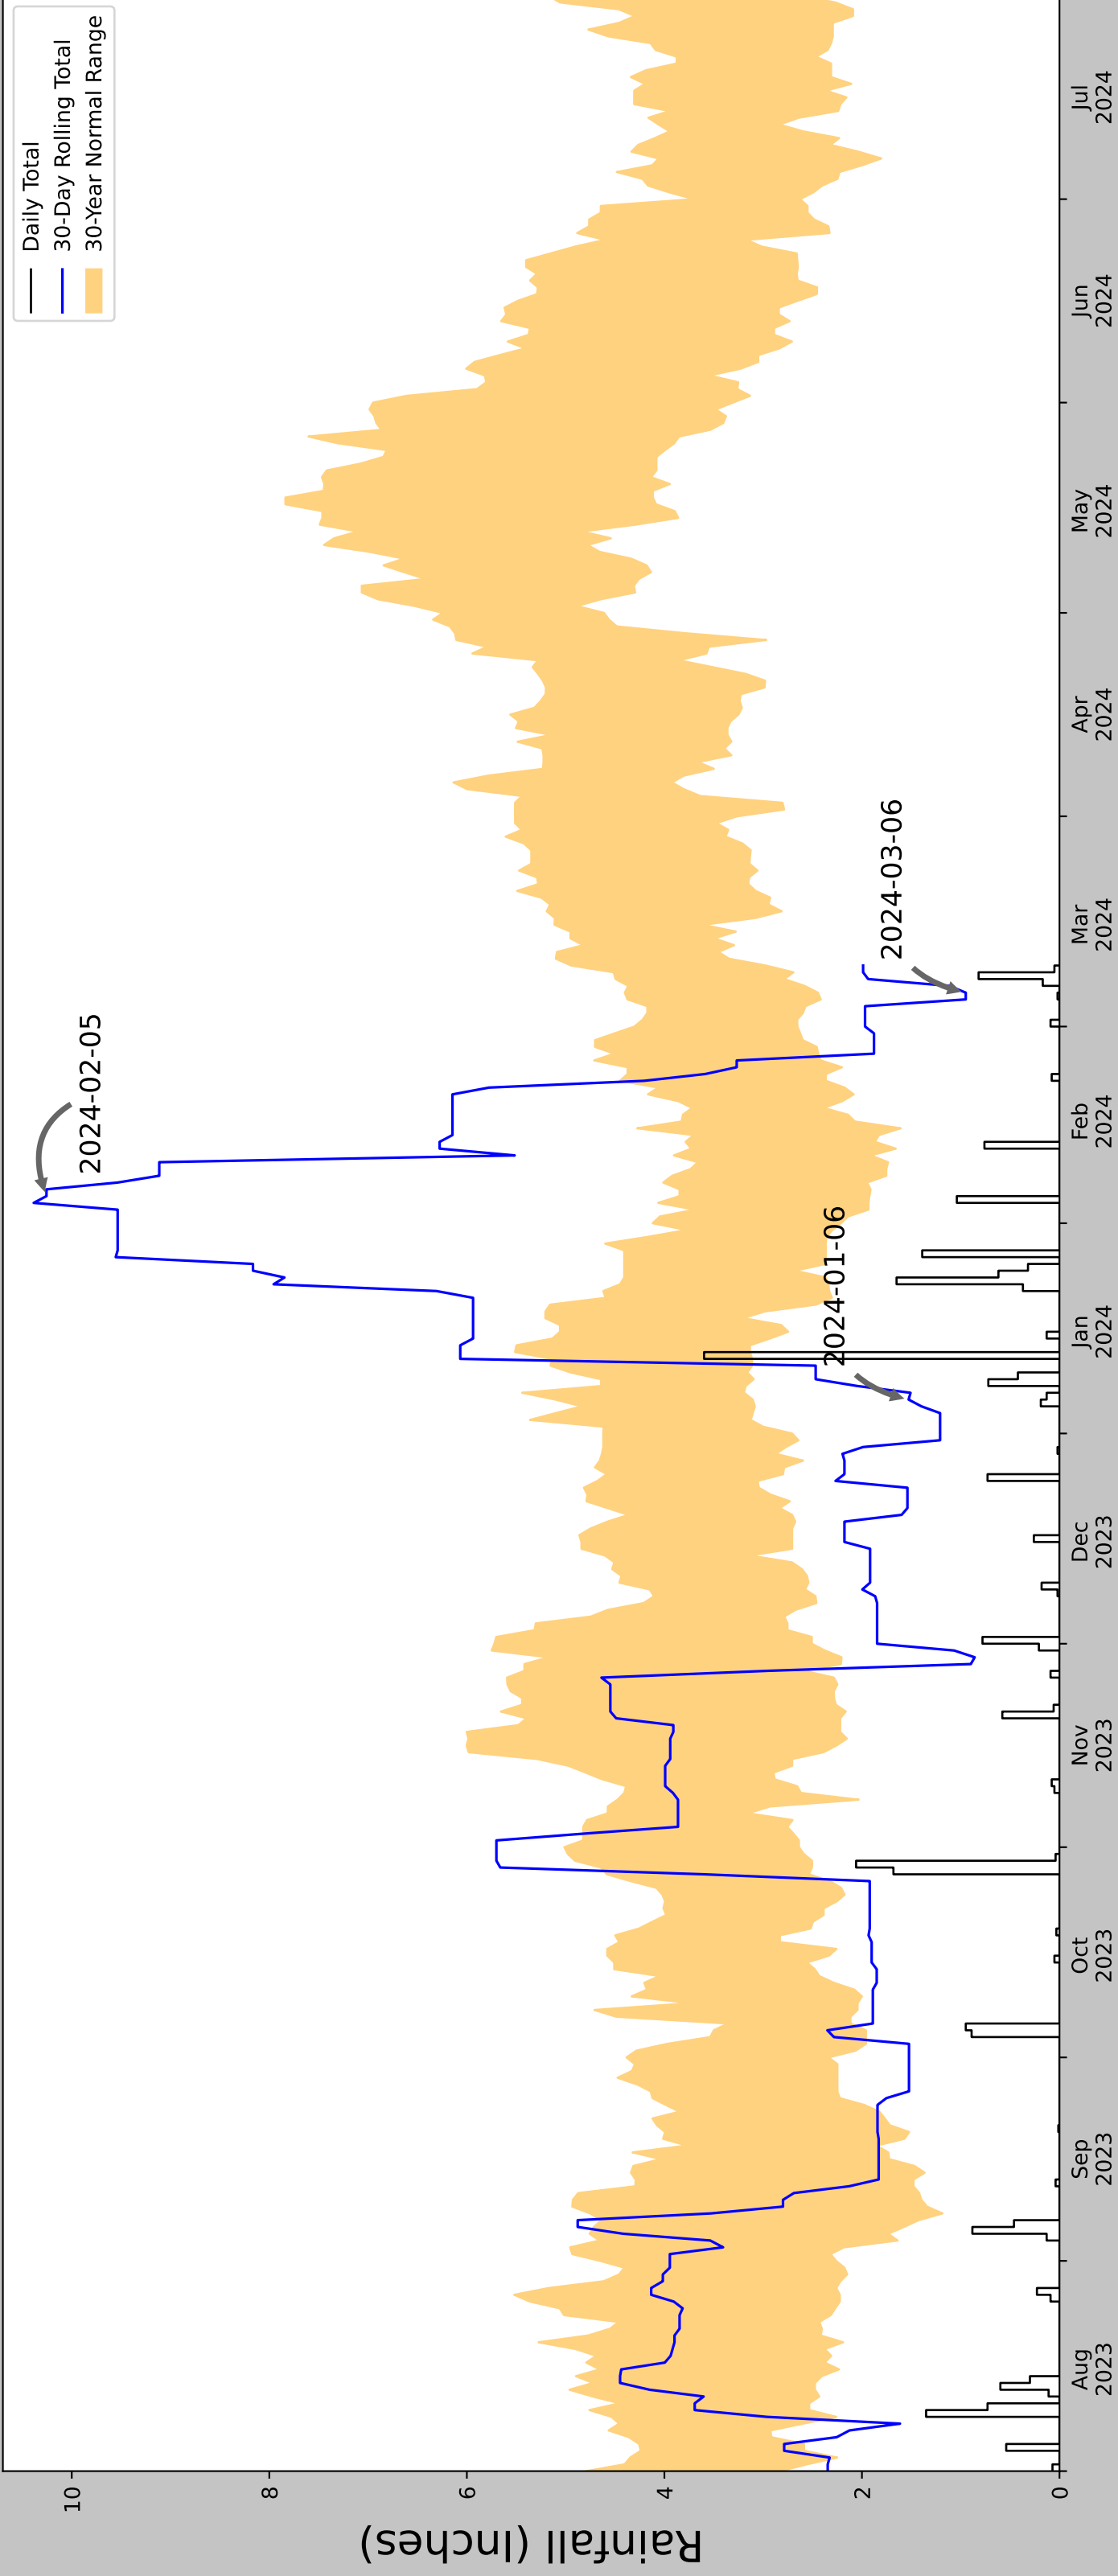
Antecedent Precipitation vs Normal Range based on NOAA's Daily Global Historical Climatology Network

Coordinates	36.444300, -90.590281
Observation Date	2024-03-06
Elevation (ft)	294.285
Drought Index (PDSI)	Incipient drought (2024-02)
WebWIMP H ₂ O Balance	Wet Season

30 Days Ending	30 th %ile (in)	70 th %ile (in)	Observed (in)	Wetness Condition	Condition Value	Month Weight	Product
2024-03-06	2.446457	4.400788	0.948819	Dry	1	3	3
2024-02-05	1.924803	3.846457	10.255906	Wet	3	2	6
2024-01-06	3.105906	5.103937	1.527559	Dry	1	1	1
Result							Normal Conditions - 10
