Bridge #03009(Routine, Underwater type 2)

SH 163-04-LM 8.83 over BARKER CREEK

Team Lead: James Adams **Inspection Date:** May 18, 2020

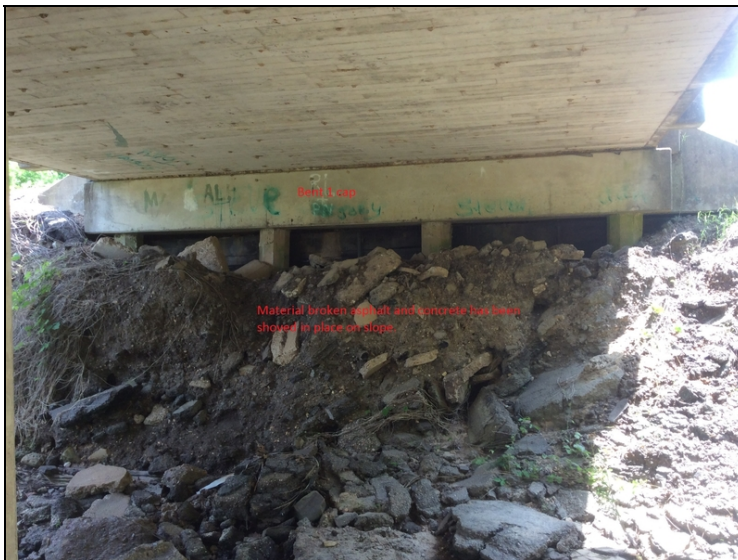
Bent 1 is undermined up to 4' below and 2' back under cap.
Bent 3 is undermined up to 2' below and 2' back under cap.

Bent 1 is undermined up to 4 ft. below and 2 ft. back under cap. Timber lagging & broken concrete are in place.

Bent 3 cap is undermined up to 2 ft. below and 2 ft. back under.

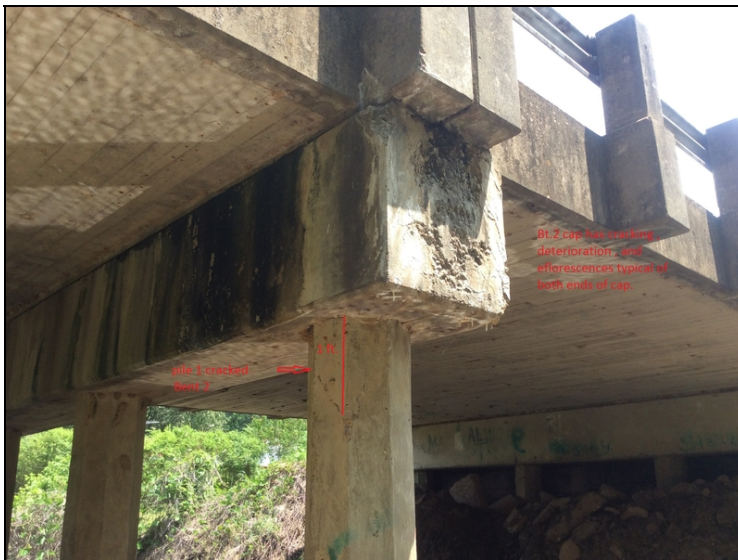
Bent 2 cap has deterioration, spalls & efflorescence on Lt and Rt ends.

Bent 2 cap has deterioration with spalls & efflorescence on left and right ends.
