BRIDGE #M3138

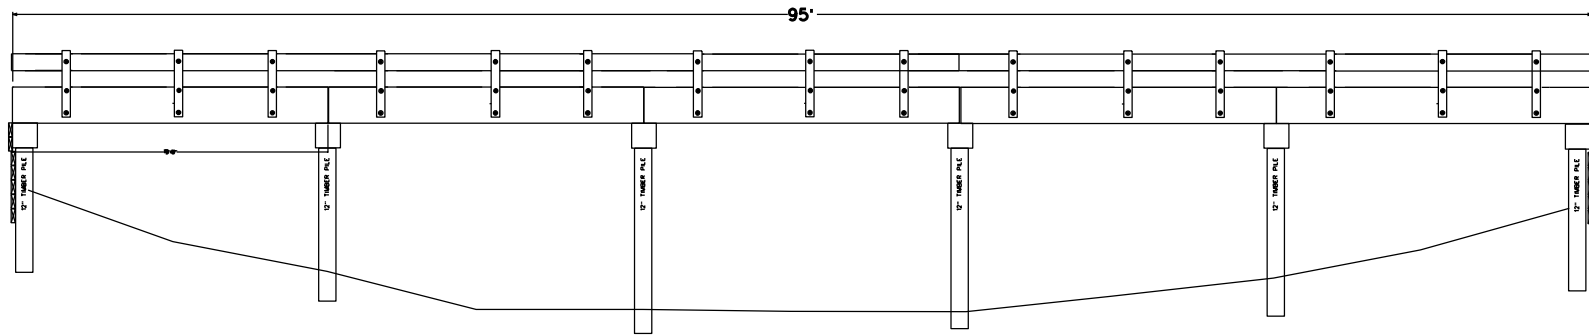
BENT #1

BENT #2

BENT #3

BENT #4

BENT #5

BENT #6

Piles have unknown depth or length

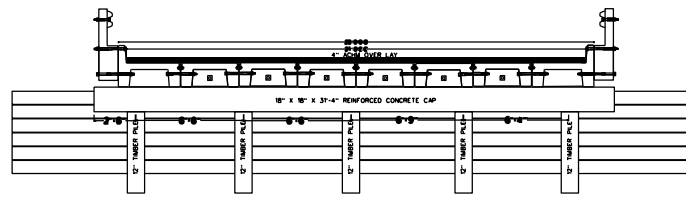
TYPICAL CROSS SECTION AND PILE SPACING AT BENTS #1 AND #4

3"x10" TIMBER BACKWALL

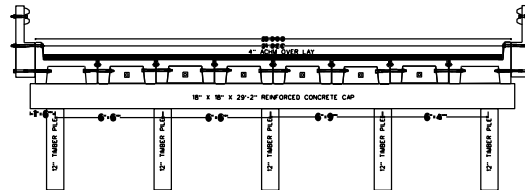
TYPICAL CROSS SECTION AND PILE SPACING AT BENTS #2 AND #3

RAIL POST

UNITS ARE BOLTED AND ASSUMED TO BE GROUTED
