Bridge #07127(Routine)

SH 138-04 LM 0.30 over Canal No. 19

Location: 1.1 Mi E US 65-Winchester

Team Lead: Sharon Hooks Inspection Date: May 26, 2020

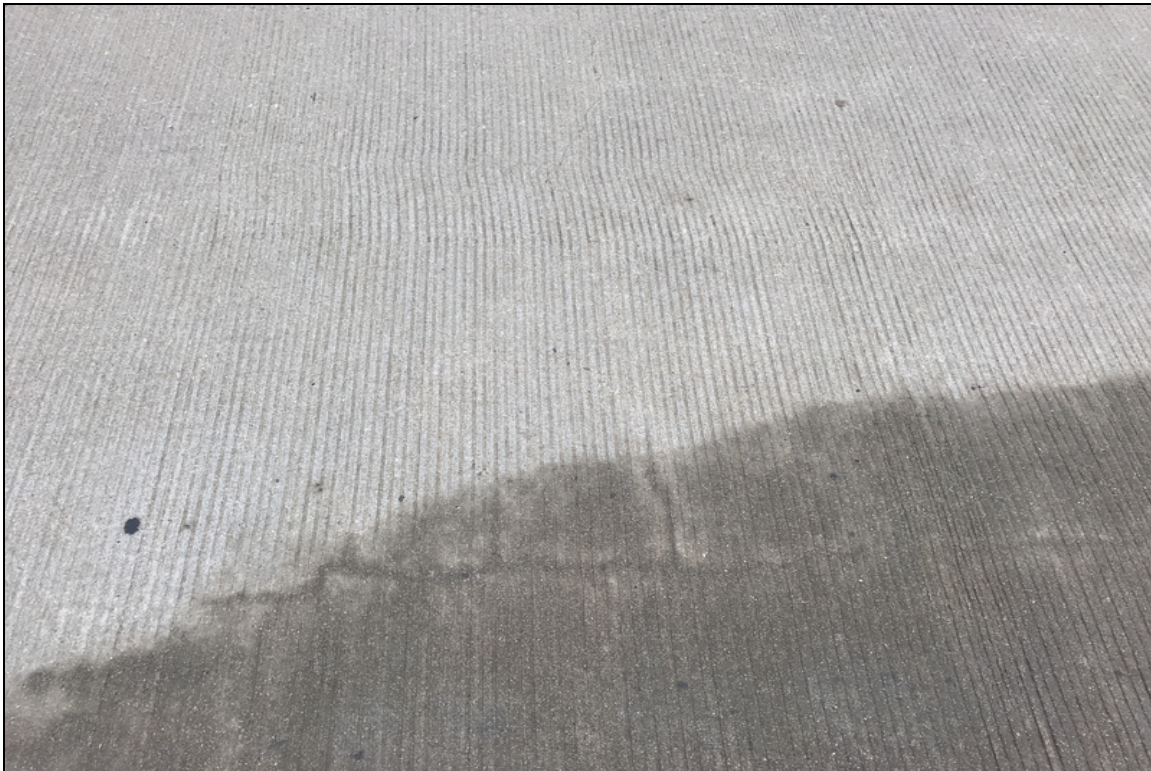
ELEM	DESCRIPTION	UNITS	TOTAL	CS1	CS2	CS3	CS4
12	Reinforced Concrete Deck	SF	6996	6972	24	0	0
1130	Cracking (RC and Other)	SF	24	0	24	0	0
(12)	Deck: 33' wide x 212' long. Span 2: Small transverse crack in left lane Span 3: Small transverse cracks in scattered locations.						
107	Steel Open Girder/Beam	LF	840	840	0	0	0
515	Steel Protective Coating	SF	6972	6972	0	0	0

Deck cracking.

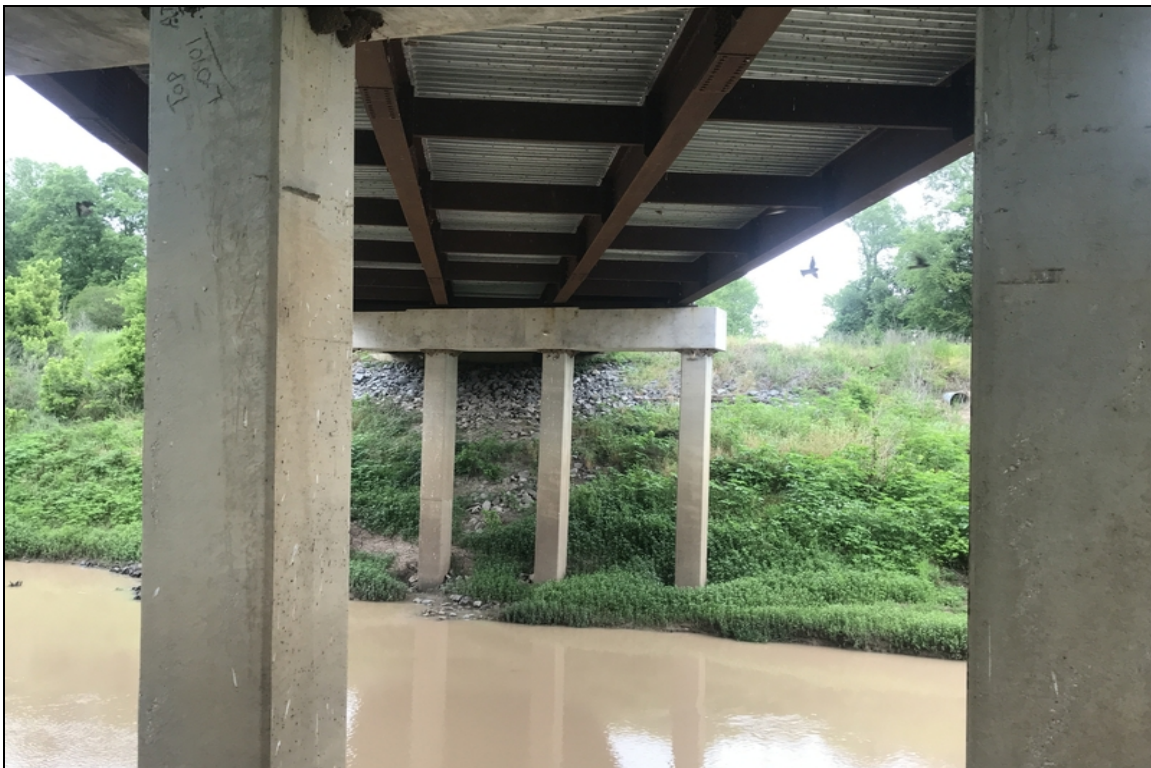
(107)	Girders: 4 per span / Spans 1-3 (212' total span). Coating: 8.3 square feet per linear feet of girder. Uniform covering of a light reddish brown rust building over all steel members.						
215	Reinforced Concrete Abutment	LF	70	63	7	0	0
1130	Cracking (RC and Other)	LF	7	0	7	0	0

Overview of soffit and girders.

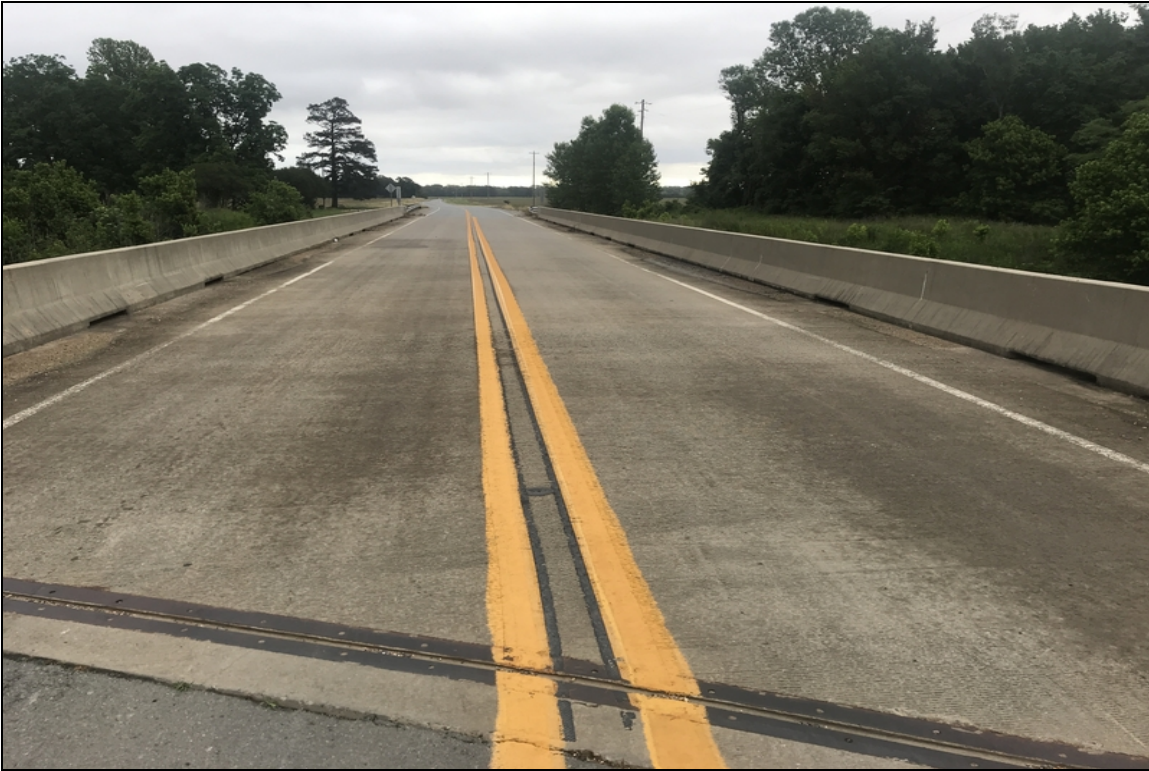
Deck overview.

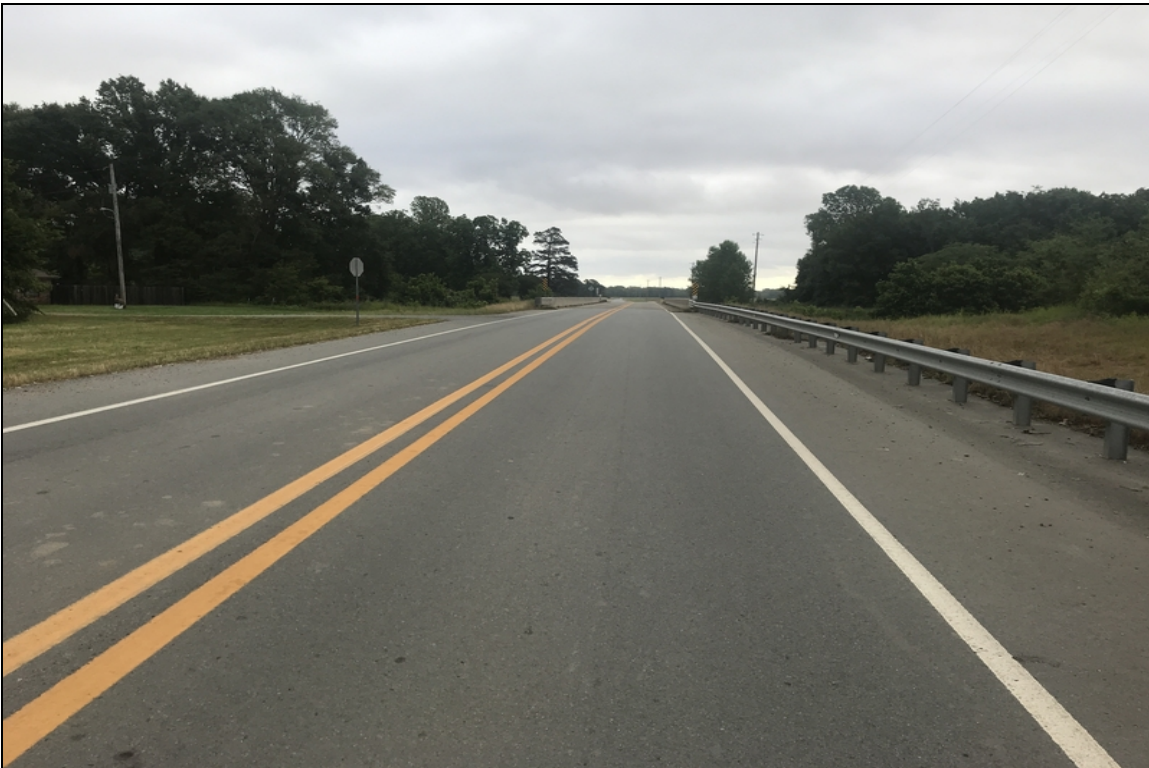
Approach.

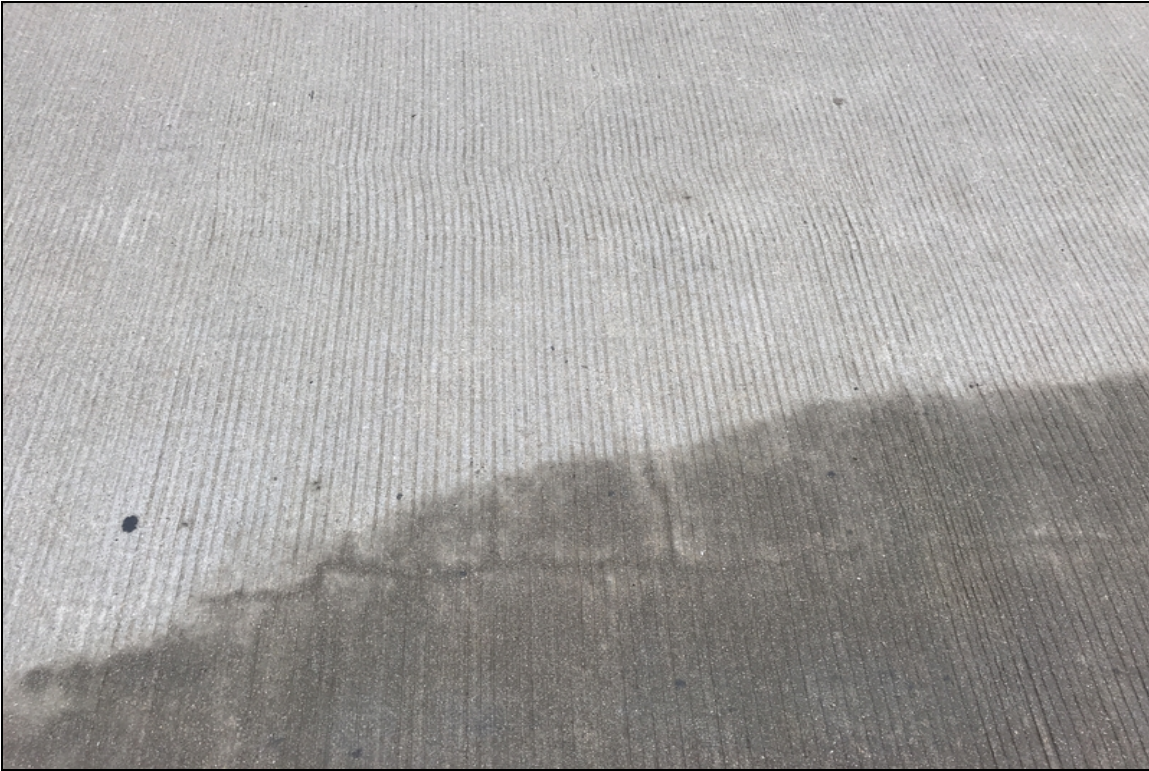
Deck cracking.

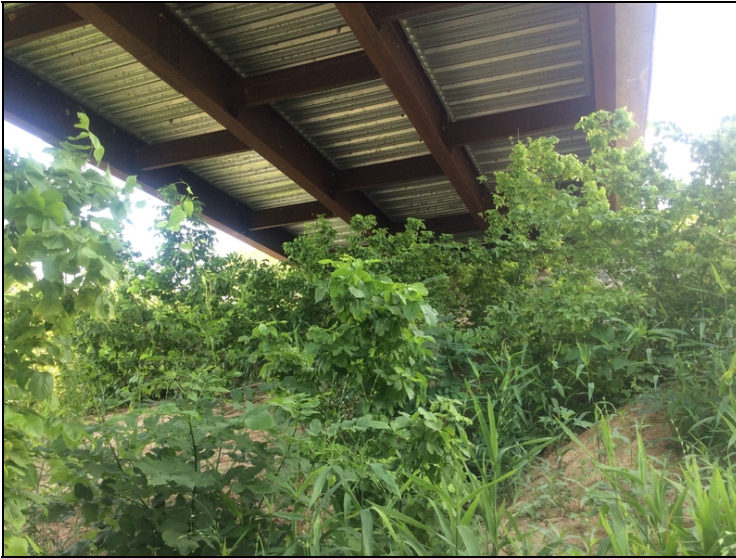
Endslopes - Spans 1 and 3: Several small trees, bushes, and other vegetation growing up under bridge.

Endslope - Span 1 : Vegetation

**Date Reported:** 06/13/2018  
**Priority:** G - General/ Preventive maintenance  
**Type of Work:** N/A  
**Status:** Assigned  
**Component:**

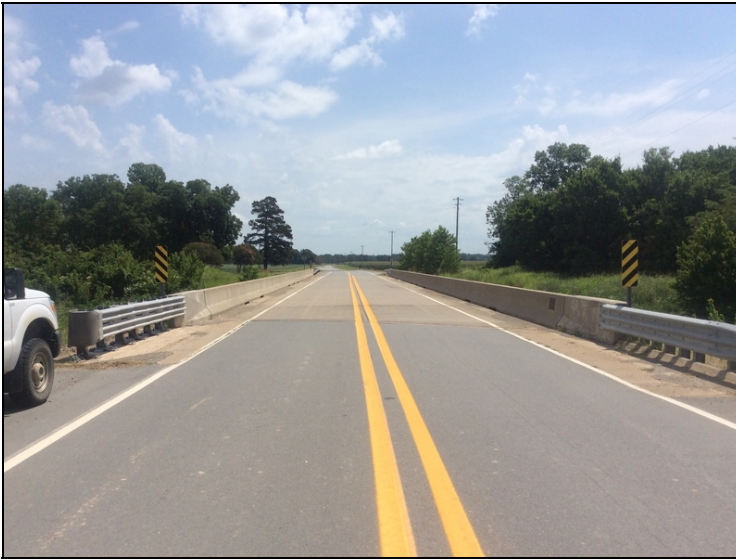
Log mile signs - both ends: No signs either end - posts and object markers in place.  
Signs in place 2020

Roadway view

**Date Reported:** 06/13/2018  
**Priority:** C - Important  
**Type of Work:** N/A  
**Status:** Repair Documented  
**Component:**
