Route:195 Section:01 Log:7.06

7.1 MI N.E. OF FULTON

Bridge #M2292(Routine)
SH 195 - 01- 7.06 over CREEK
Location: 7.1 MI N.E. OF FULTON

Team Lead: Charlie Rogers Inspection Date: September 05, 2018

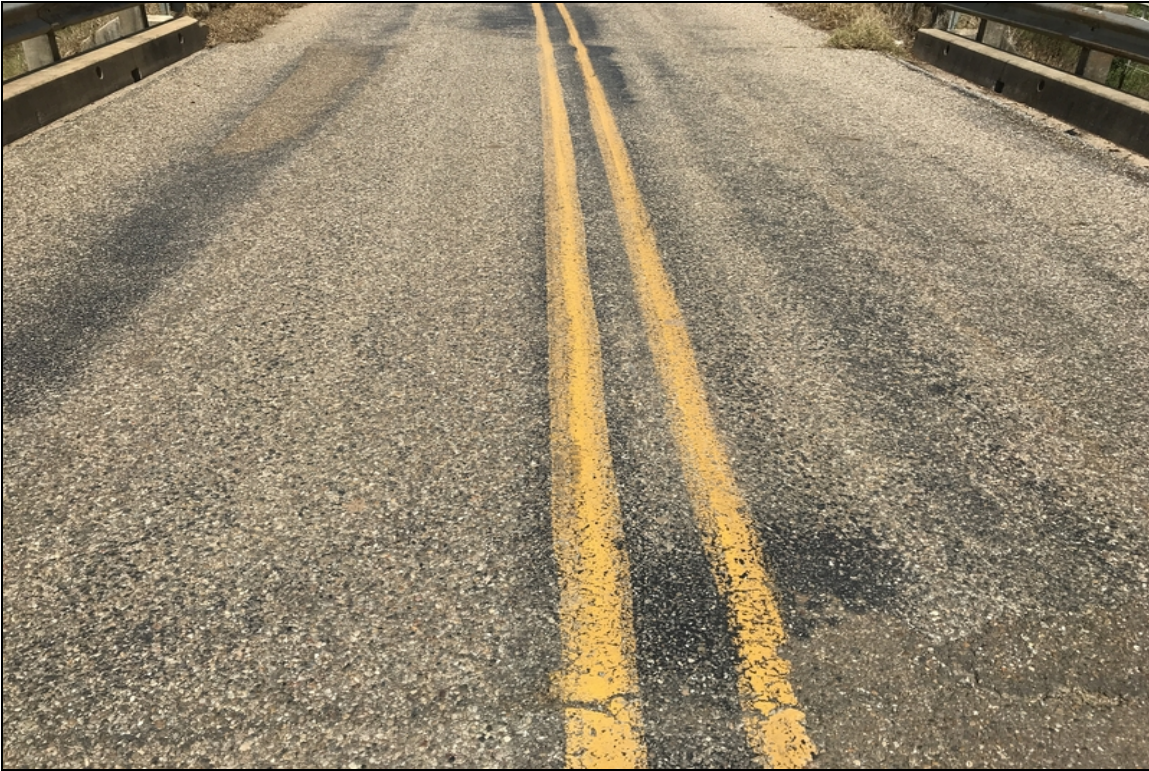
Deck

9/5/2018...AL, SS, Deck, Def. photos taken. Large erosion hole in ditch channel right before bridge, LT side. Trees and brush growing along side of bridge...

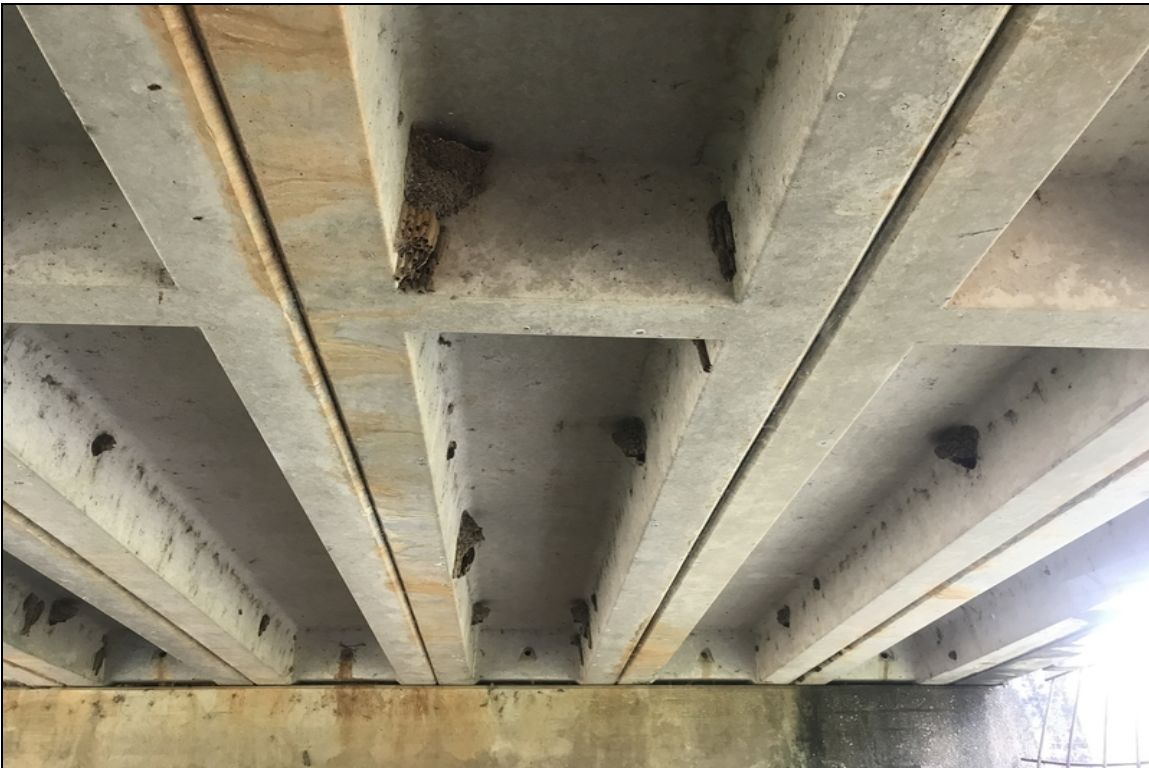
Underside of deck typical all spans
