District 05, Sharp County

Bridge #02692(Routine)
US 167 SHARP CO. over MILL CREEK
Location: 1.2 MI S JCT SH 56 E

Team Lead: Kerry Little Inspection Date: January 15, 2020

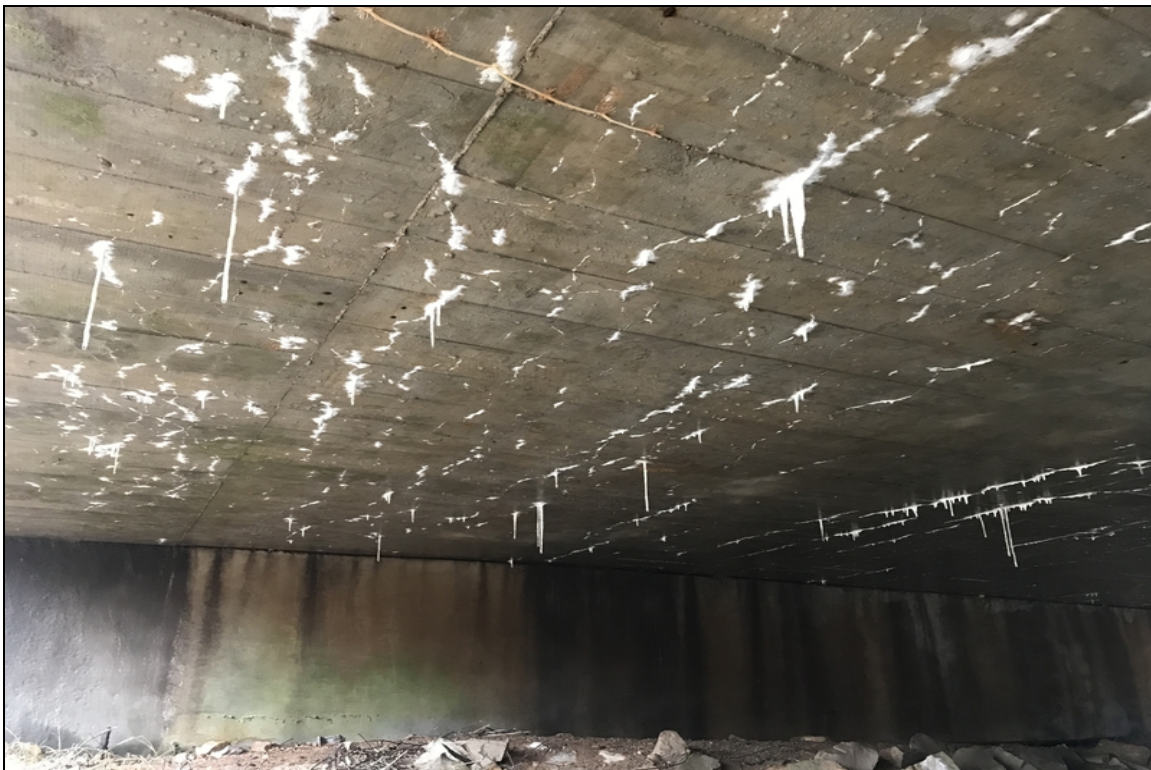
(12)							
Heavy longitudinal & transverse efflorescent cracks to soffit @ all spans. Span 4 - Spalls with 10' rebar exposed to soffit. Span 5 - Spalls with 5' rebar exposed to soffit. Delaminated area to soffit near centerline @ Span 1. Random hairline cracking to soffit. Heavy decoration to Lt and Rt curbs @ all spans.							
(12-1080)							
(12-510)							
Cracking to wearing surface @ Abut. 1 & 2 joint and an area of cracking @ Span 4. Spall to wearing surface near Bent 5.							
210	Reinforced Concrete Pier Wall	LF	143	118	18	7	0
1080	Delamination/Spall/Patched Area	LF	2	0	2	0	0
1090	Exposed Rebar	LF	7	0	0	7	0
1120	Efflorescence/Rust Staining	LF	9	0	9	0	0
1130	Cracking (RC and Other)	LF	7	0	7	0	0

Typical efflor cracksnto soffit @ all spans.

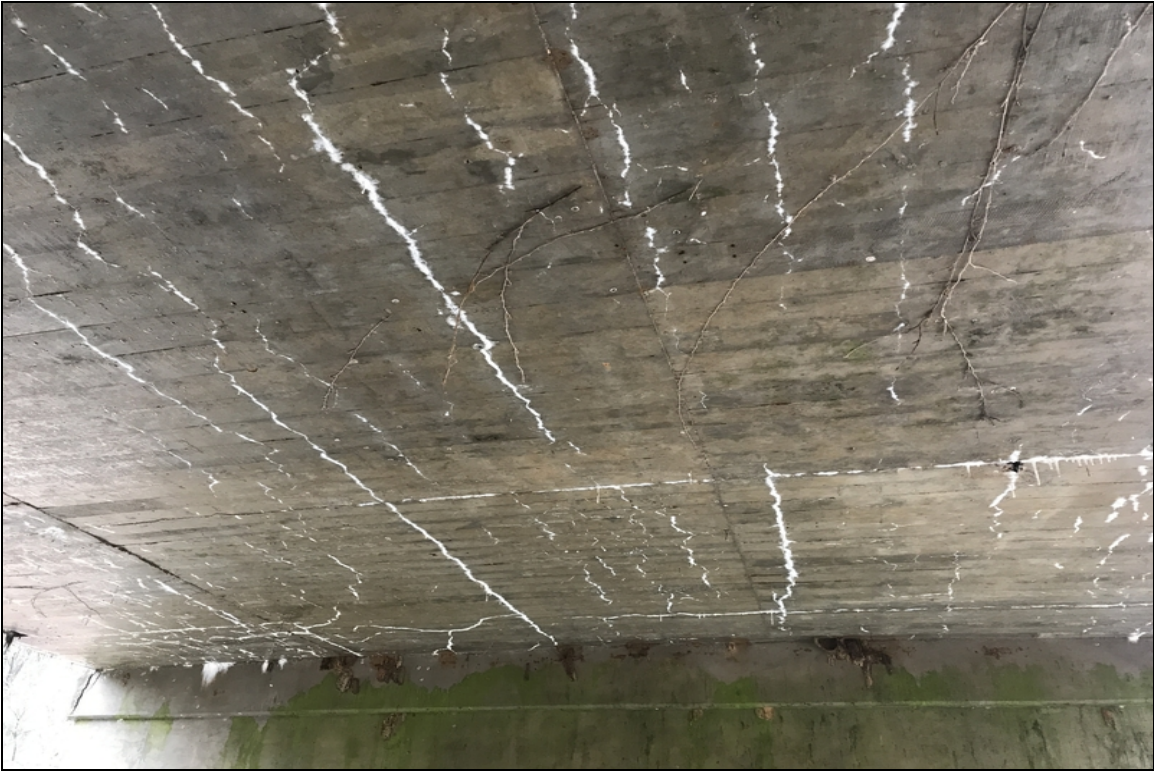
Overall soffit @ span 2.

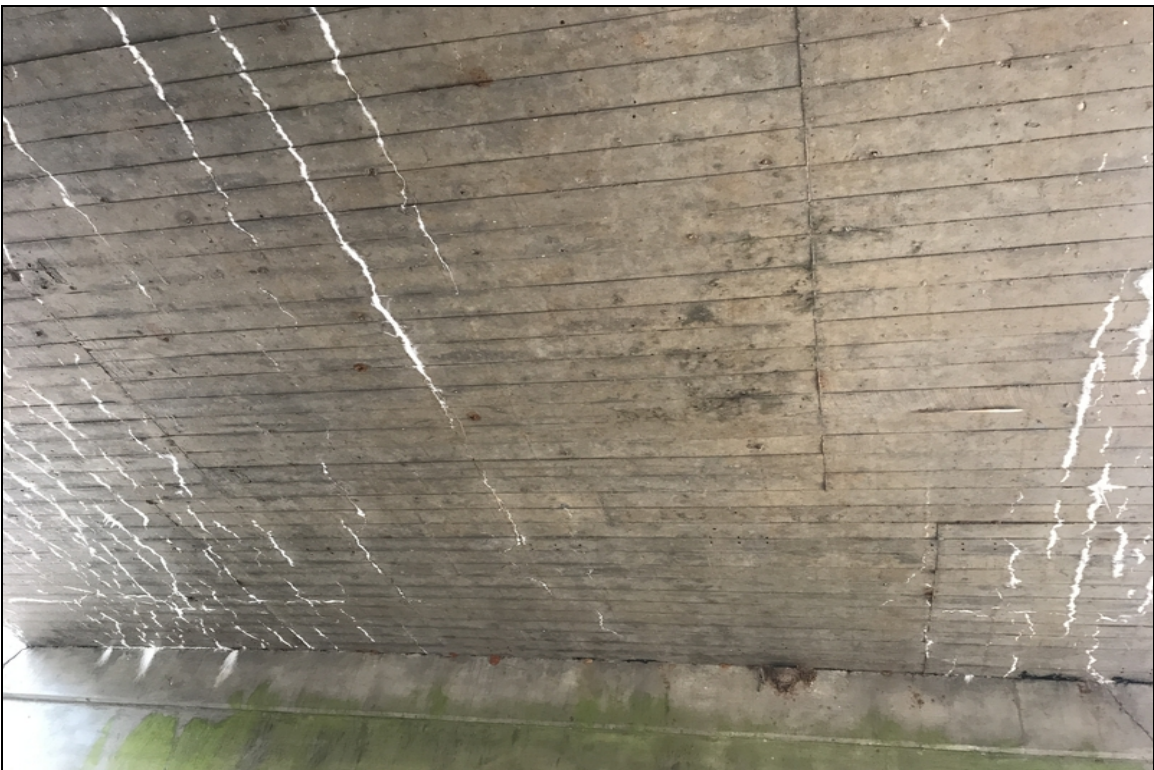
Overall soffit @ span 4.

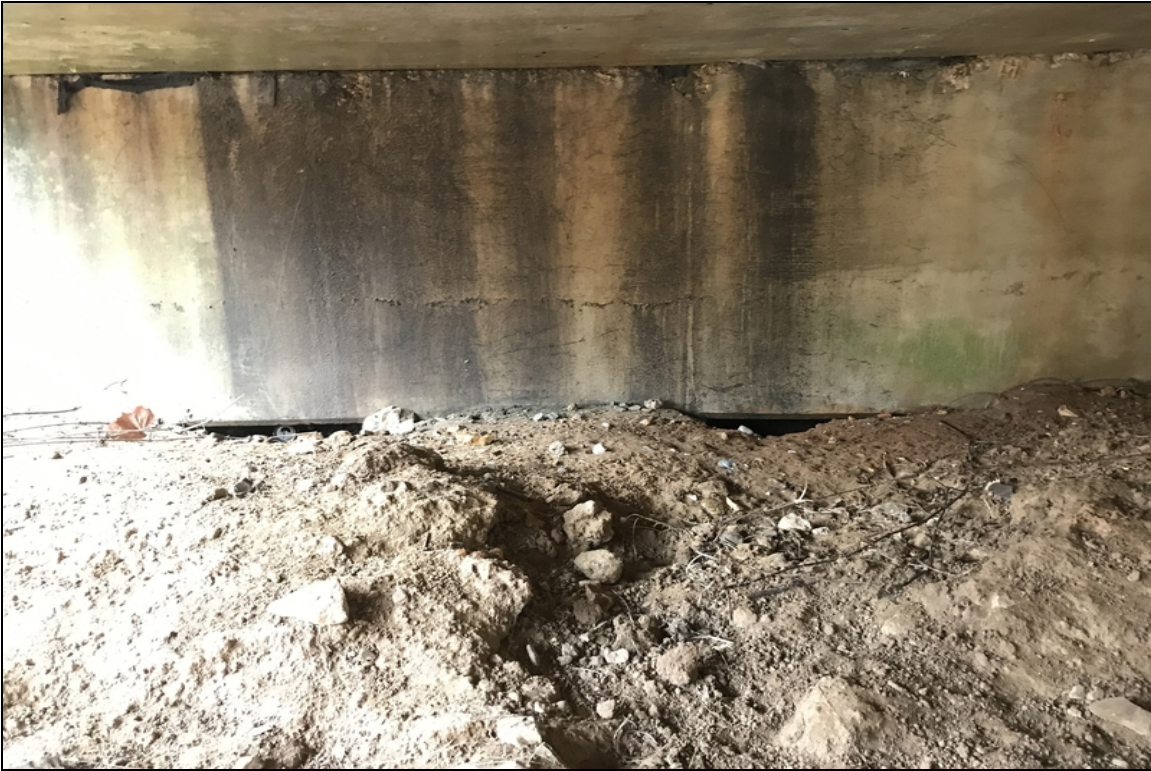
Minor settlement to abutment 2.

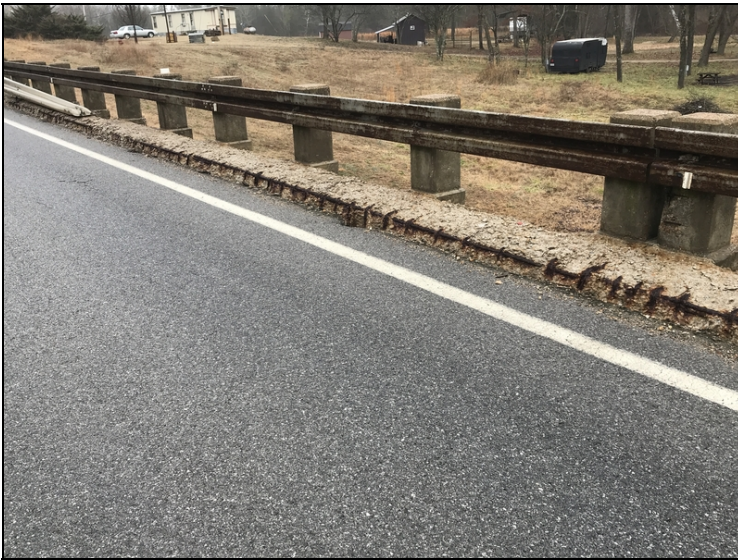
Heavy deterioration with Rebar Exposed to Left & Right curbs @ all Spans.

Date Reported: 01/09/2012
Priority: D- Routine
Type of Work: None
Status: Monitor
Component:

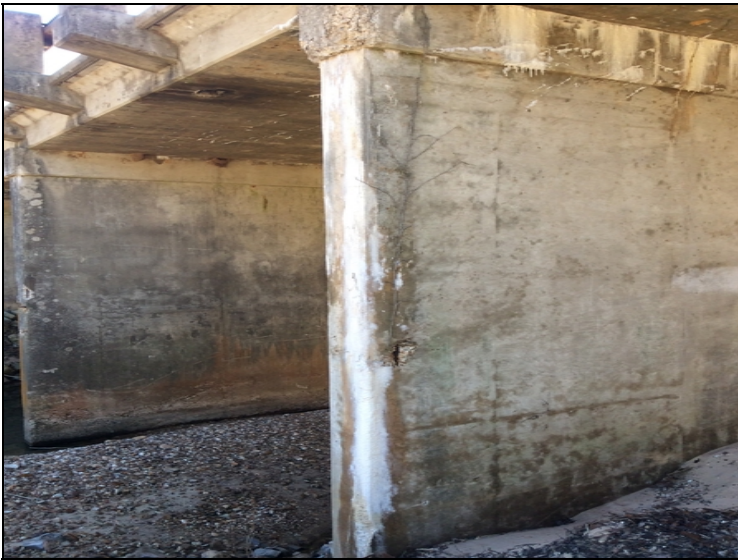
(210)							
Scour @ Bents 2 & 3. Minor full height vertical cracks near centerline to all Pier Walls. Bent 2 - Spalls with Rebar on Left & spall with 4' rebar exposed on Right. Bent 3 - Spalls with 1' Rebar exposed on Right. Bent 5 - Spalls with 3' wire mesh & 2' Rebar Exposed. Delaminated area to concrete Pier Wall @ Bent 5.							
220	Reinforced Concrete Pile Cap/Footing	LF	30	0	30	0	0
6000	Scour	LF	30	0	30	0	0

Spalls/delaminating with efflorescence, Rebar & wire mesh exposed to Pier walls @ Bent 2 & 3.

Spalls/delaminating with efflorescence, Rebar & wire mesh exposed to Pier walls @ Bent 3.

Date Reported: 01/09/2012
Priority: D- Routine
Type of Work: Repair
Status: Monitor
Component: Substructure

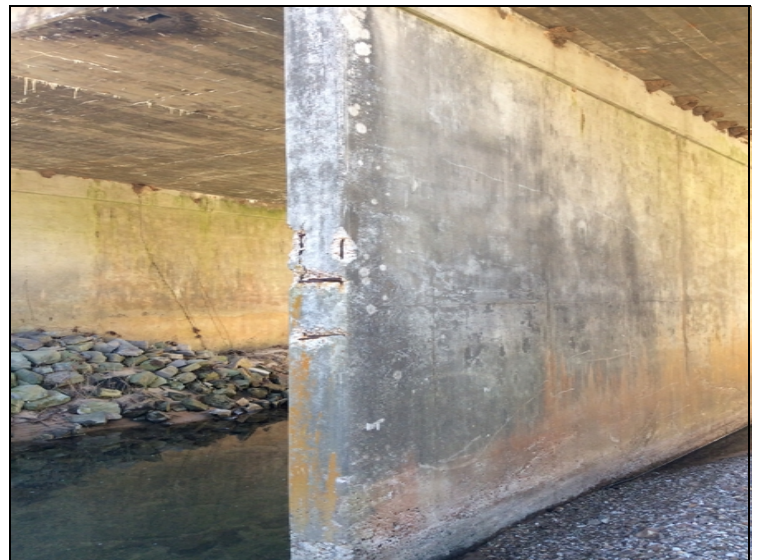
Spalls/delaminating with efflorescence, Rebar & wire mesh exposed to Pier walls @ Bent 2.

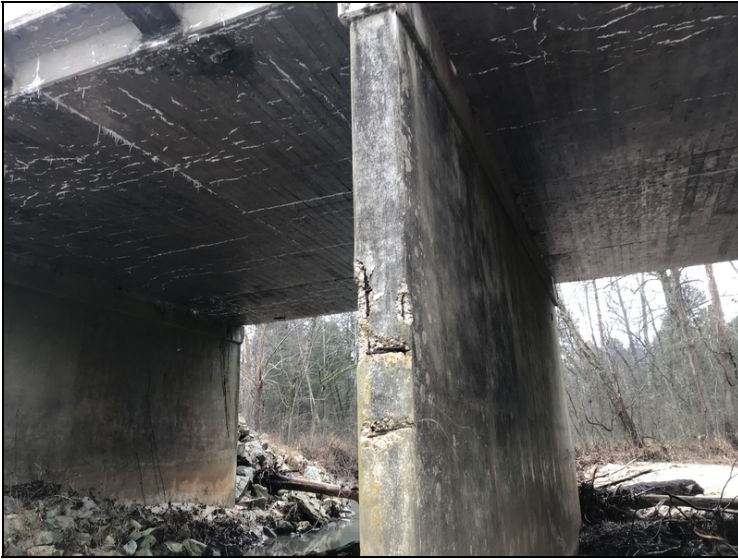
Spalls/delaminating with efflorescence, Rebar & wire mesh exposed to Pier walls @ Bent 2 & 3.

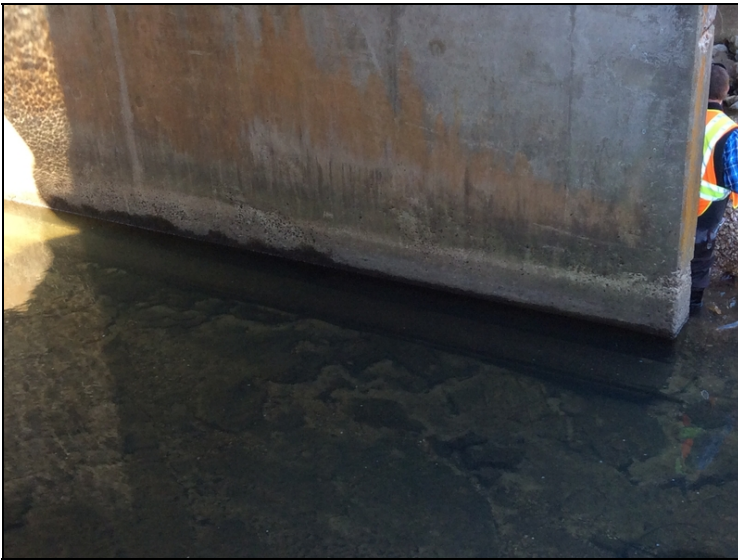
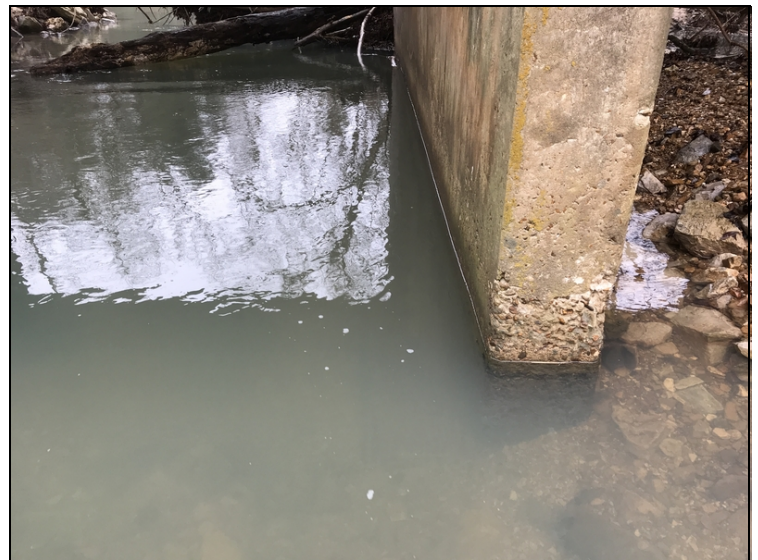
(220)							
Footing exposed full length of Bent 2. Scour up to 1' below top of Footing.

Scour up to 1' below top of Footing @ Bent 2.

Scour up to 1' below top of footing @ Bent 2.

Date Reported: 01/10/2014
Priority: D- Routine
Type of Work: None
Status: Monitor
Component:

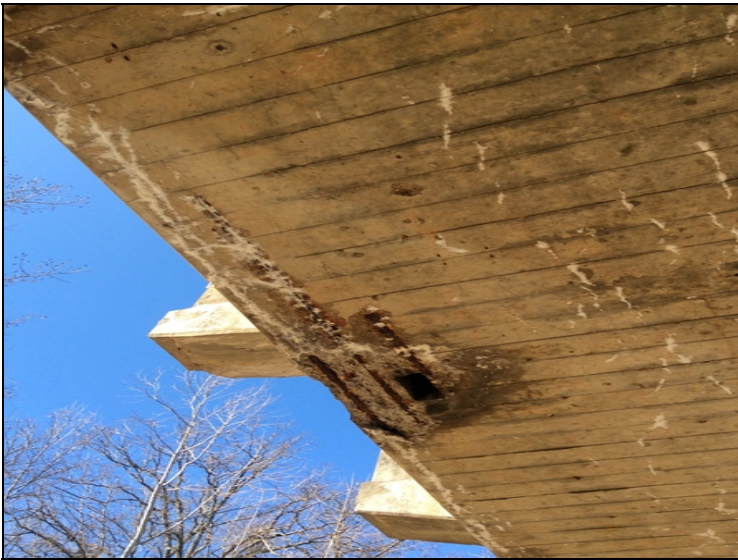
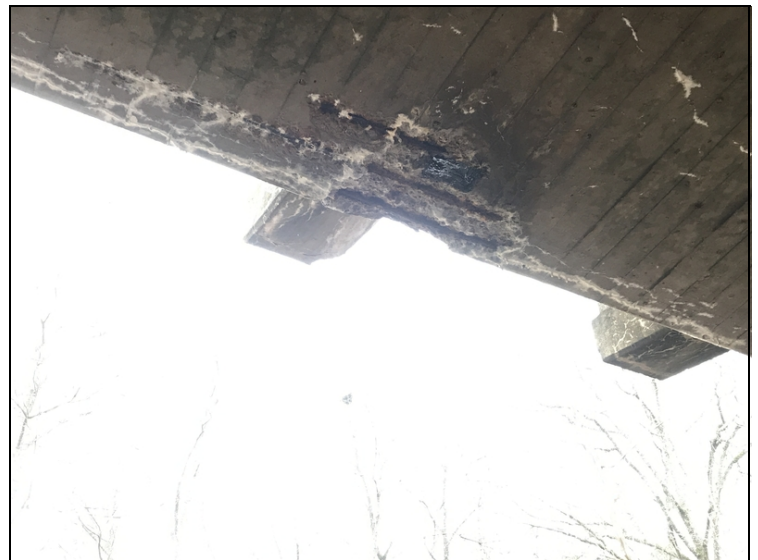
Spalls with Rebar Exposed to Deck below @ Spans 4 & 5.

Spalls with Rebar Exposed to Deck below @
Spans 4 & 5.

Date Reported: 01/10/2014
Priority: C - Important
Type of Work: None
Status: Monitor
Component:

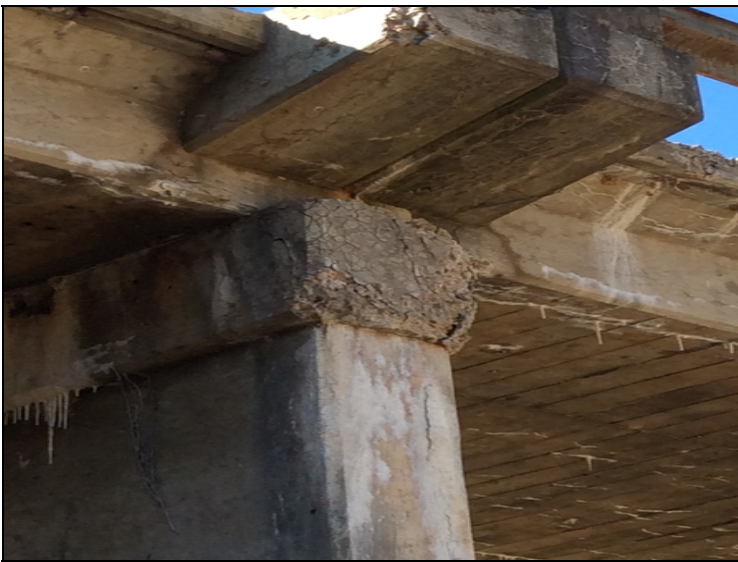
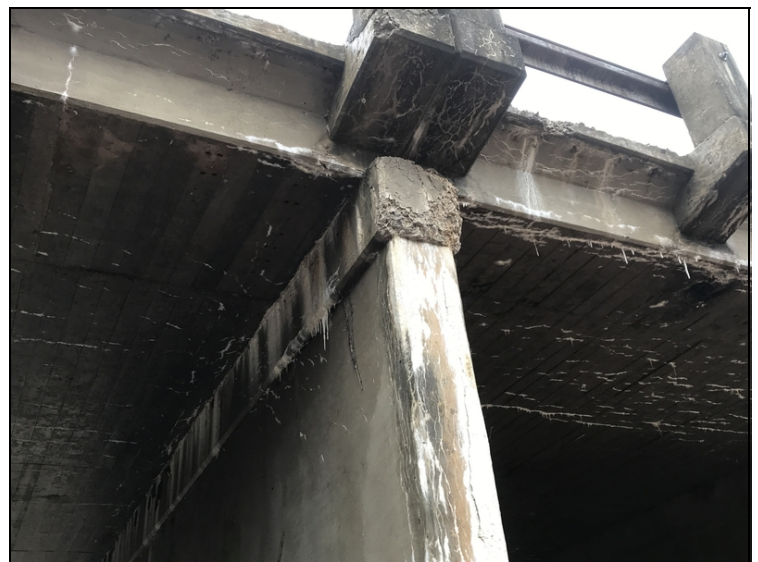
Deterioration & efflorescent map cracking to Left & Right ends of Cap @ Bents 1 - 5.

Date Reported: 01/10/2014
Priority: C - Important
Type of Work: None
Status: Monitor
Component:

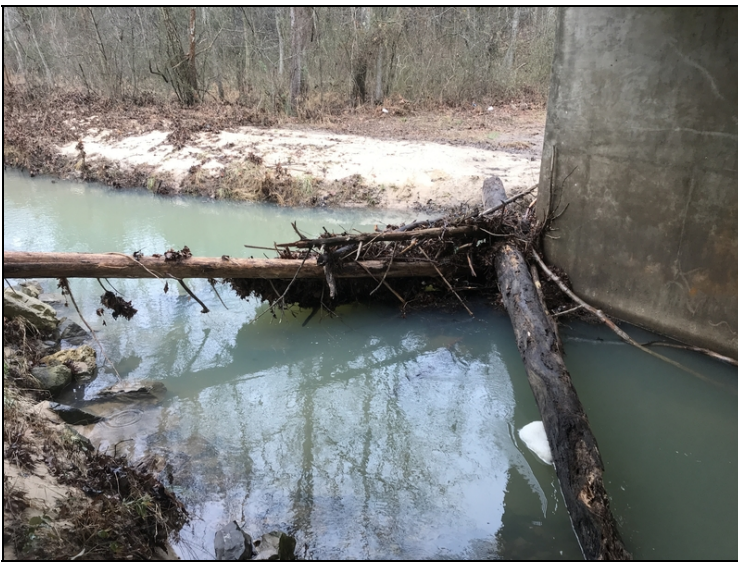
Drift buildup @ span 2 & 3.

Drift buildup @ spans 2 & 3.

Date Reported: 01/15/2020
Priority: C - Important
Type of Work: Repair
Status: Open
Component: Bridge
