Bridge #03858(Routine, Underwater type 2)
SH 9/Stone County over NORTH FORK TOMAHAWK CK

Location: 5.6 M SW SH 66

Team Lead: Nathan Edwards **Inspection Date:** December 14, 2020

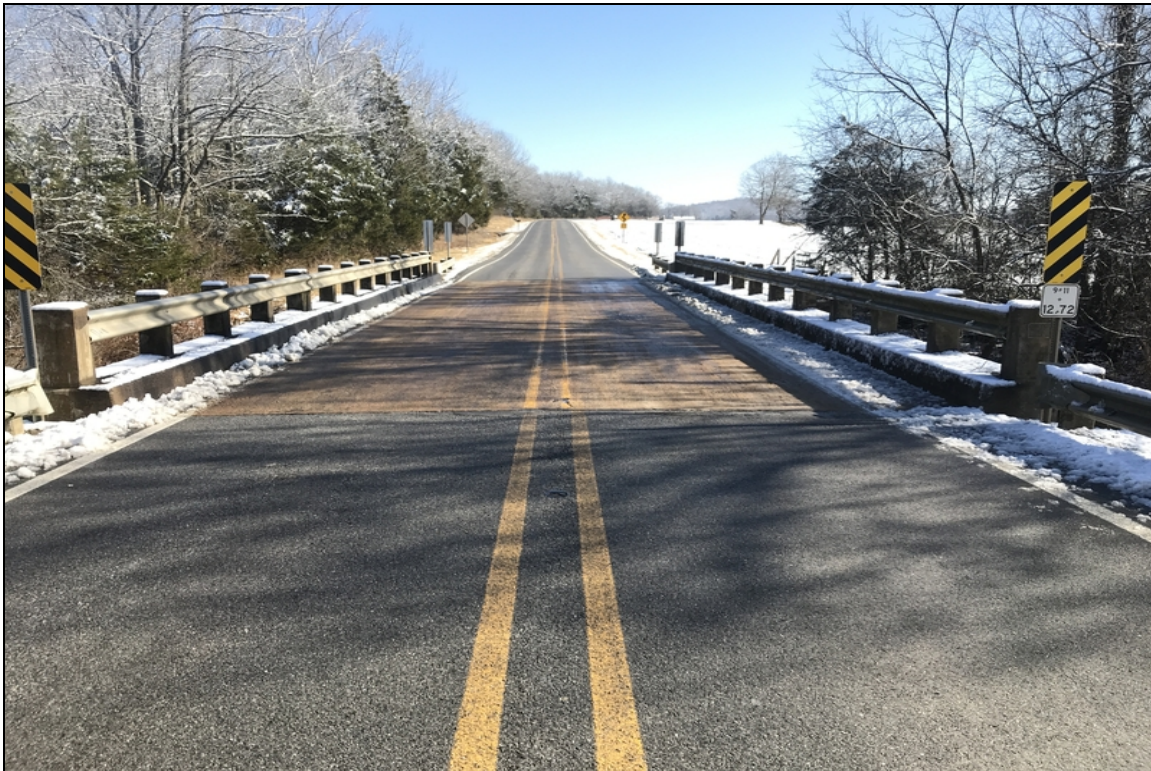
Roadway with Log Mile running West to East.

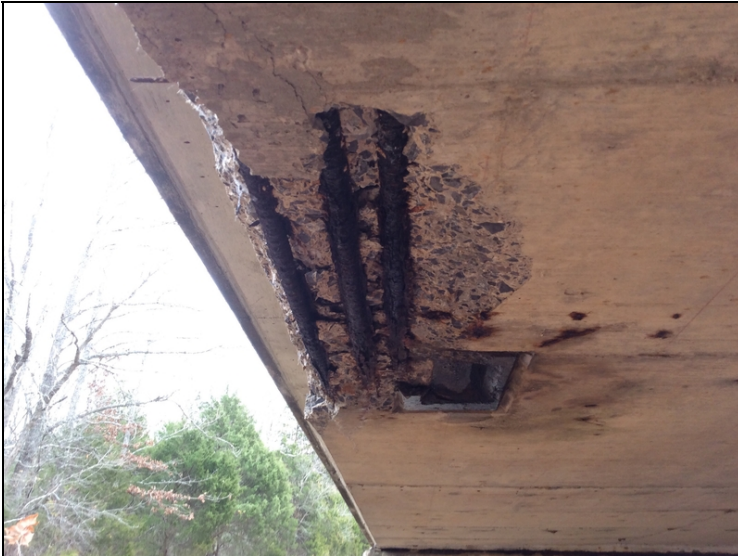
Spans 1 thru 3 have cracks and delaminated areas at drain openings.

Spans 1 & 2 have spalls with corroded rebar exposed near Left & Right drain openings.

Spalls with rebar exposed to Left drain opening @
Span 2.

Date Reported: 11/30/2010
Priority: D- Routine
Type of Work: N/A
Status: Monitor
Component:

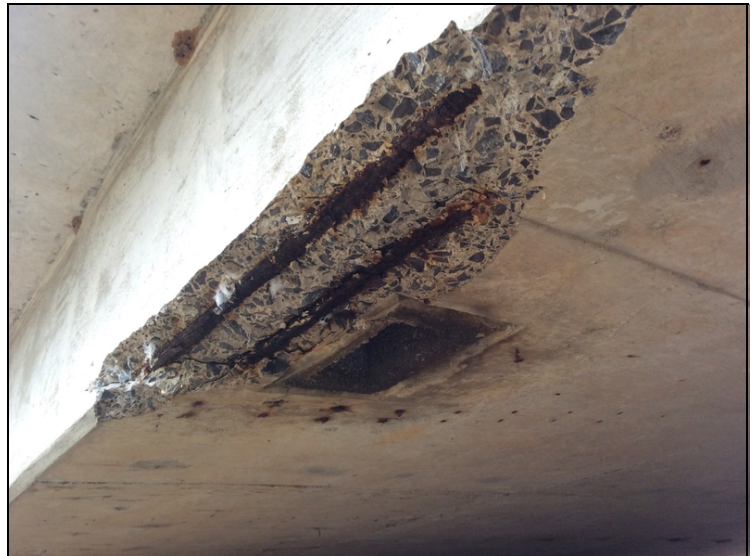
Spalls with rebar exposed to Right drain opening
@ Span 1.

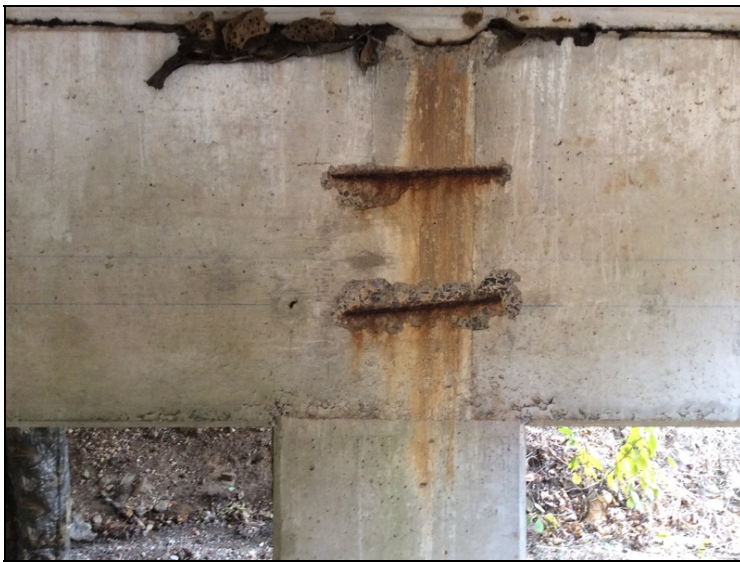
(234)	Spall with 2.5' of rebar exposed to ahead face of Cap at Bent 1 near Column 1. 9' of horizontal cracks to back face of Cap at Bent 1. 1' spall to top corner of ahead face of Cap on Right side at Bent 1. 40" of rebar exposed to bottom of Cap on Left end at Bent 1.						
301	Pourable Joint Seal	LF	48	0	0	5	43
2320	Seal Adhesion	LF	48	0	0	5	43

Bent 1 has spalls with rebar exposed to face and bottom of cap.

Spalls with rebar exposed to ahead side of cap @ Bent 1.

Priority: D- Routine

Status: Monitor

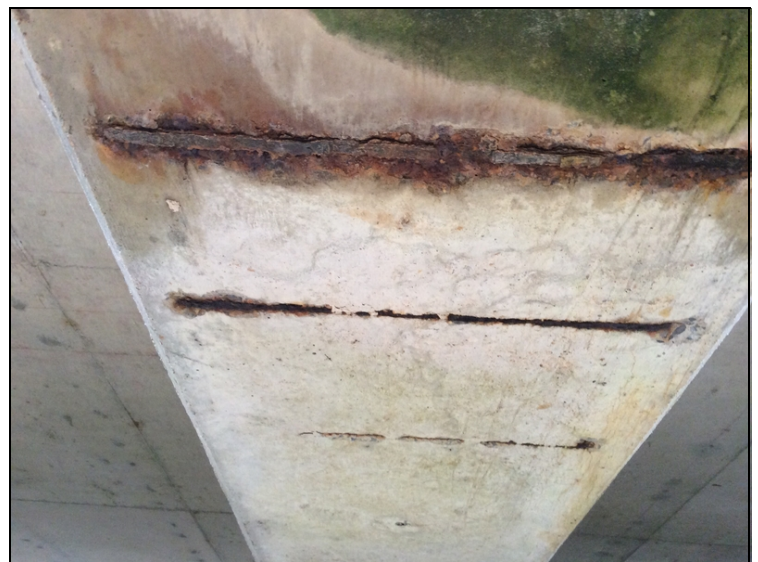
Spalls with rebar exposed to bottom of cap @ Bent 1 Left.

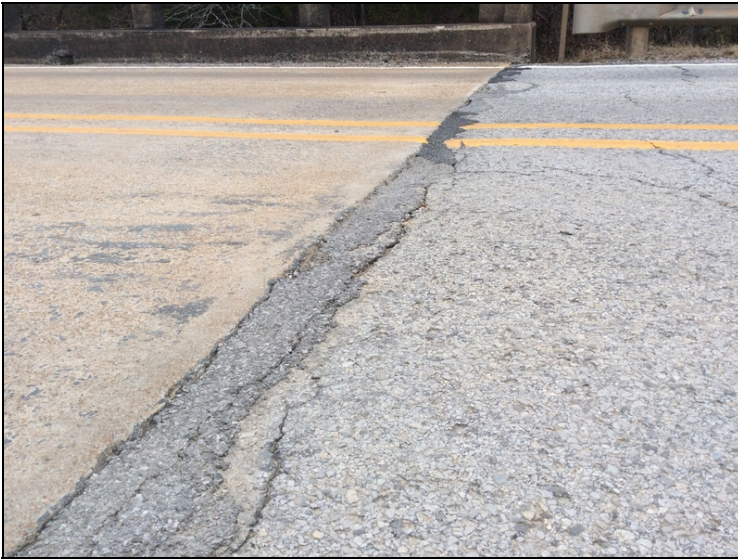
Approach roadway
Settlement at Abutments 1 & 2.

Roadway settlement @ Abutment 2.

Priority: D- Routine

Status: Monitor

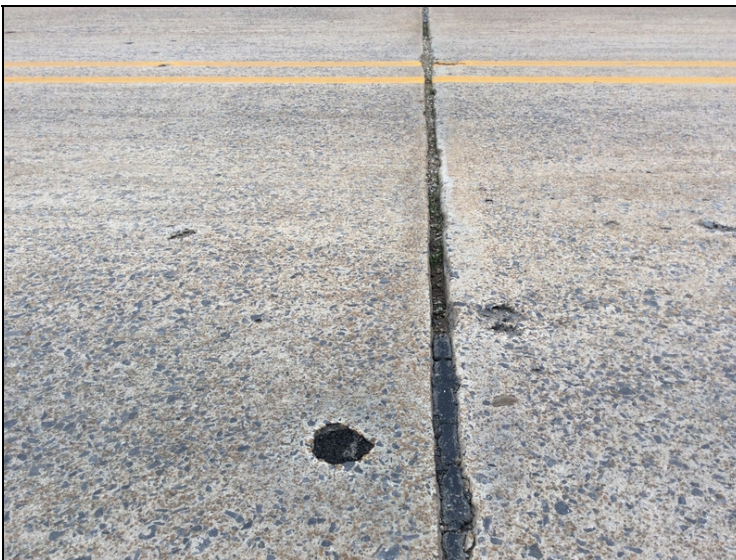
(301)	Joint material has lost adhesion and most is missing.						
330	Metal Bridge Railing	LF	150	150	0	0	0
515	Steel Protective Coating	SF	450	450	0	0	0

Joint material missing at Bents 1 & 2.

Priority: D- Routine

Status: Monitor
