Bridge No. M1027	Dist. 5	Co. Izard - 33
Log 15.53	Rt. 56	Sect/Zone - 2
Date Drawn 12/1/04 Date Redrawn 11/23/10 By RRJ

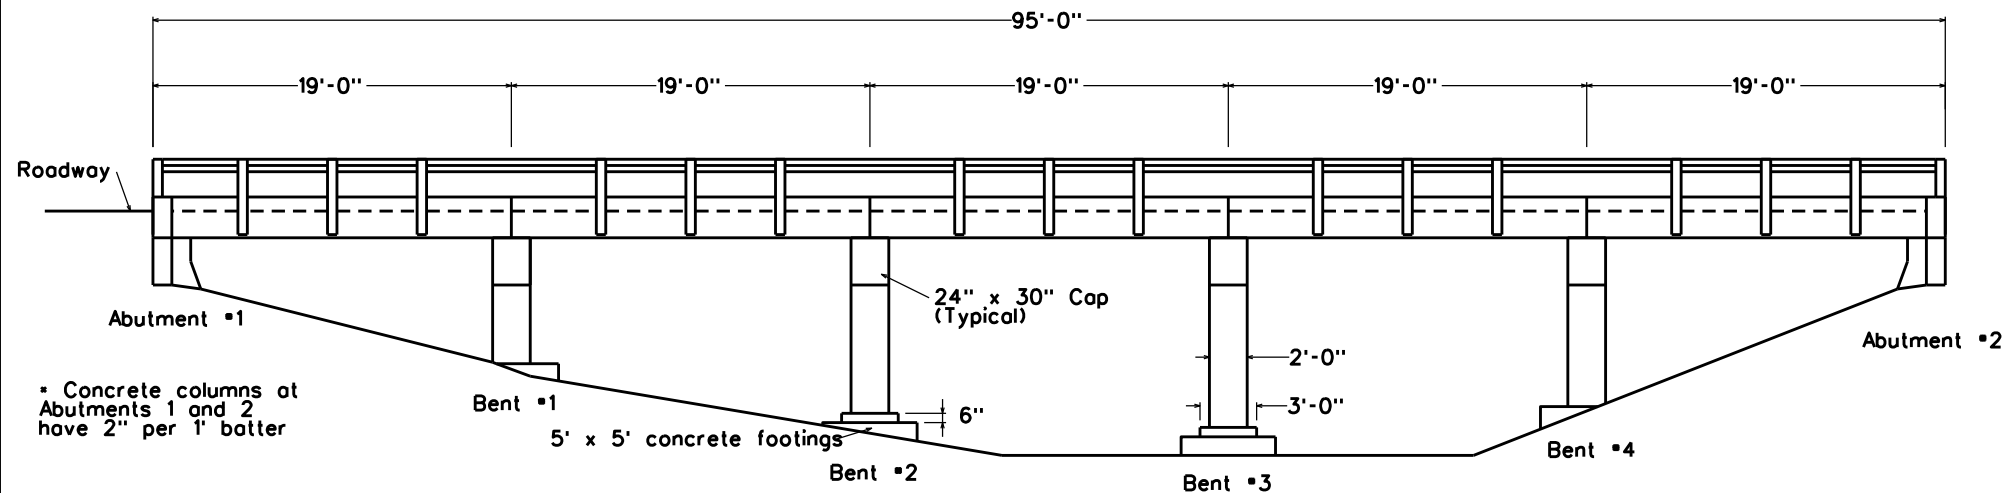
Typical of Abutments and Interior Bents

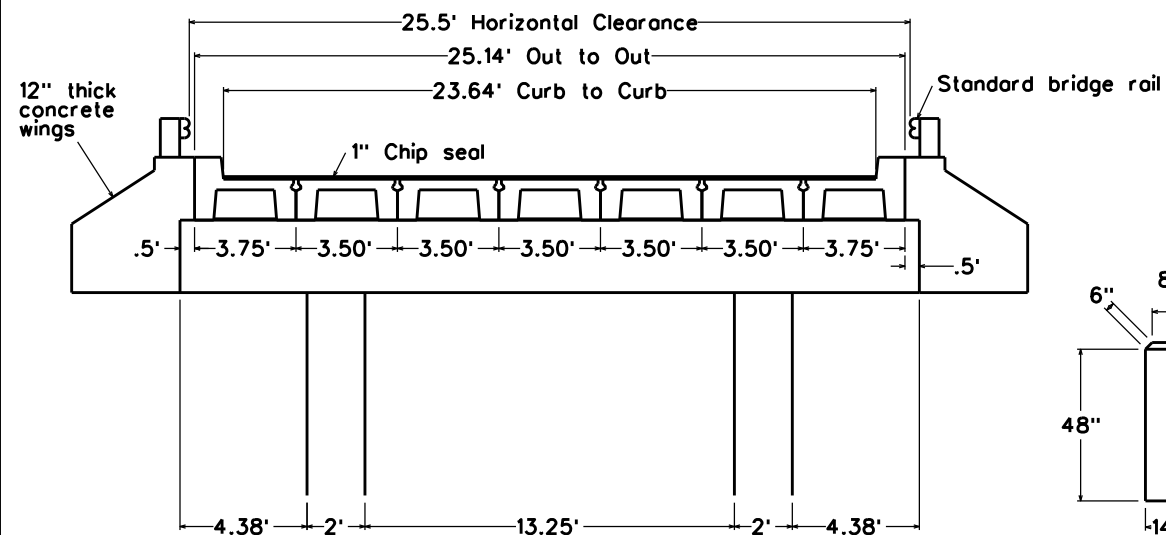
Interior Channel Beam Detail

Diaphragm Detail

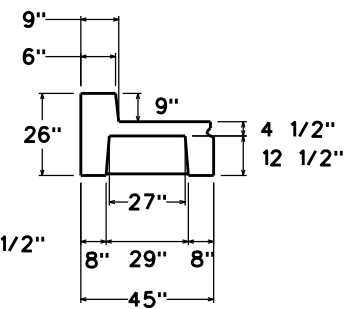
Exterior Channel Beam Detail
