Bridge #M2970(Routine)
SH 365 Log 9.03 over NEWTON CREEK
Location: 5.62 MI N I-40/I-2

Team Lead: Chris Doggett Inspection Date: February 03, 2020

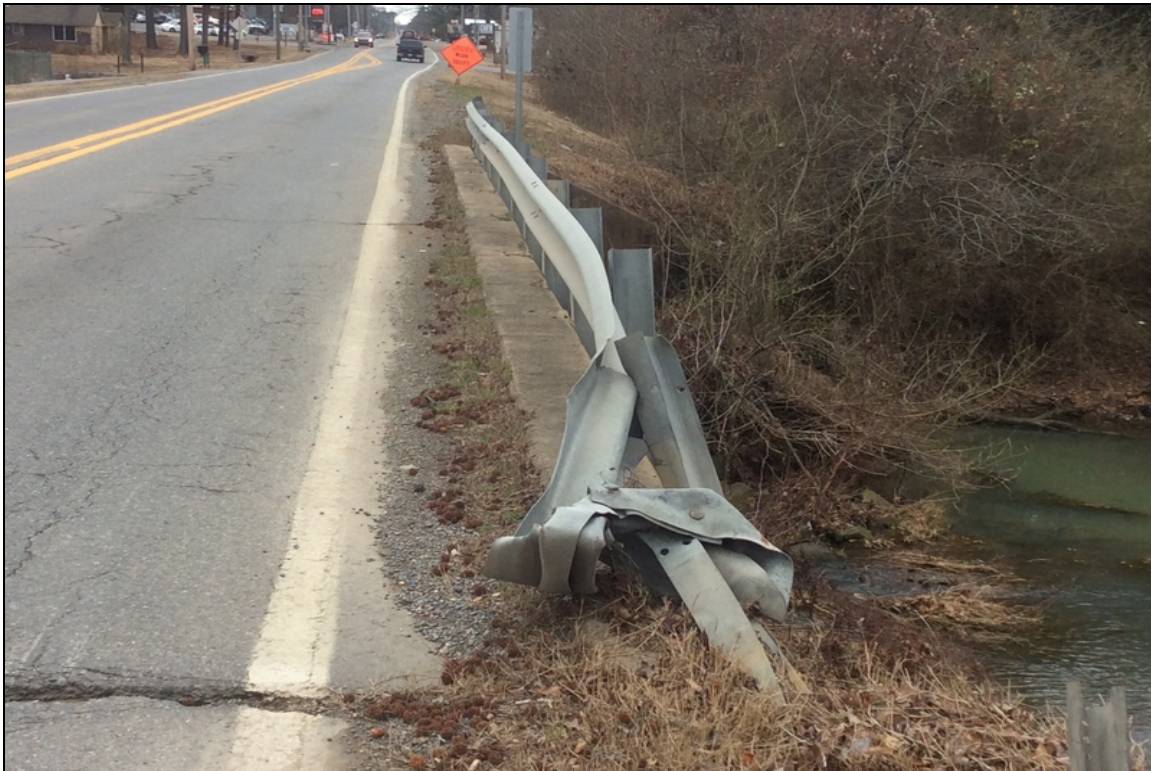
(330)							
Traffic impact to right bridge rail at bent 1. See photo. State forces have painted metal bridge rail.

Right guardrail has collision damage.

Right bridge rail at bent 1 damaged due to traffic impact.

Assigned District Bridge Crew 06001 5/17/18

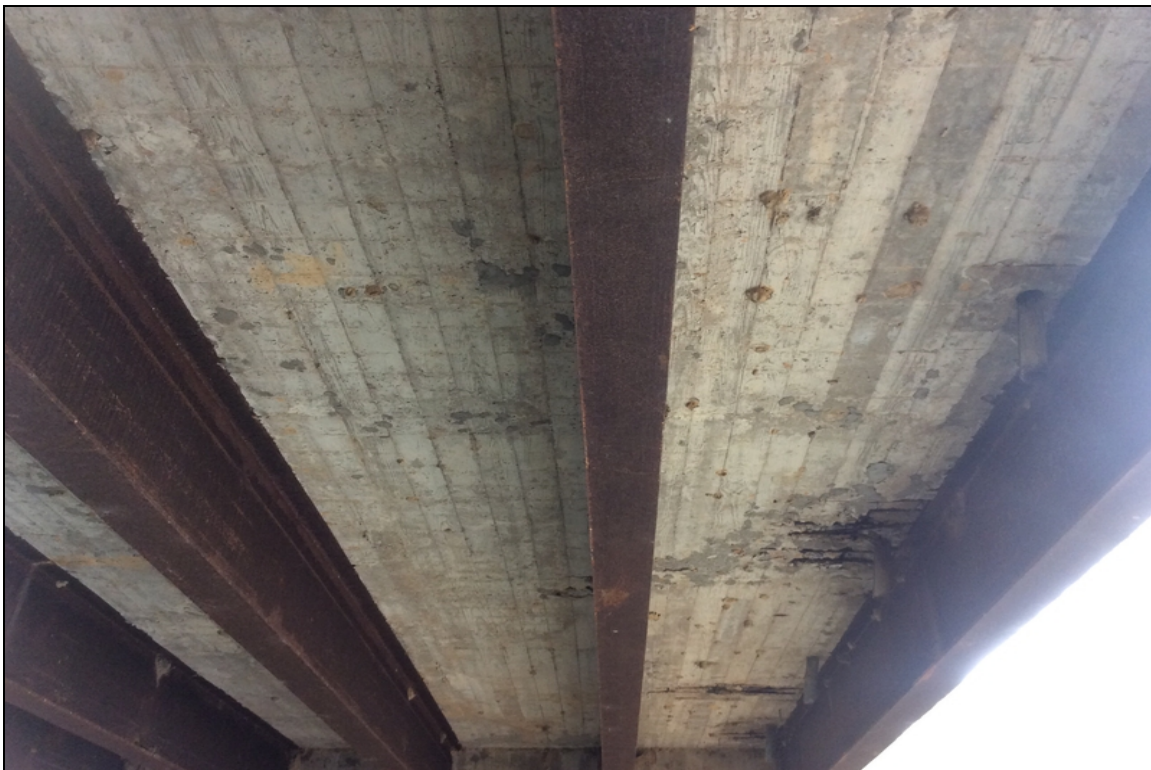
(12)							
Both spans have spalls with exposed rebar on the soffit. Span 2 worst case.Photo attached. Random cracks in the asphalt overlay.							
107	Steel Open Girder/Beam	LF	528	0	411	117	0
1000	Corrosion	LF	528	0	411	117	0
515	Steel Protective Coating	SF	3069	0	0	400	2669
3440	Effectiveness (Steel Protective Coatings)	SF	3069	0	0	400	2669

Soffit has spalls with exposed rebar at span 2 between beams 7&8.

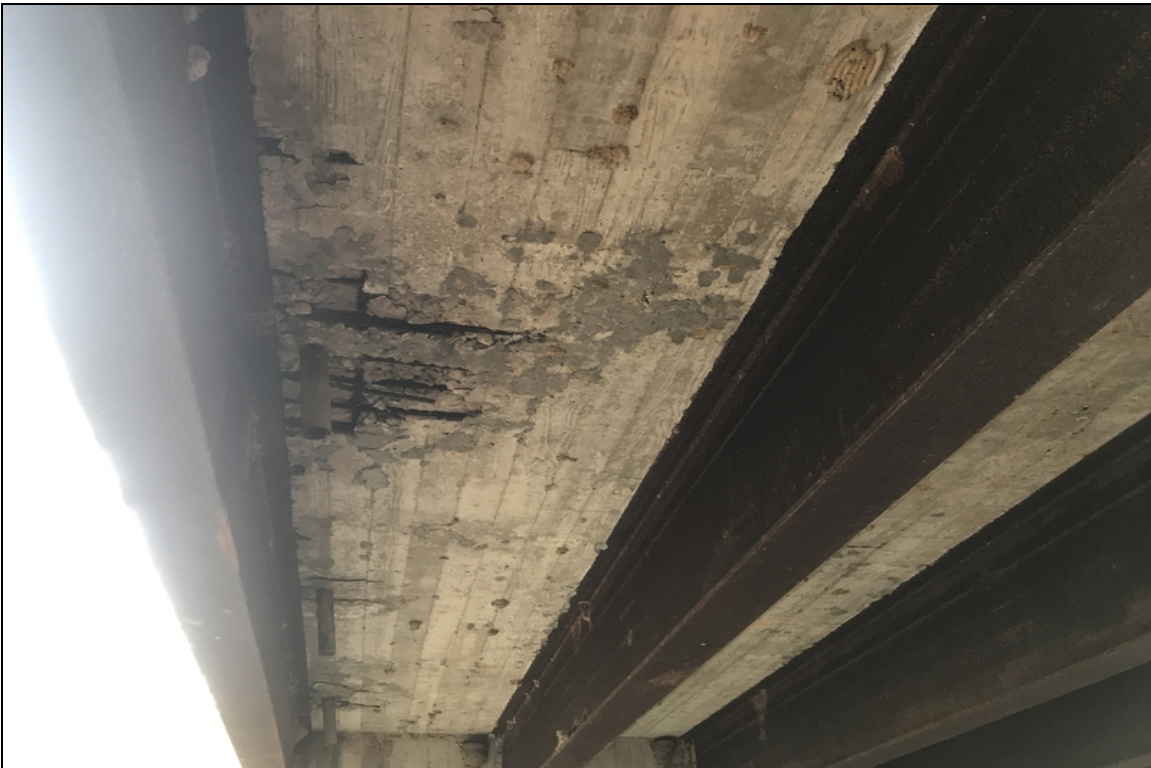
Span 2, between beams 7 & 8: large spall in soffit with exposed steel. Multiple locations with similar spalls.

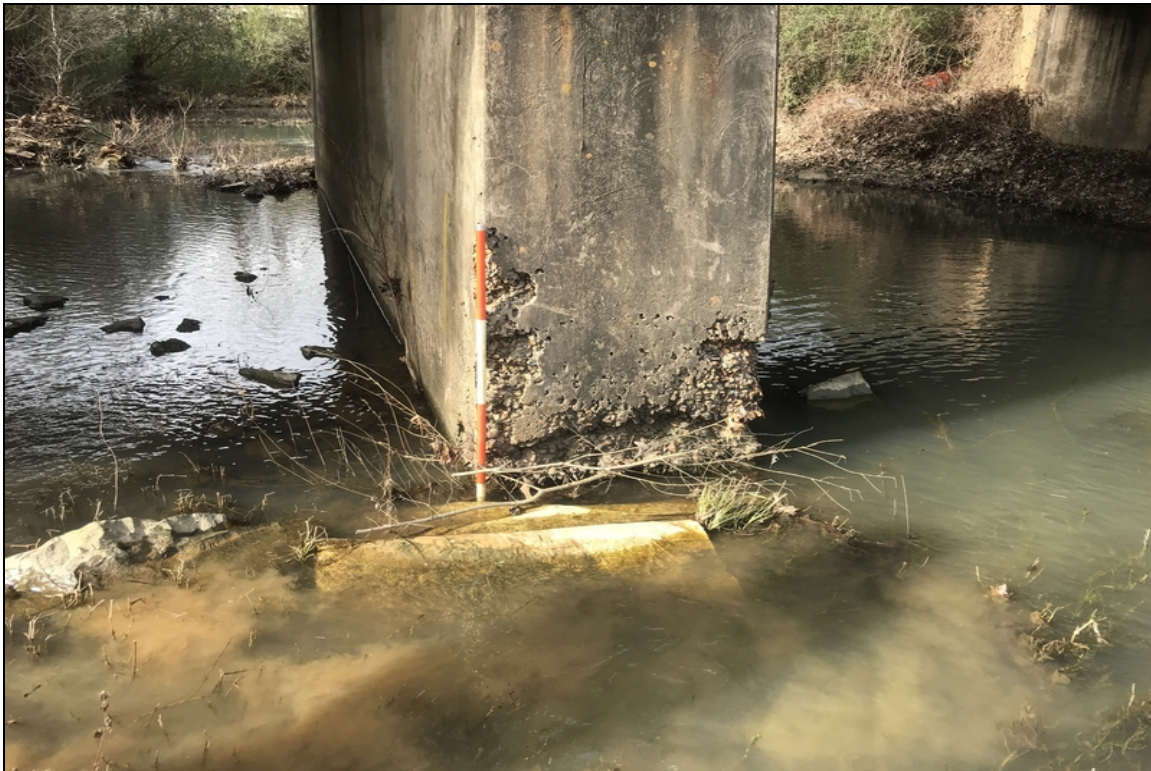
(210)							
Bent 2 left end of pier wall has severe abrasion. See photo.							
215	Reinforced Concrete Abutment	LF	137	123	12	2	0
1130	Cracking (RC and Other)	LF	14	0	12	2	0

Bent 2, left end with severe abrasion exposing reinforcing steel

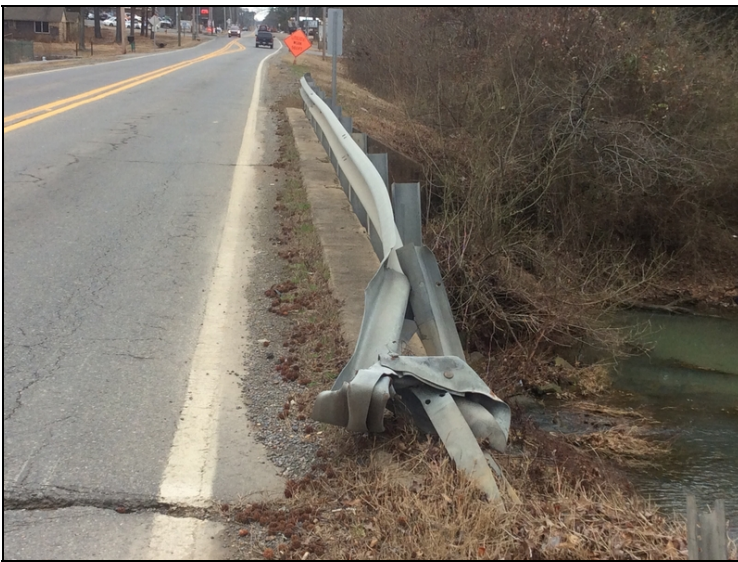
Right guardrail has collision damage.

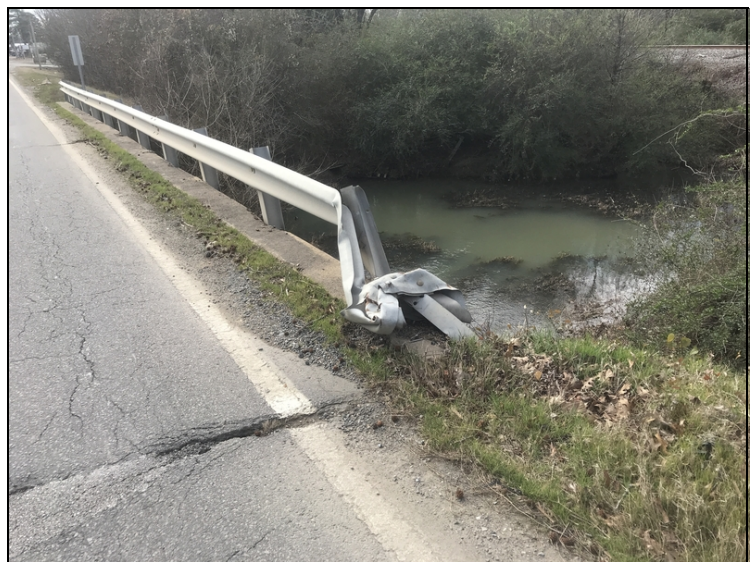
Right guardrail has collision damage
