Engineering Ethics: Keeping Bridges from Falling Down

Graham Bettis, P.E.

Engineering Ethics – Keeping Bridges from Falling Down

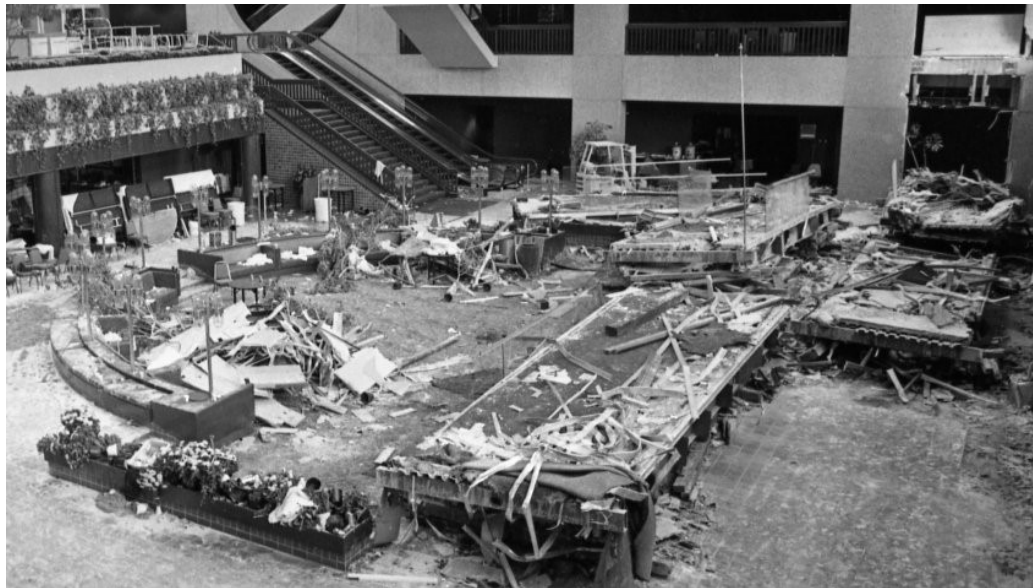
Hyatt Regency Walkway Collapse

- On July 17, 1981 two overhead walkways collapsed at the Kansas City Hyatt Regency during a party, killing 114 and injuring another 216.
- Deadliest structural failure in United States history. What happened?

- Load was doubled on an already under-designed connection detail.
- Change proposed by fabricator and contractor.
- Acceptance given by designer as part of review of large submittal package.

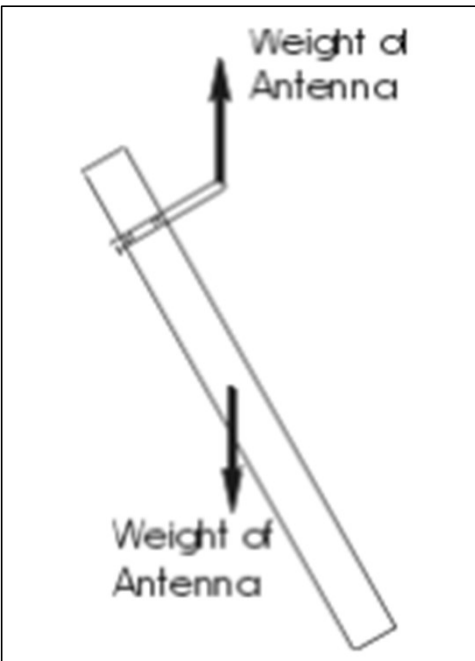
While the unloading from the truck was vertical, the lift to the top of the tower was far from it. Induced moment resulted in stresses 7x what they assumed.

- Contractor designed a connection based on the lug used to lift the antennae from the truck, which involved vertical forces only.

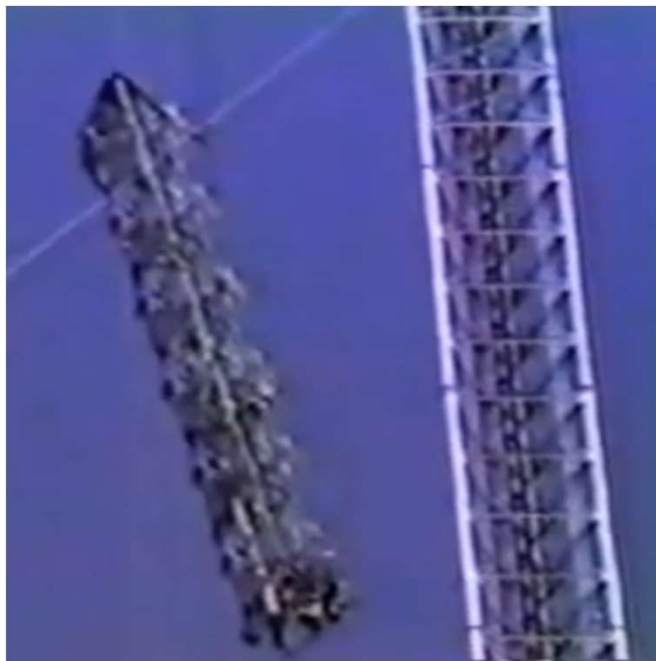
While the unloading from the truck was vertical, the lift to the top of the tower was far from it. Induced moment resulted in stresses 7x what they assumed.

- Contractor designed a connection based on the lug used to lift the antennae from the truck, which involved vertical forces only.

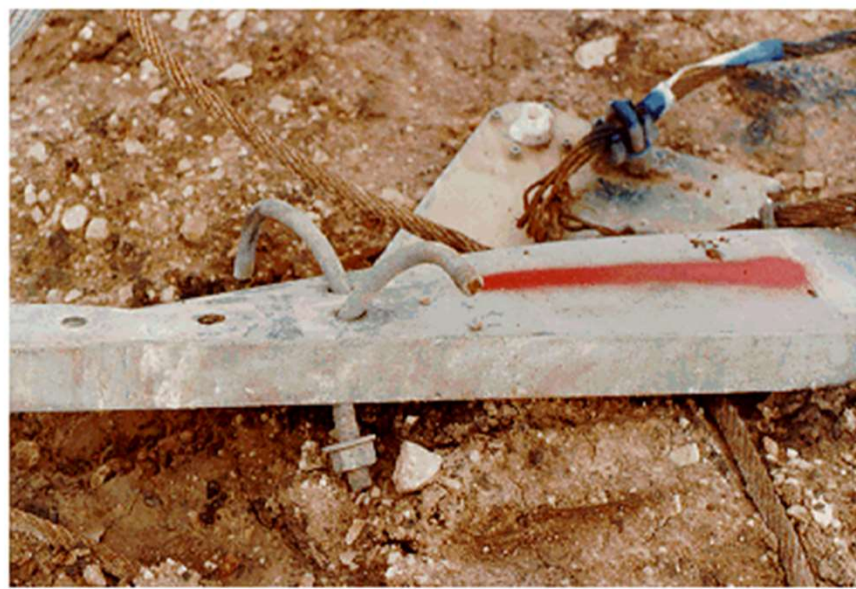
Close-up of Failed U-bolts:

- There was a local TV news station present, and they captured photo and video of the collapse as it occurred.

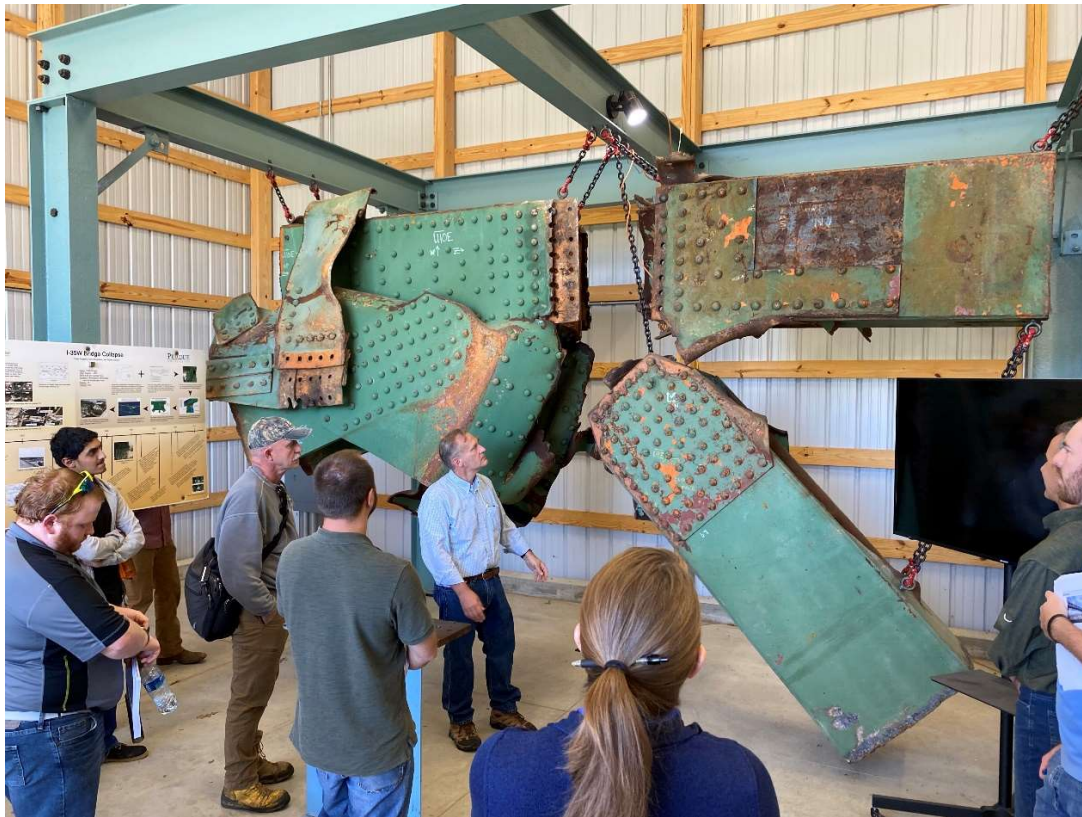
Minneapolis IH 35 Mississippi River Bridge

Collapse occurred due to gusset plate design issue combined with storage of heavy construction material as part of 2007 rehab.

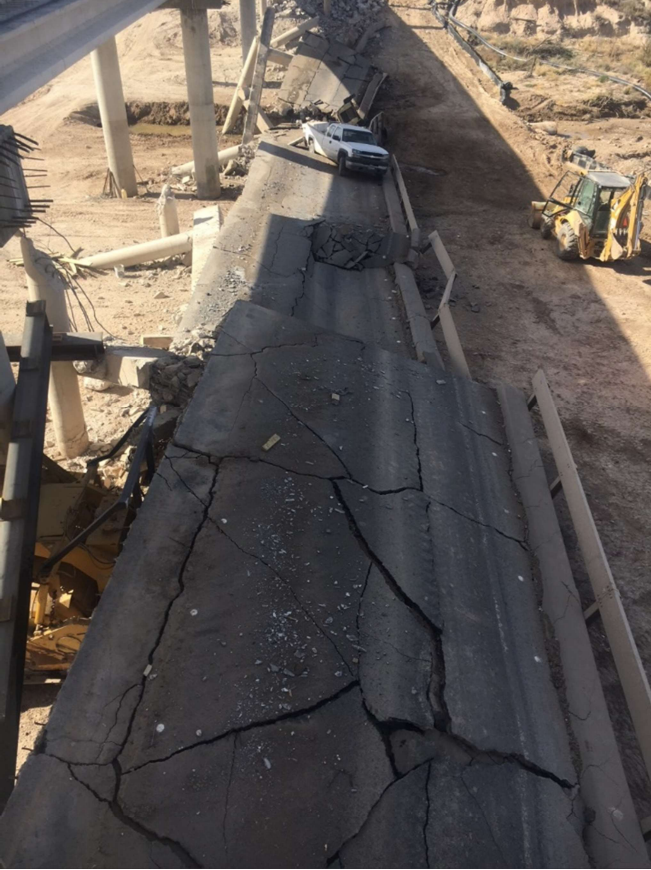
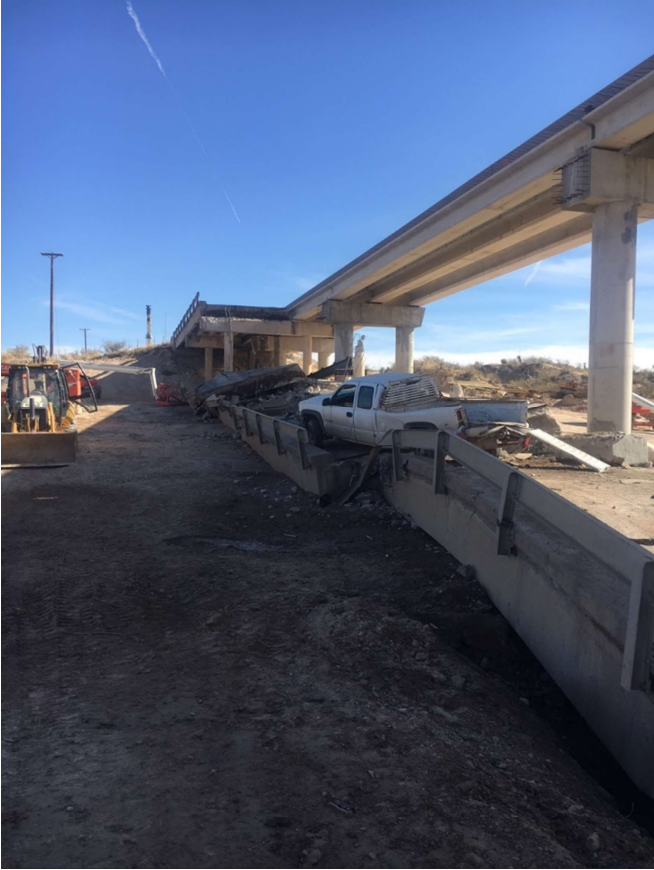
West Texas Pan Girder Bridge Collapse

Sudden collapse occurred during demolition activities.

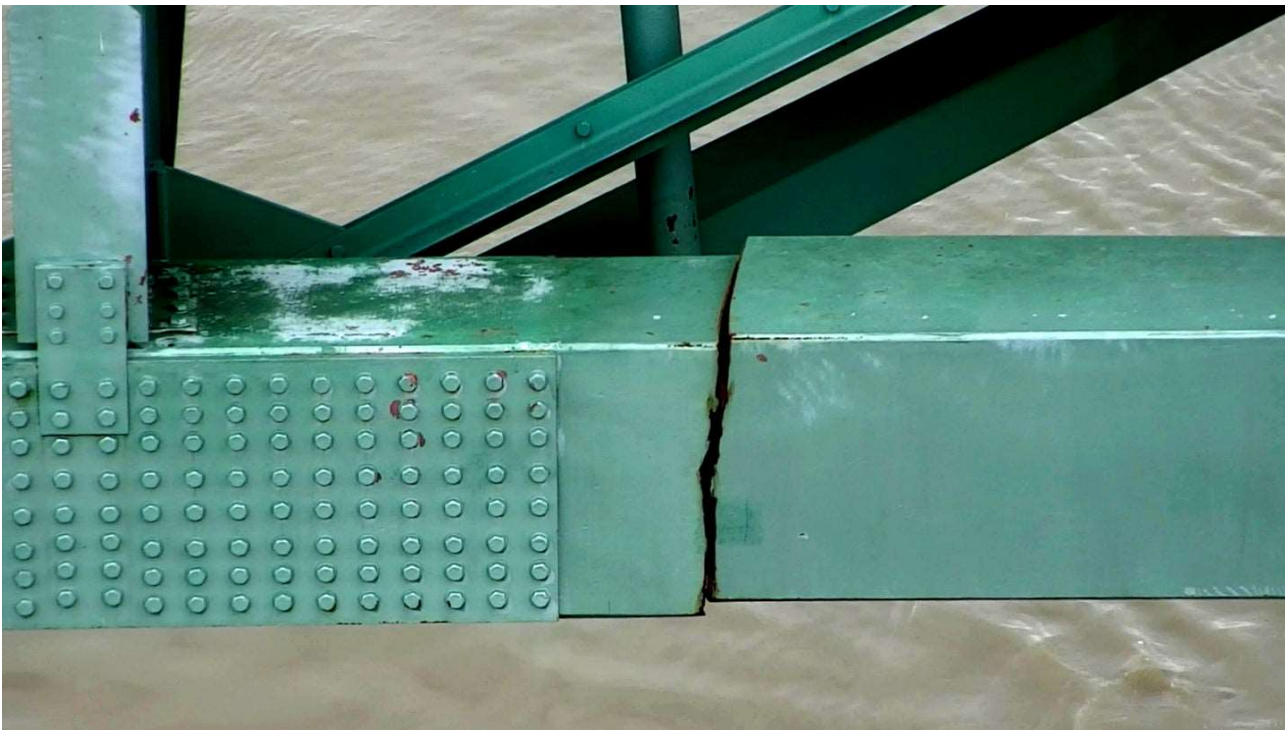
Hernando de Soto Bridge – May 11, 2021

- Fracture discovered and reported by consultant inspector.
- Inspecting truss and cable elements, NOT the tie beam.
- Why that matters...

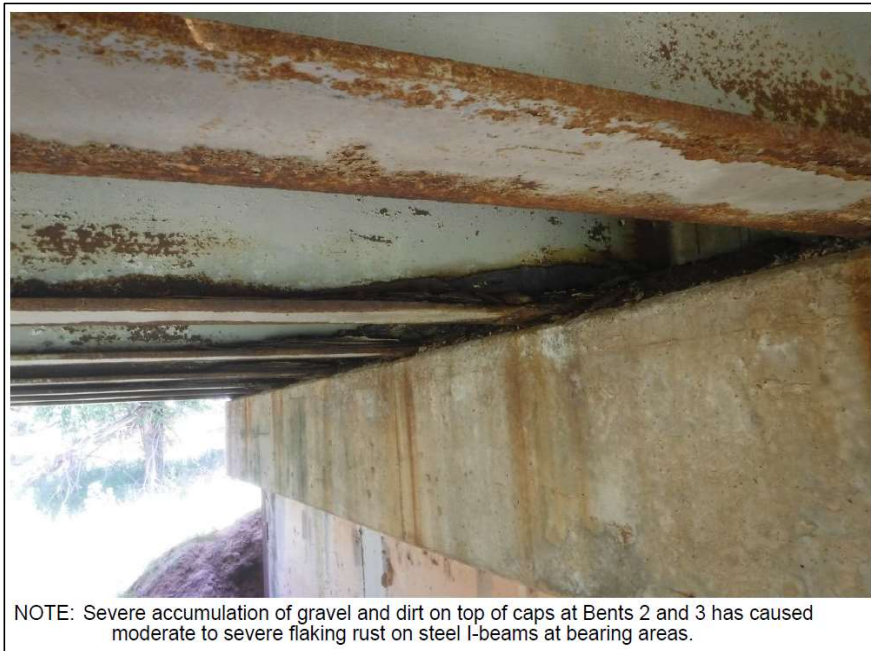
2017 Routine Safety Inspection

NOTE: Severe accumulation of gravel and dirt on top of caps at Bents 2 and 3 has caused moderate to severe flaking rust on steel I-beams at bearing areas.

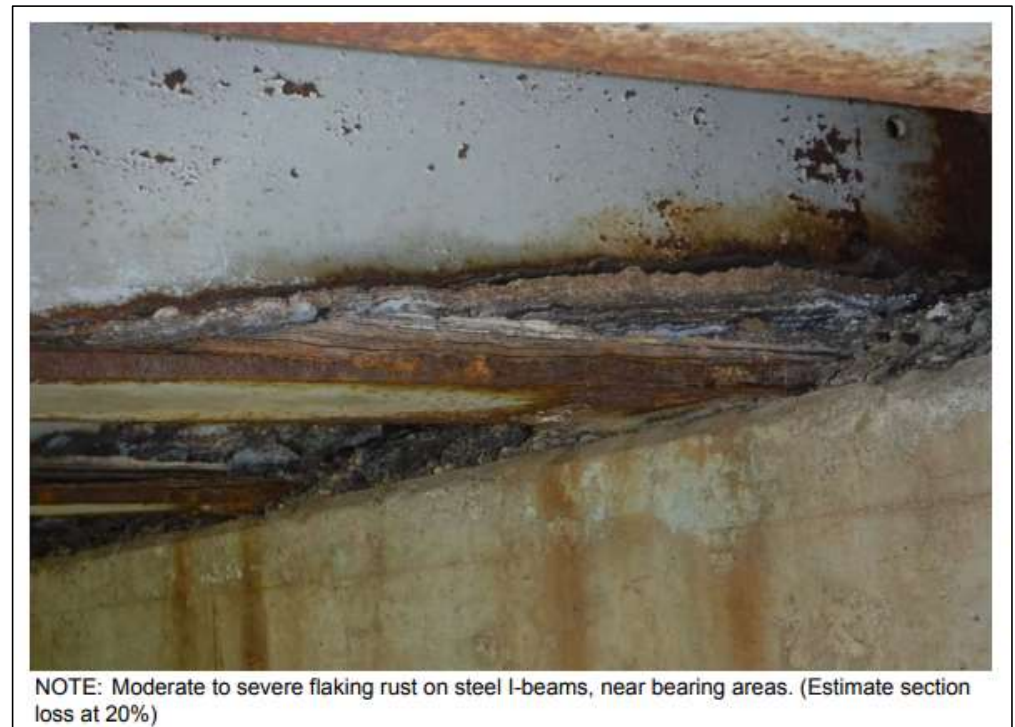
2019 Routine Safety Inspection

NOTE: Moderate to severe flaking rust on steel I-beams, near bearing areas. (Estimate section loss at 20%)

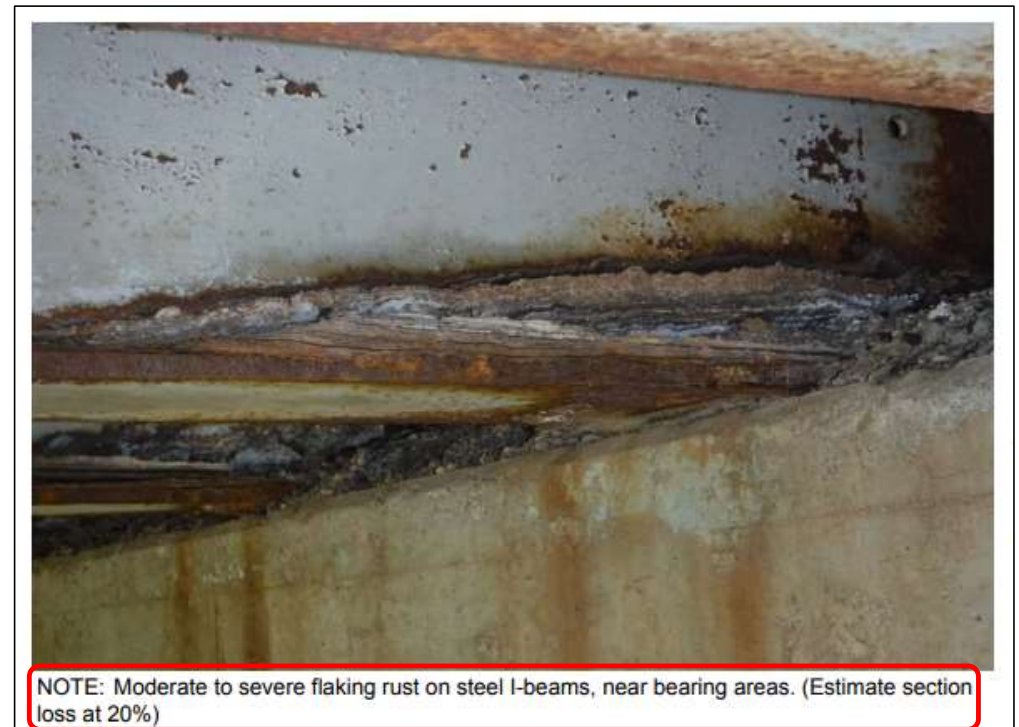
2019 Routine Safety Inspection

Estimated how???

NOTE: Moderate to severe flaking rust on steel I-beams, near bearing areas. (Estimate section loss at 20%)

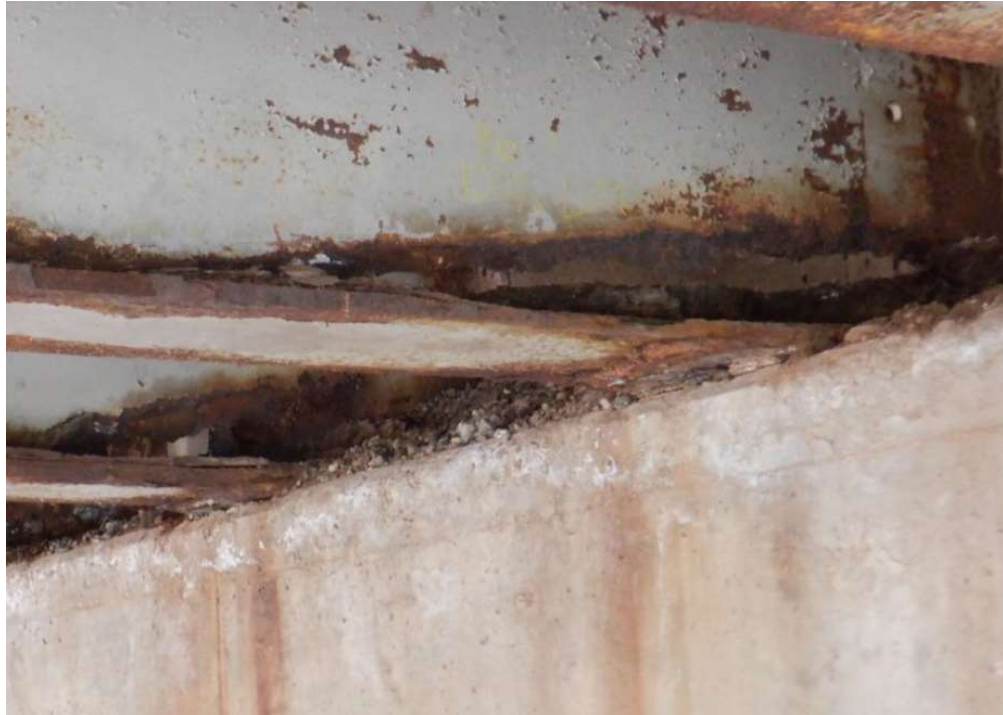
Back to West Texas

Emergency bridge closure on May 11, 2021

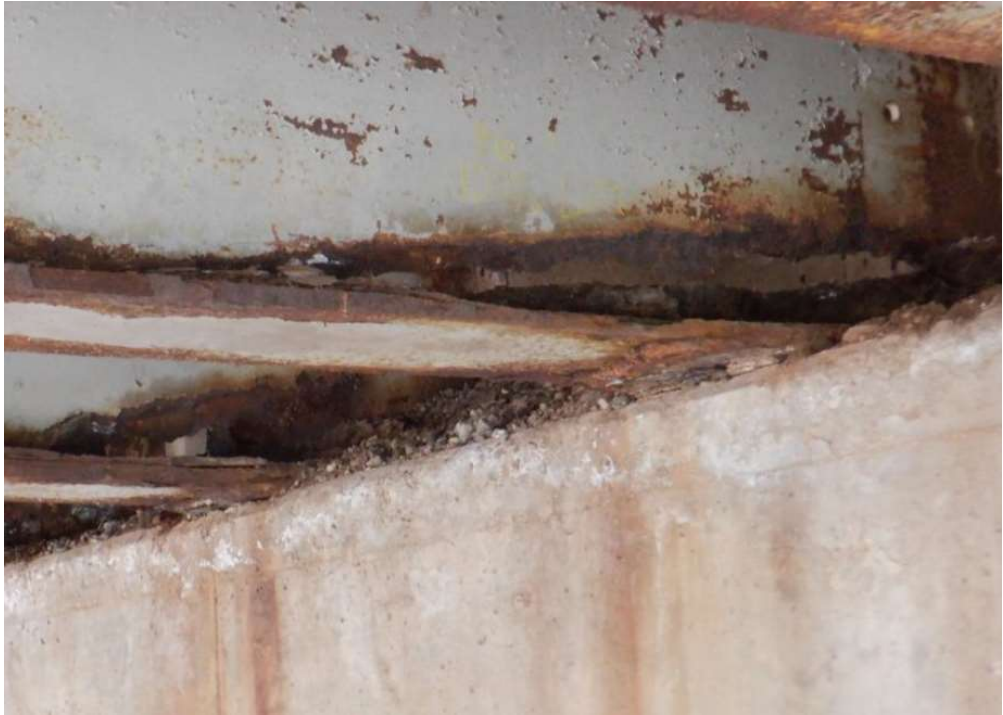
Back to West Texas

Emergency bridge closure on May 11, 2021

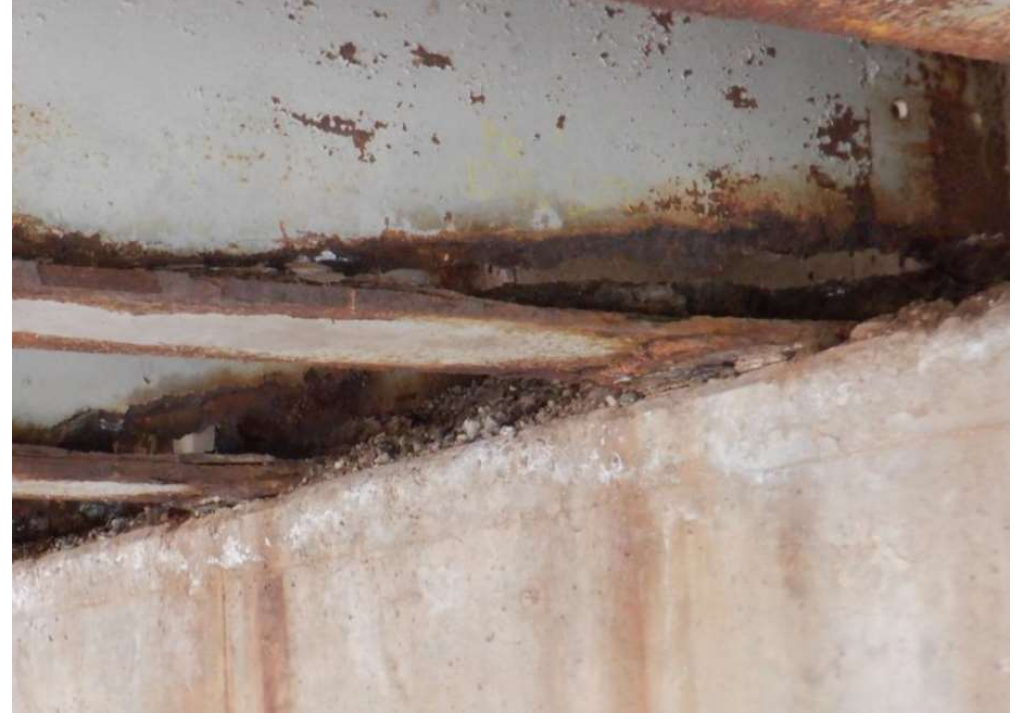
Emergency bridge closure on **May 11, 2021**

- Over a decade of inspection reports outlining this issue.
- TxDOT used this as an example for in-house and consultant inspectors.
- Bridges typically tell us when they aren't feeling well. We have to listen!
