March 20, 2015
Job No. 14-030

**GEOTECHNICAL INVESTIGATION
BRIDGE FOUNDATIONS and EMBANKMENTS
AHTD JOB CA0608
BAPTIST HOSPITAL-UNIVERSITY AVENUE (WIDENING)(S)
LITTLE ROCK, PULASKI COUNTY, ARKANSAS**

Submitted herein are foundation recommendations for bridge structures included in the I-630 widening project in Little Rock, Pulaski County, Arkansas. This project is designated as AHTD Job CA0608: Baptist Hospital-University Avenue (Widening)(S). Results of stability analyses performed for the plan embankments at the Rock Creek Bridge location are also included in this submittal. Interim foundation recommendations for the bridges were provided on February 4 and February 7, 2015. Recommendations related to the roadway and retaining walls are provided in other report submittals under separate covers.

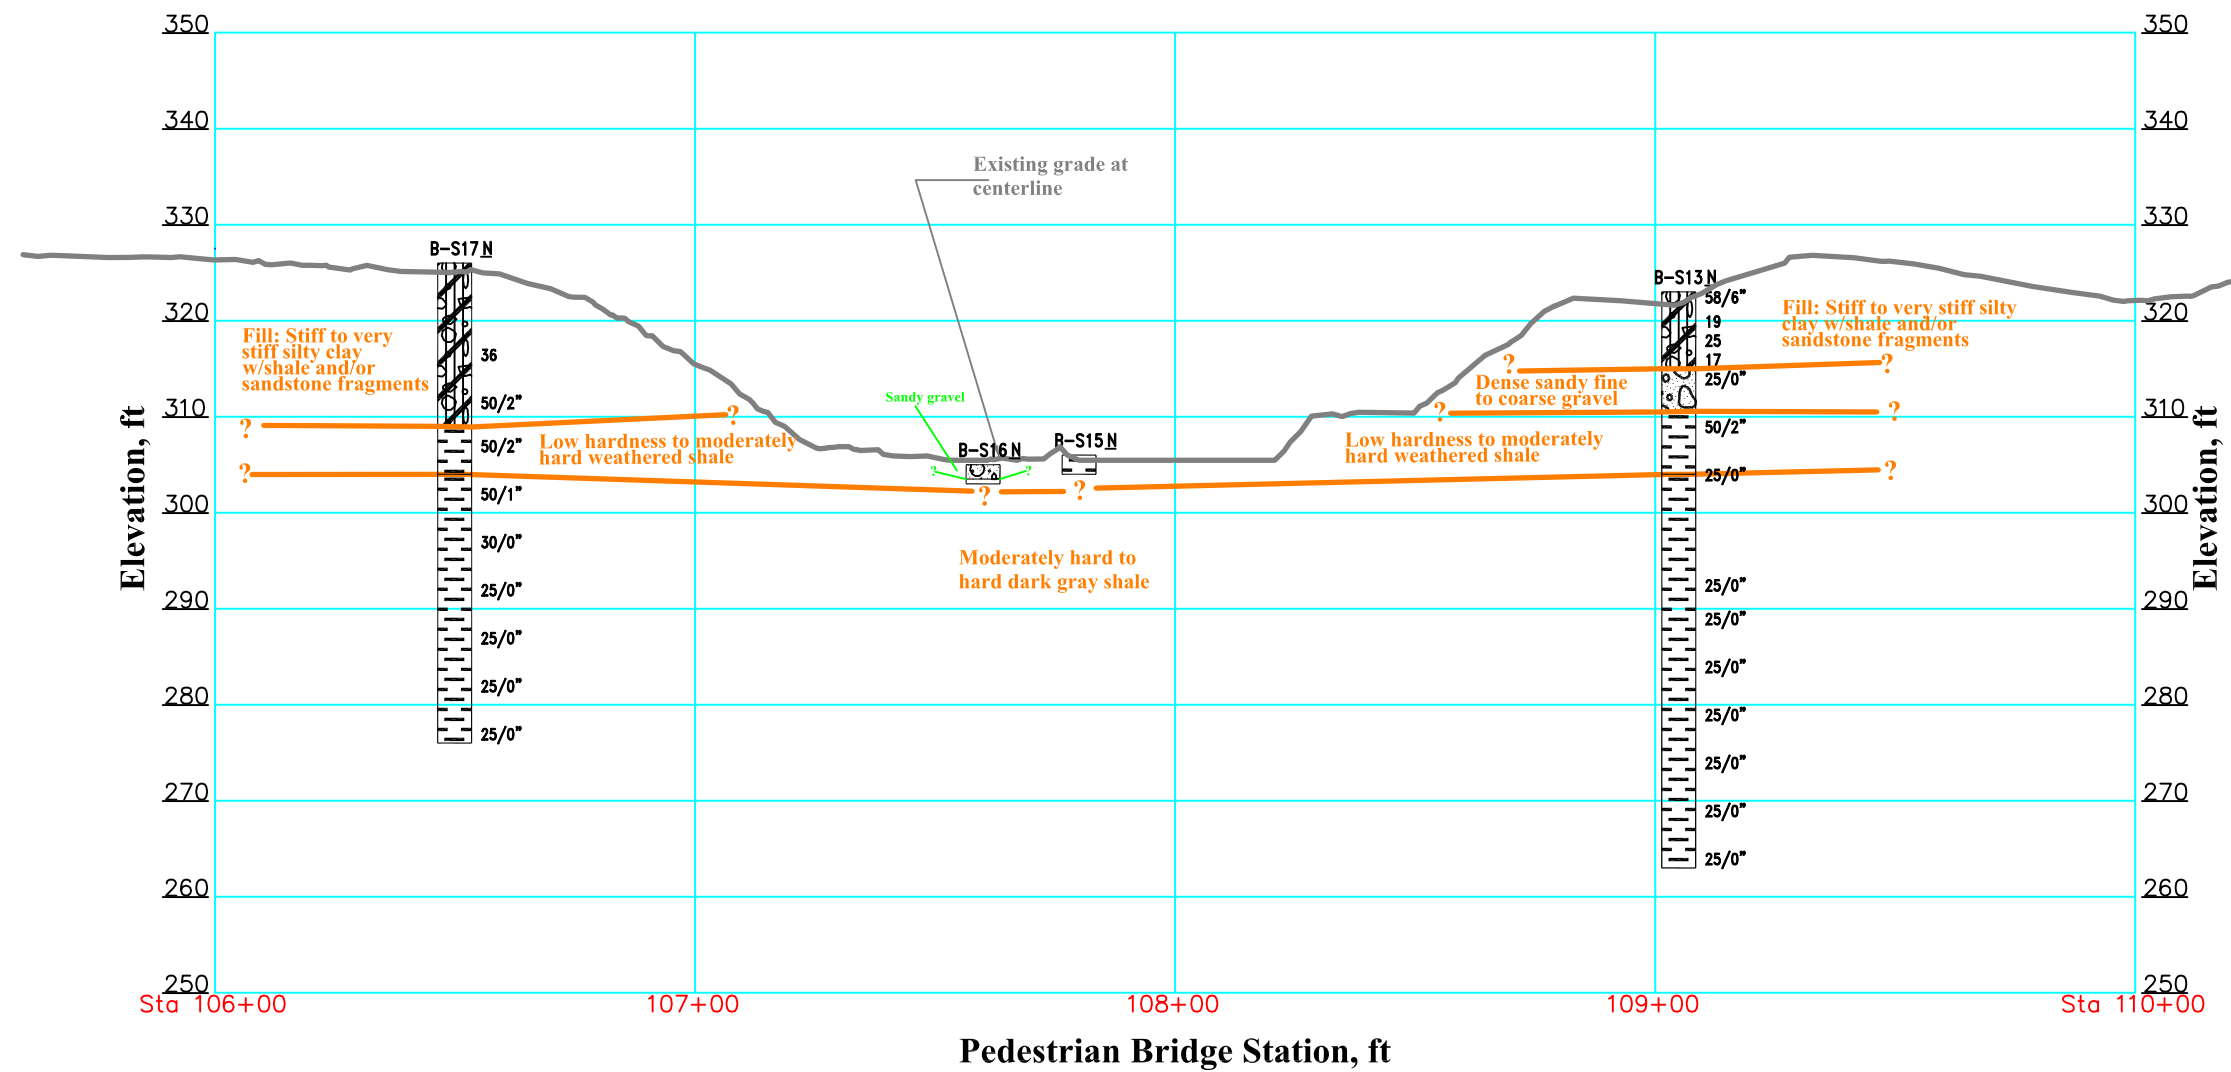
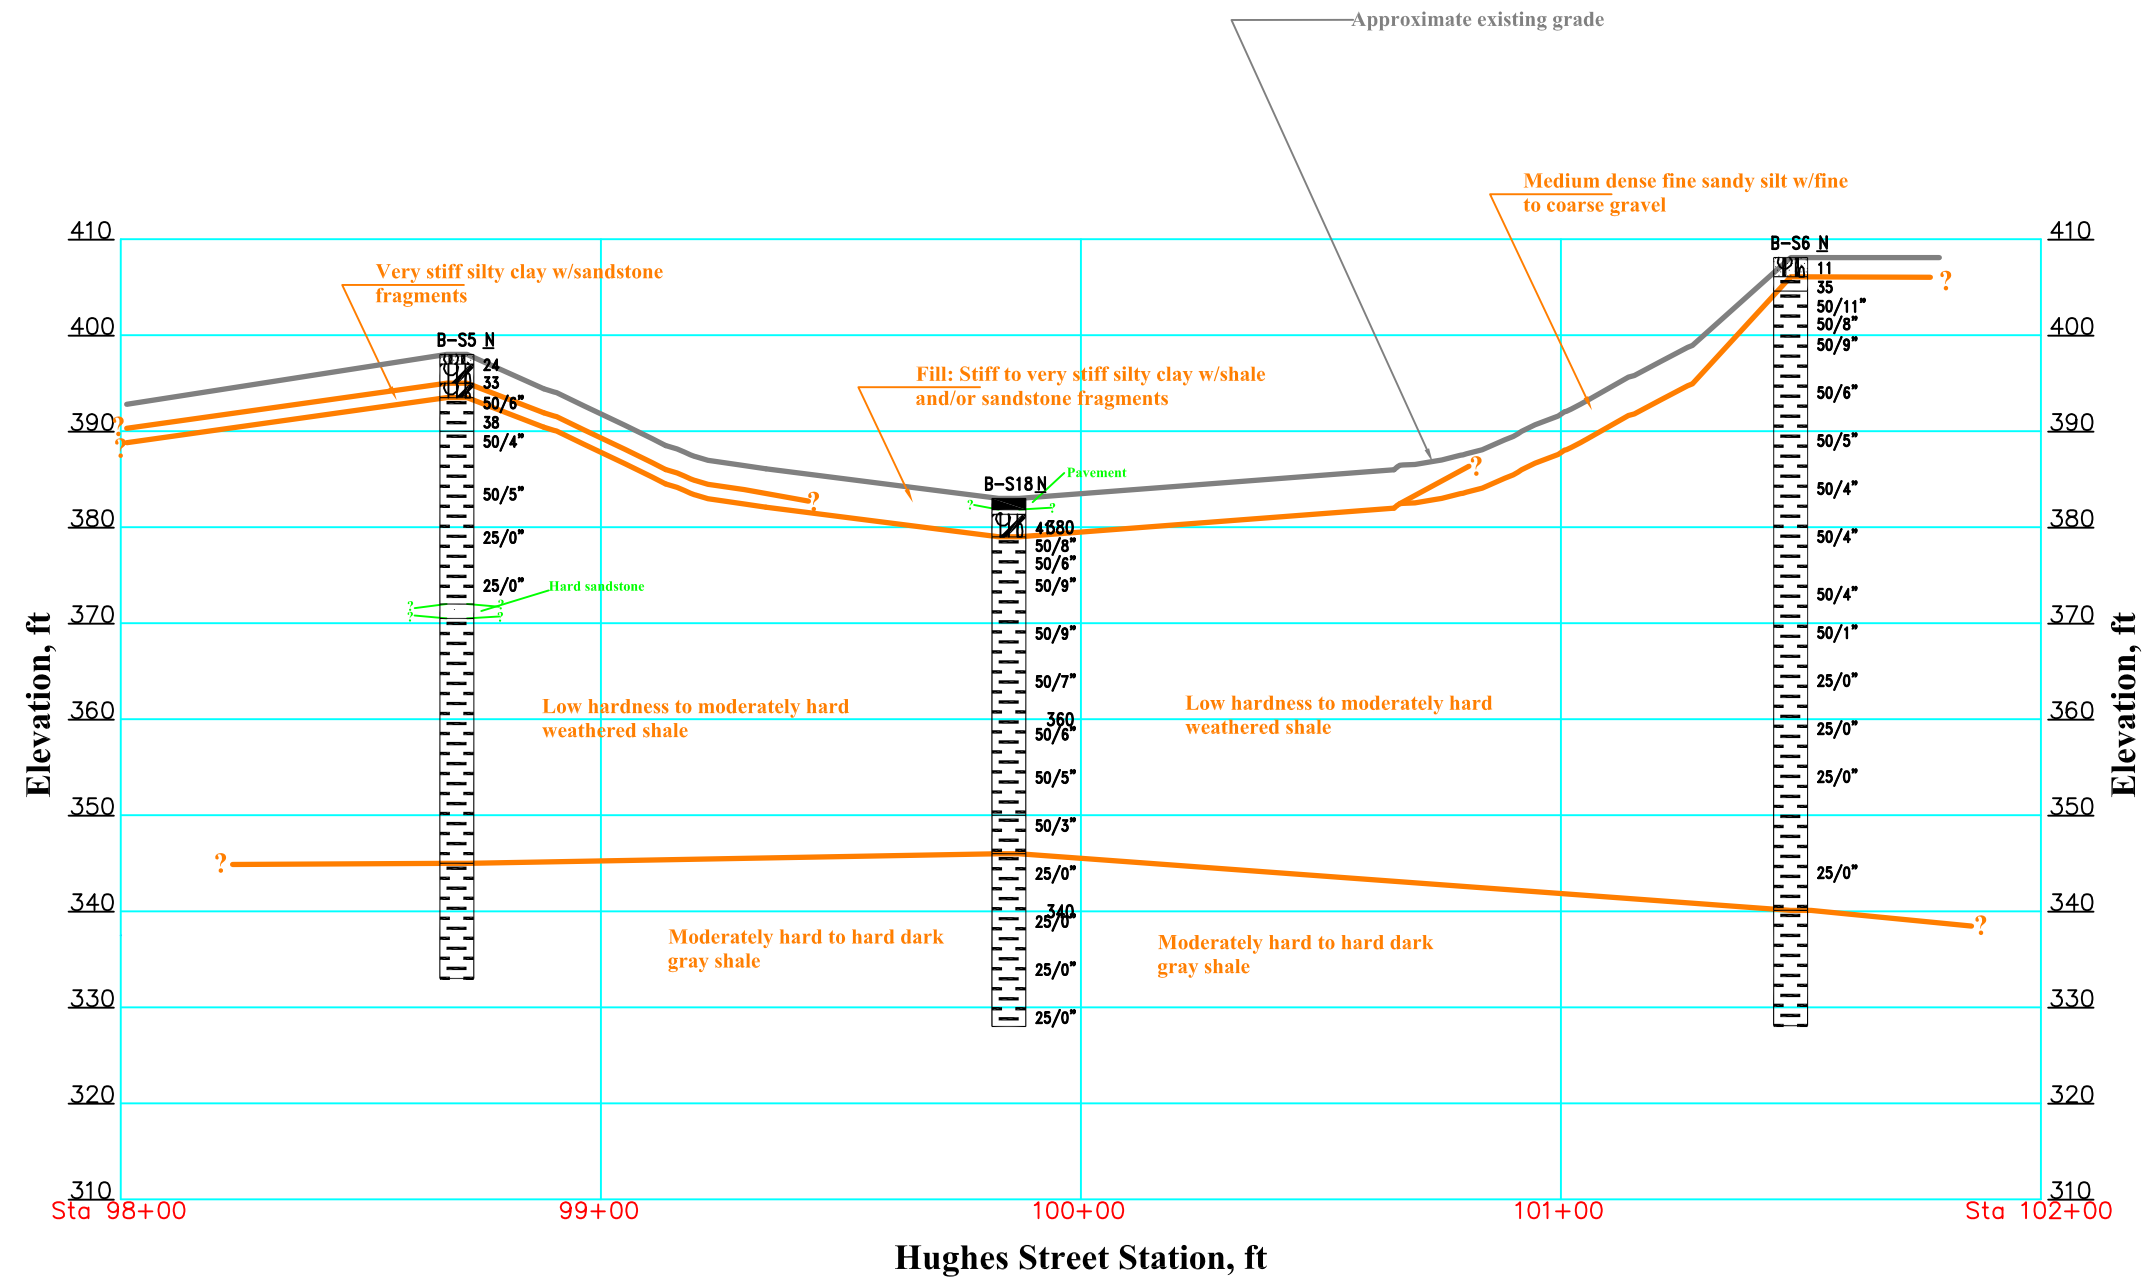
Notes: 1. Subsurface conditions have been inferred between discrete boring locations. Actual conditions may vary.
2. Ground surface elevation at boring locations are approximate.

Generalized Subsurface Profiles. To aid in visualizing the subsurface conditions in the bridge alignments, Generalized Subsurface Profiles are included in Attachment 6. It should be recognized that the stratigraphy illustrated by the profiles has been inferred between discrete boring locations. In view of the natural variations in stratigraphy and subsurface conditions, variations from the stratigraphy illustrated by the profiles should be anticipated. Additionally, the natural transition between strata is generally gradual, and the stratigraphy described in the sections above may vary.

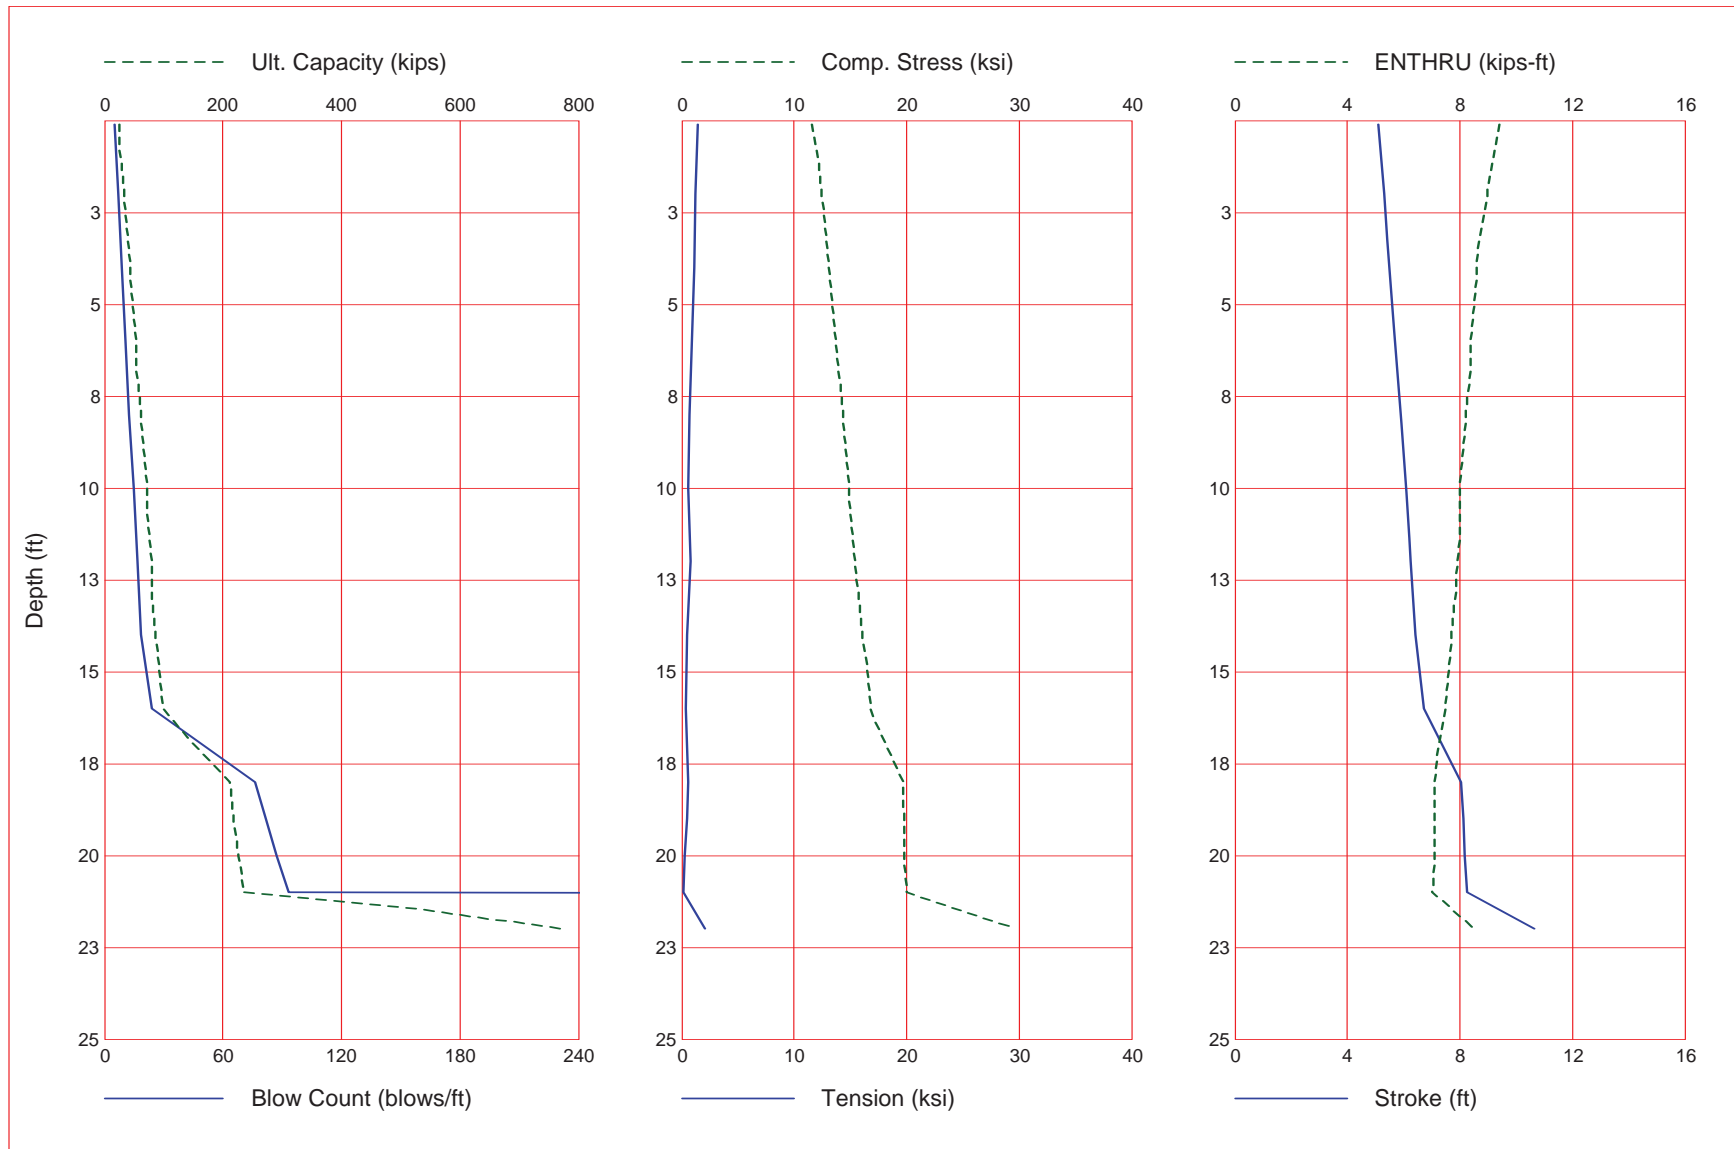
Results of Driveability Analysis
Steel HP14x73 Pile
DELMAG D 8-22 Hammer: E = 20.1 ft-kips; W = 1.8 kips
Bent 5 (East Abutment) - I-630 over Rock Creek

Based on the results of WEAP analysis, we recommend a minimum hammer energy of 20 ft-kips per blow for the HP12x53 piles and HP14x73 piles at the Rock Creek Bridge, Pedestrian Bridge, and Rodney Parham Bridge locations. For the steel piles at the Hughes Street Bridge location, a minimum hammer energy of 22.6 ft-kips per blow for HP12x53 piles and a minimum hammer energy of 27.1 ft-kips per blow for HP14x73 piles are recommended.

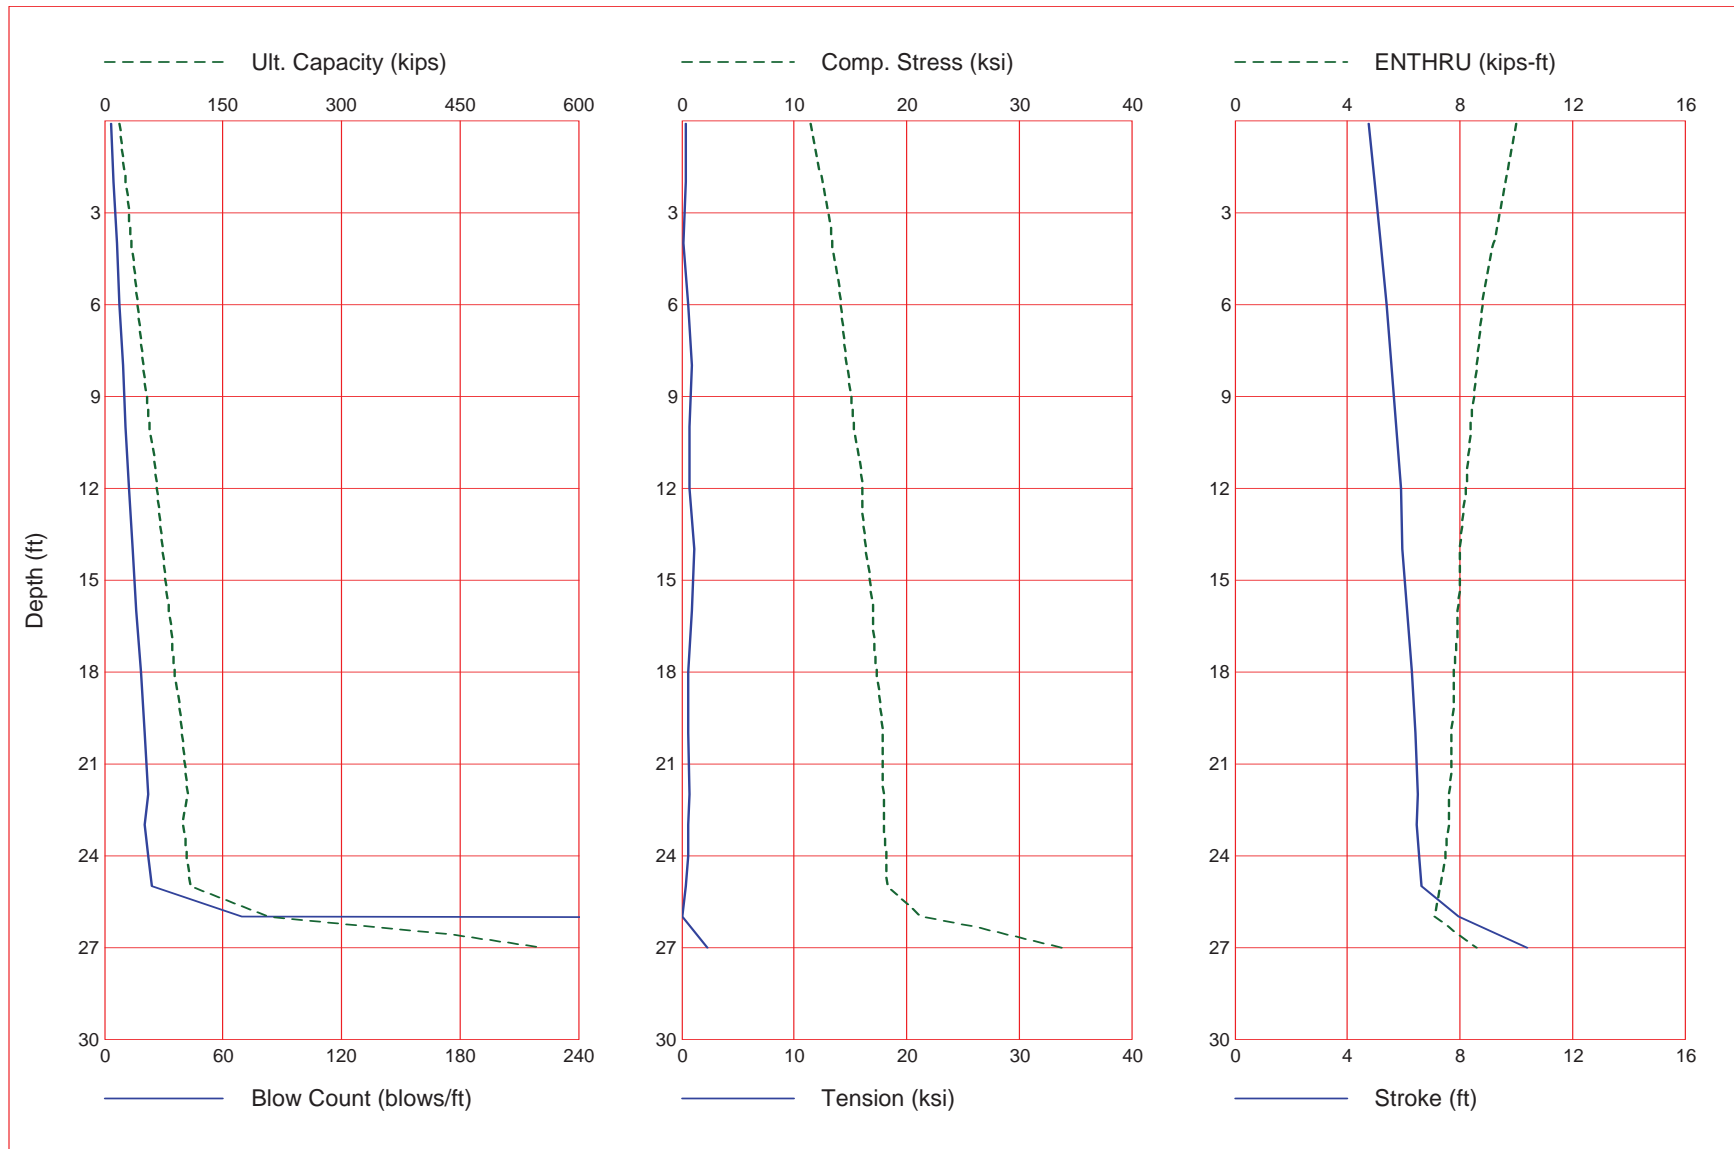
Results of Driveability Analysis
Steel HP12x53 Pile
DELMAG D 8-22 Hammer: E = 20.1 ft-kips; W = 1.8 kips
Bent 1 (West Abutment) - I-630 over Rodney Parham

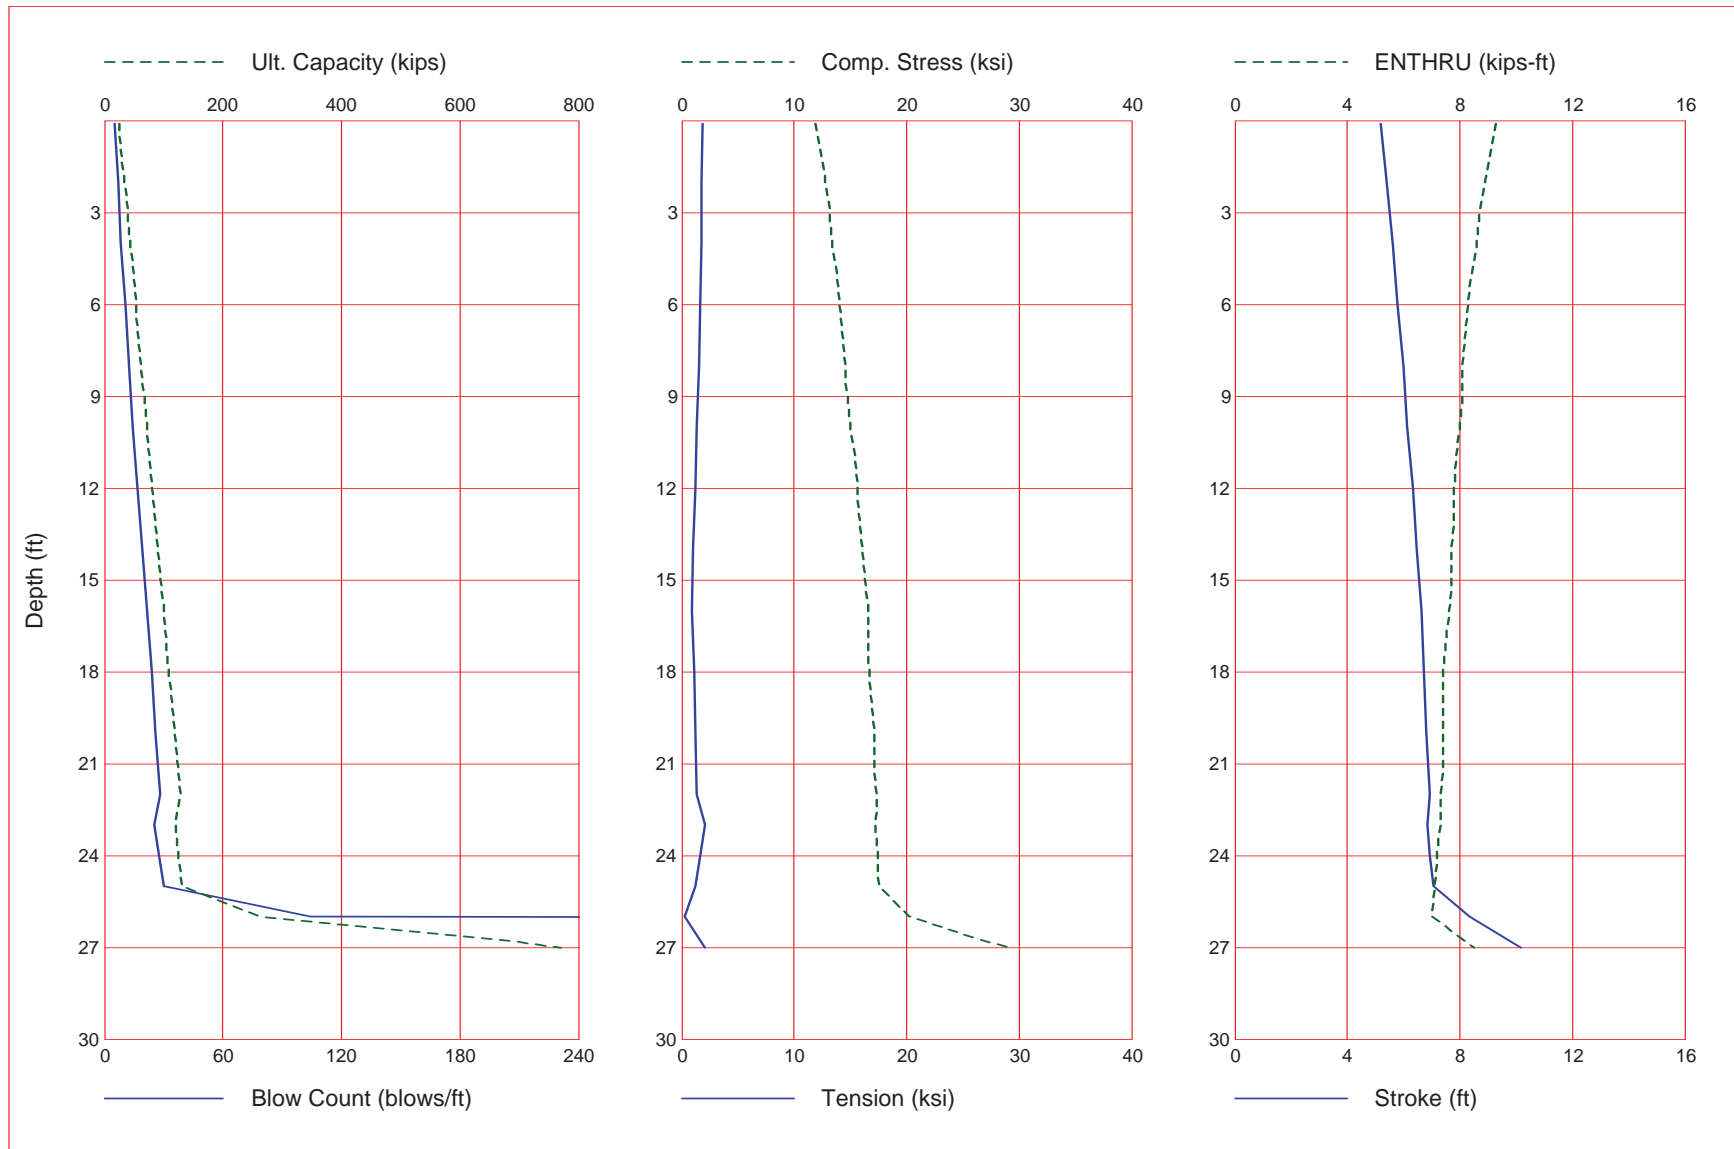
Results of Driveability Analysis
Steel HP14x73 Pile
DELMAG D 8-22 Hammer: E = 20.1 ft-kips; W = 1.8 kips
Bent 1 (West Abutment) - I-630 over Rodney Parham

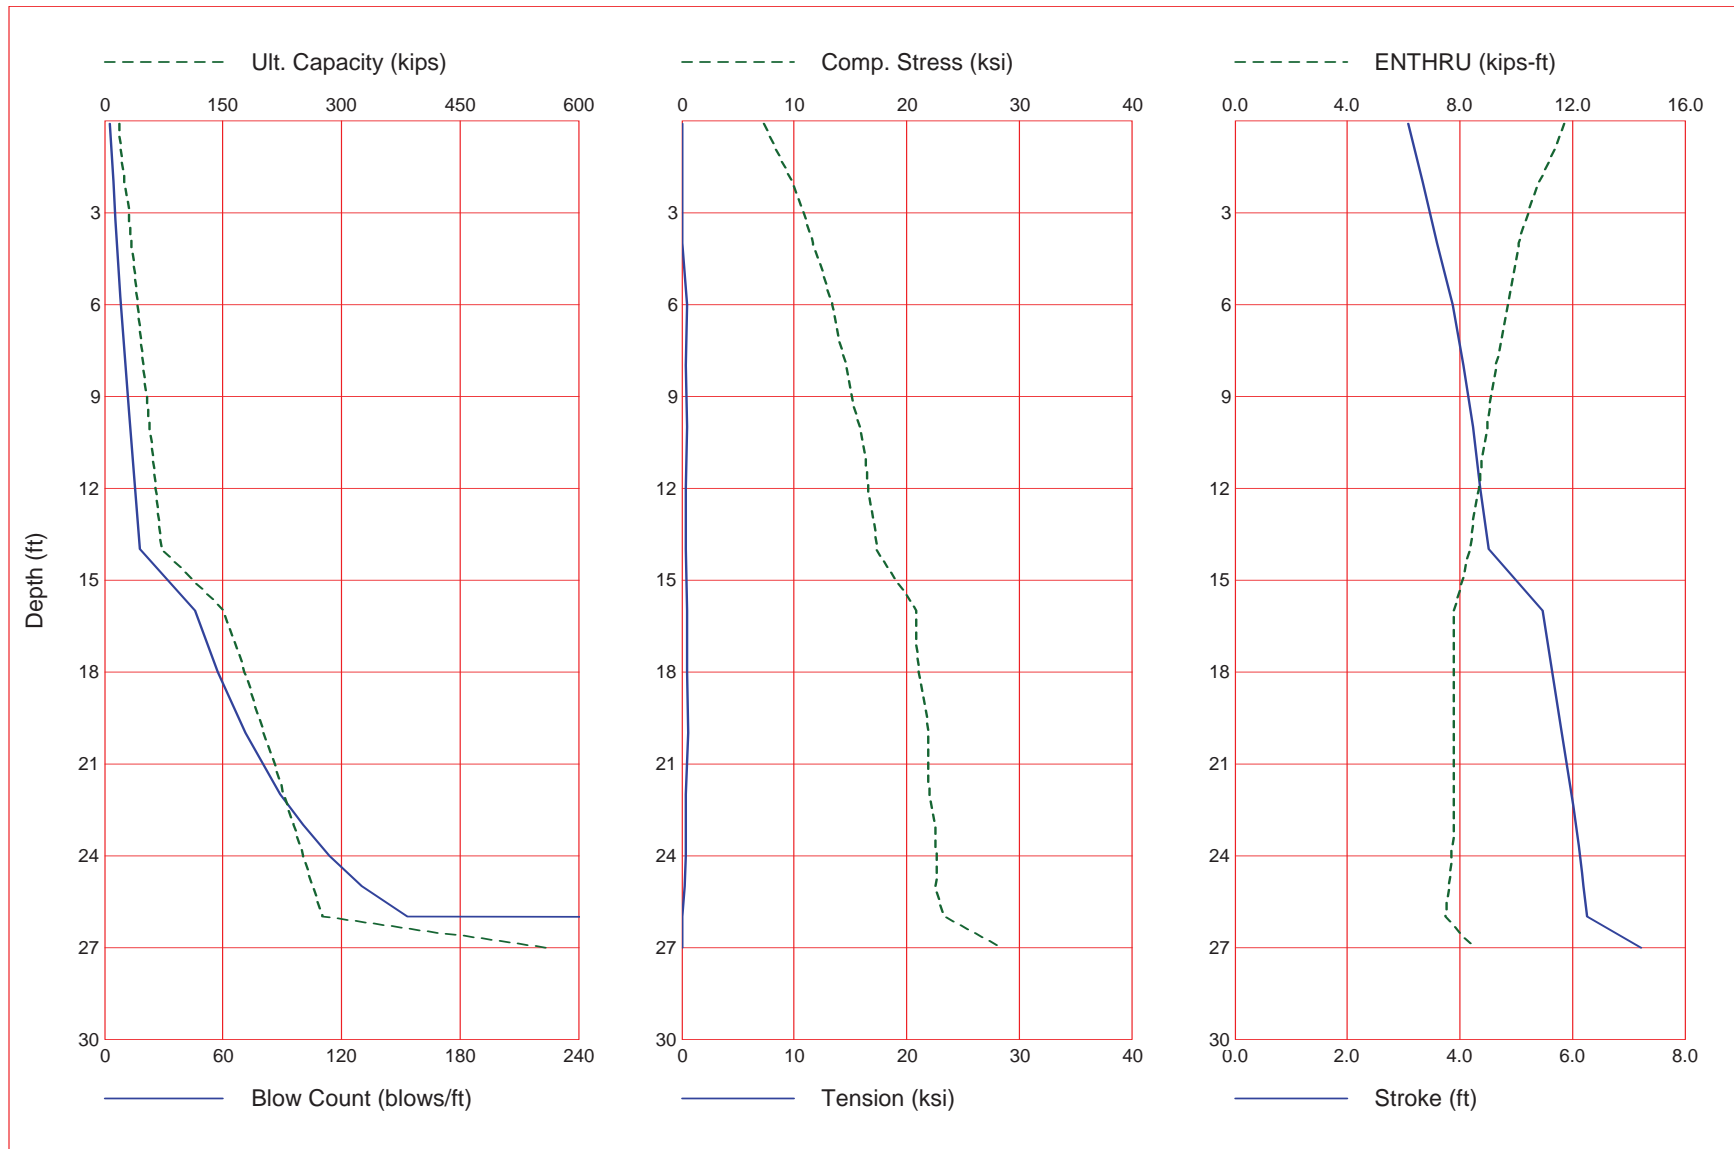
Results of Driveability Analysis
Steel HP12x53 Pile
DELMAG D 12 Hammer: E = 22.6 ft-kips; W = 2.8 kips
Bent 3 (North Abutment) - Hughes Street over I-630

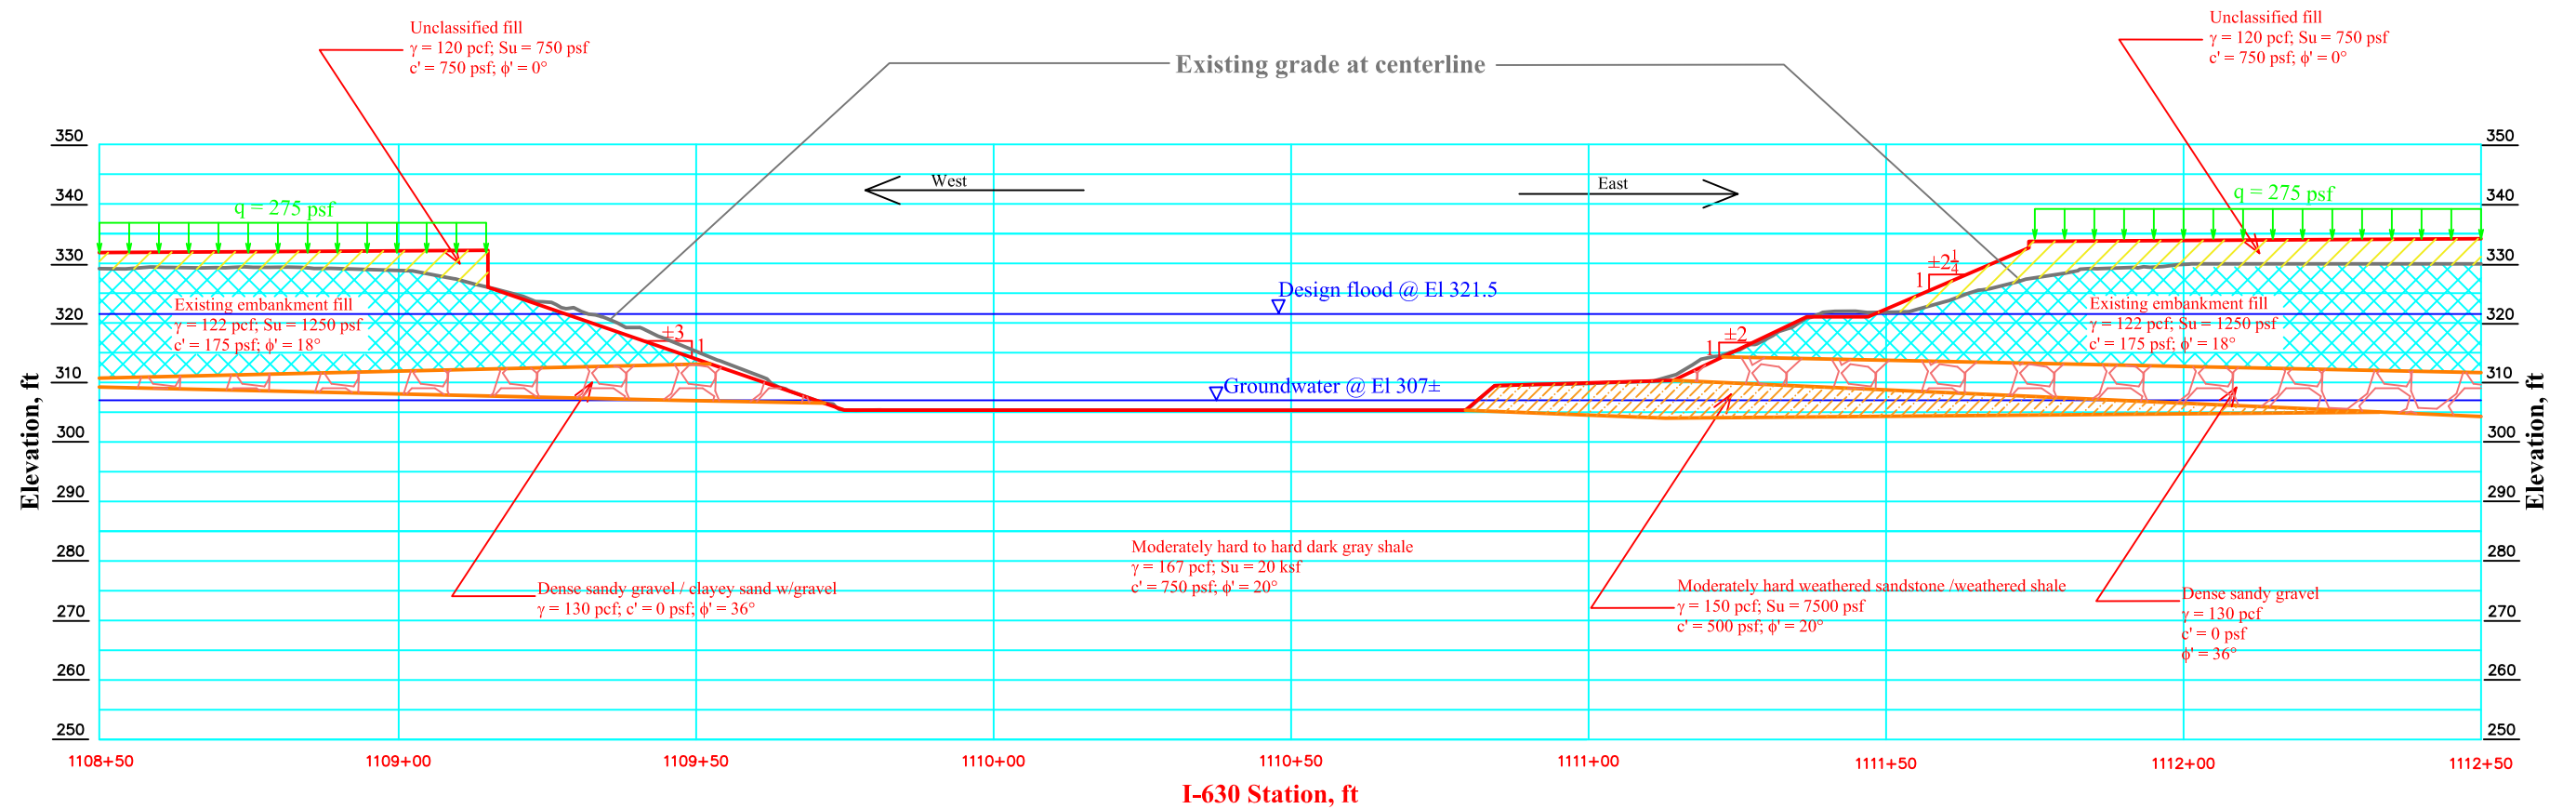
Note: Section developed for purpose of stability analysis only, not for construction.

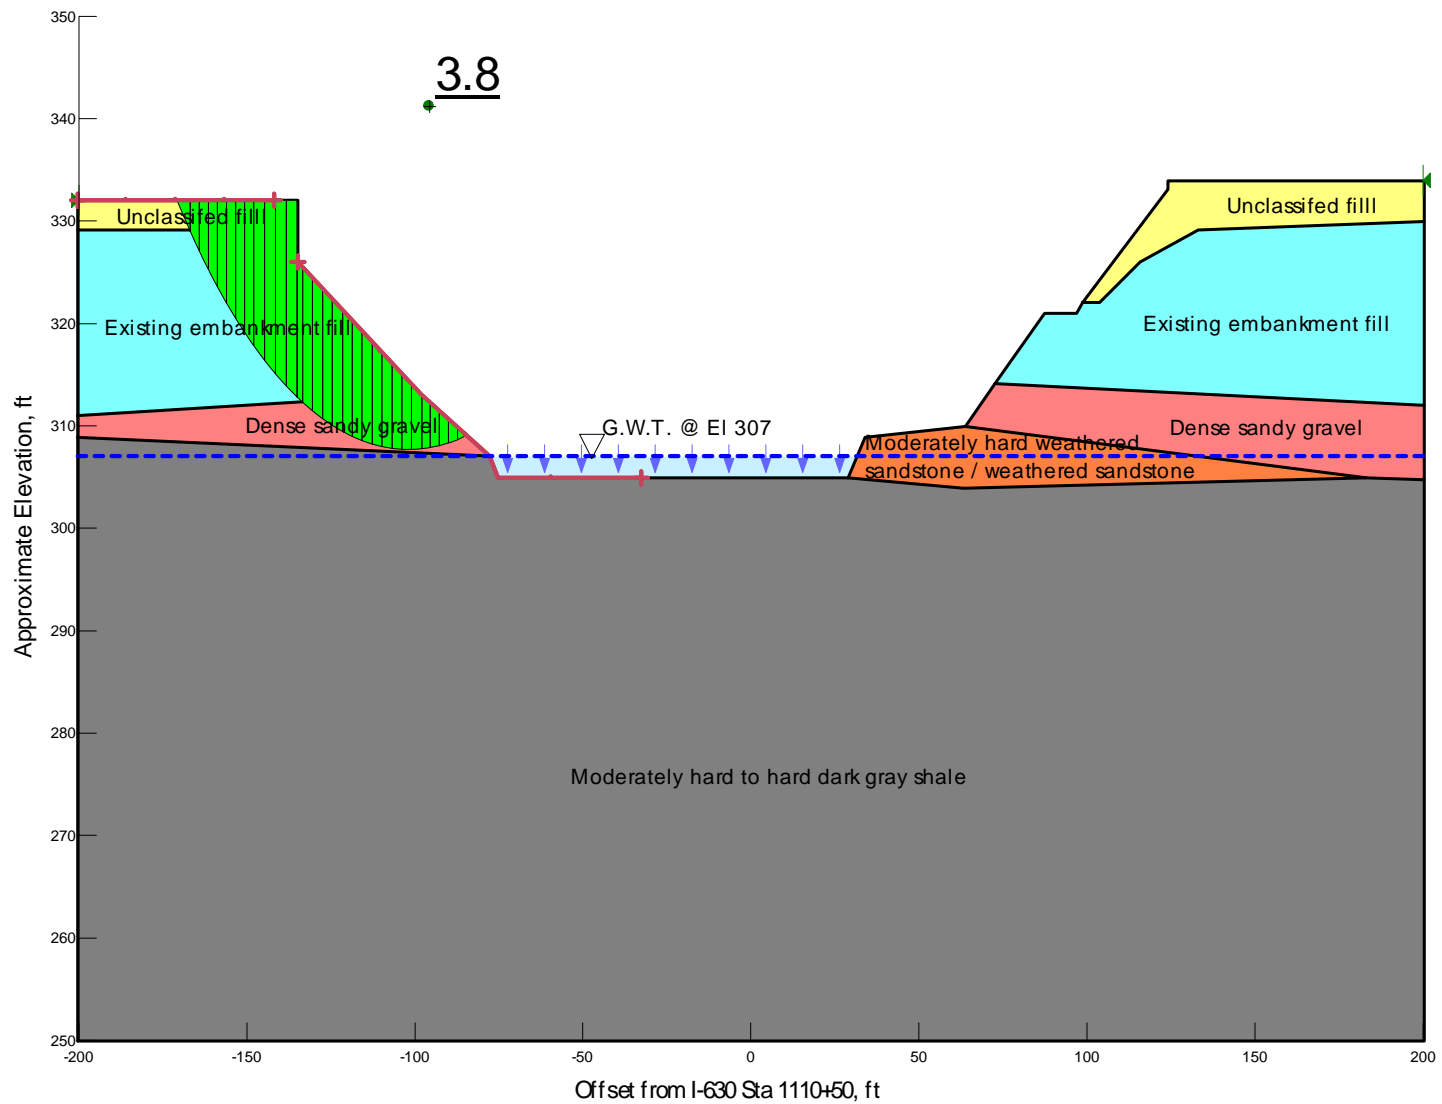
Results of Stability Analyses – End of Construction Condition
Groundwater @ El 307±
End Slope @ West Bridge Abutment – I-630 over Rock Creek

Design Loading Condition	Design Water Condition	Calculated Minimum Factor of Safety
End of Construction	Groundwater @ El 307±	3.8
Long Term	Groundwater @ El 307±	1.6
	Design flood @ El 321.5	1.5
Seismic ($k_h = 1.0A_s = 0.13$)	Groundwater @ El 307±	1.3
Rapid Drawdown	Drawdown from design flood to embankment toe	1.4

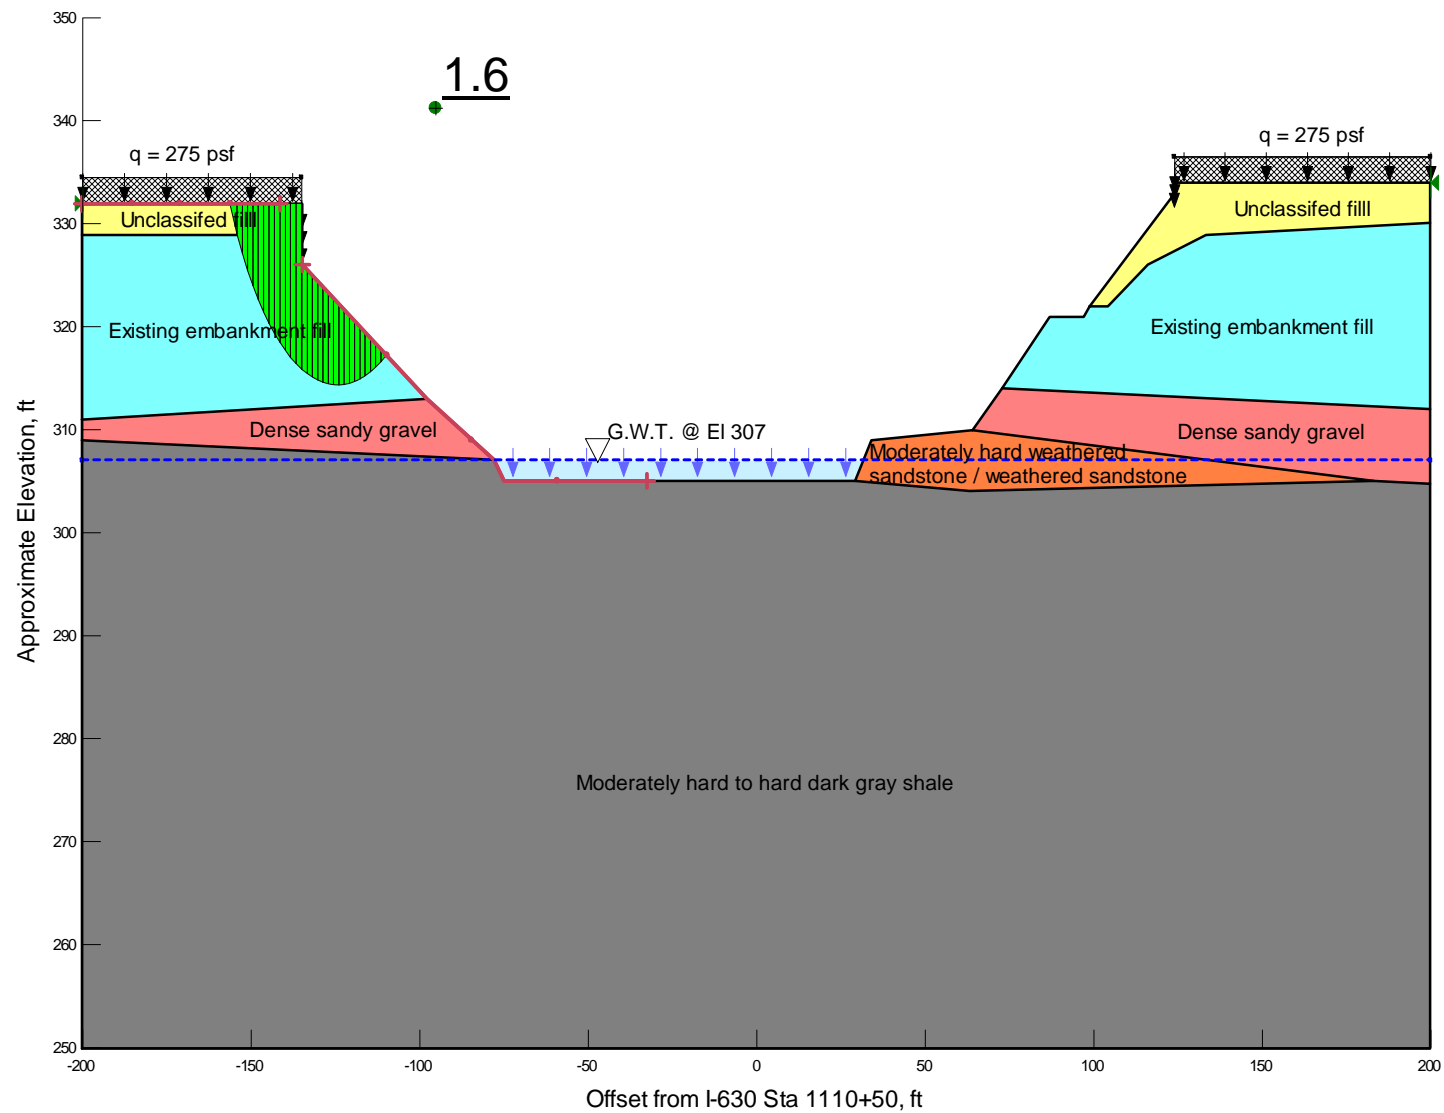
Results of Stability Analyses – Long Term Condition
 Groundwater @ El 307±
 End Slope @ West Bridge Abutment – I-630 over Rock Creek

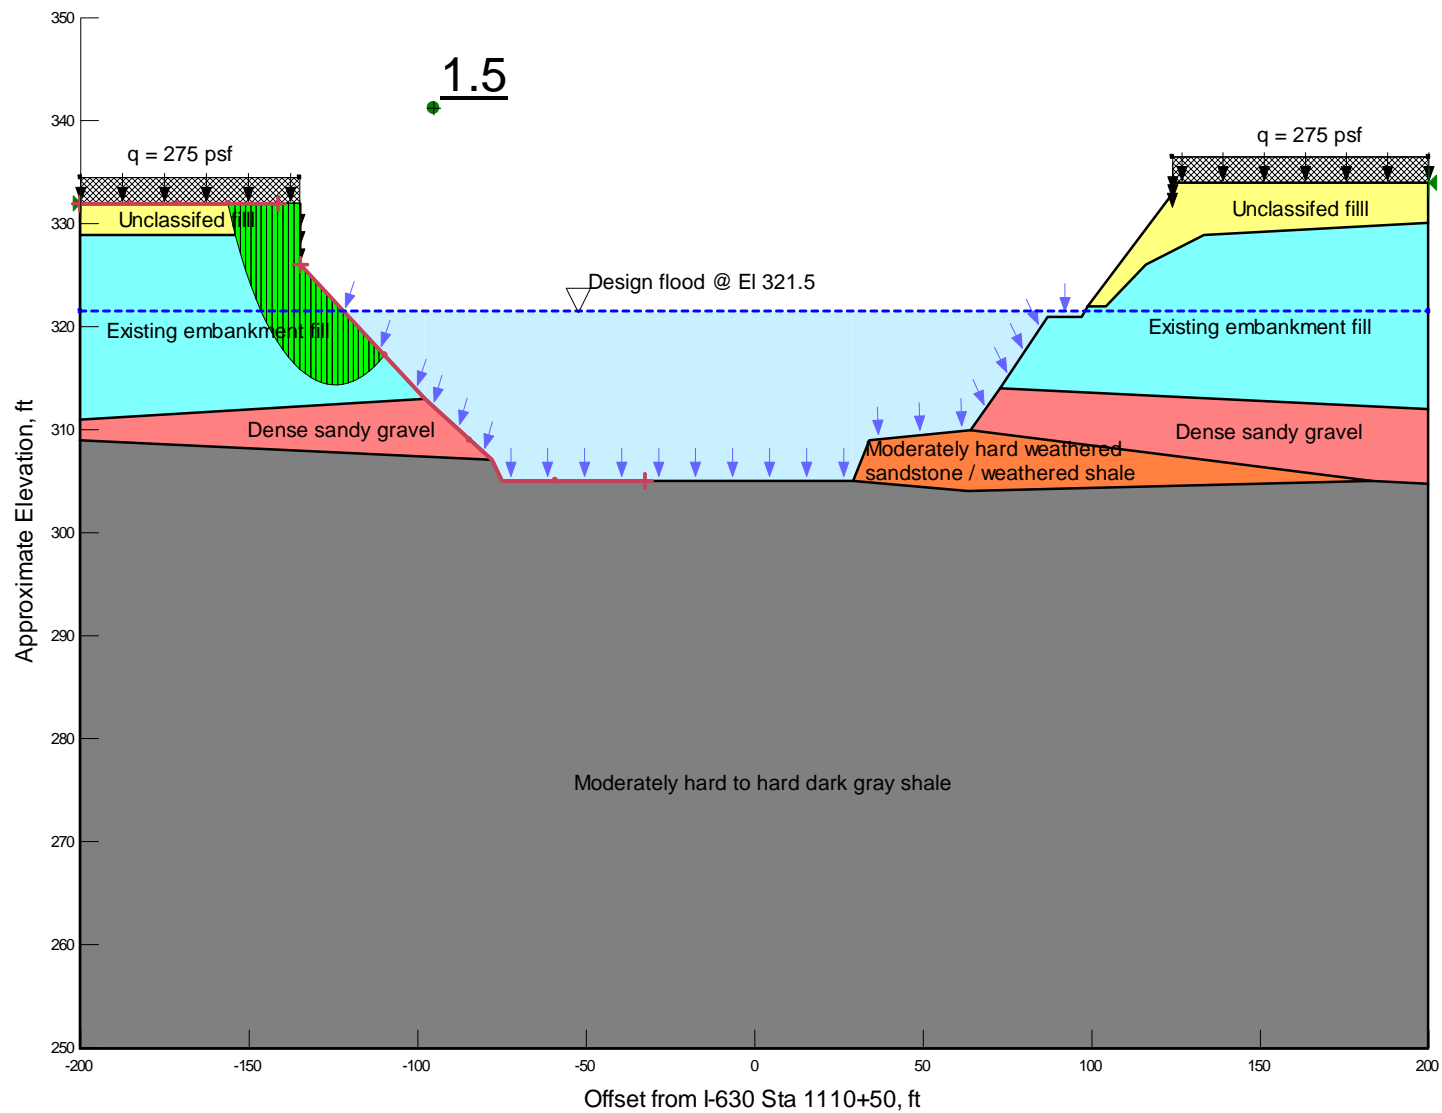
Results of Stability Analyses – Long Term Condition
 Design Flood @ El 321.5
 End Slope @ West Bridge Abutment – I-630 over Rock Creek

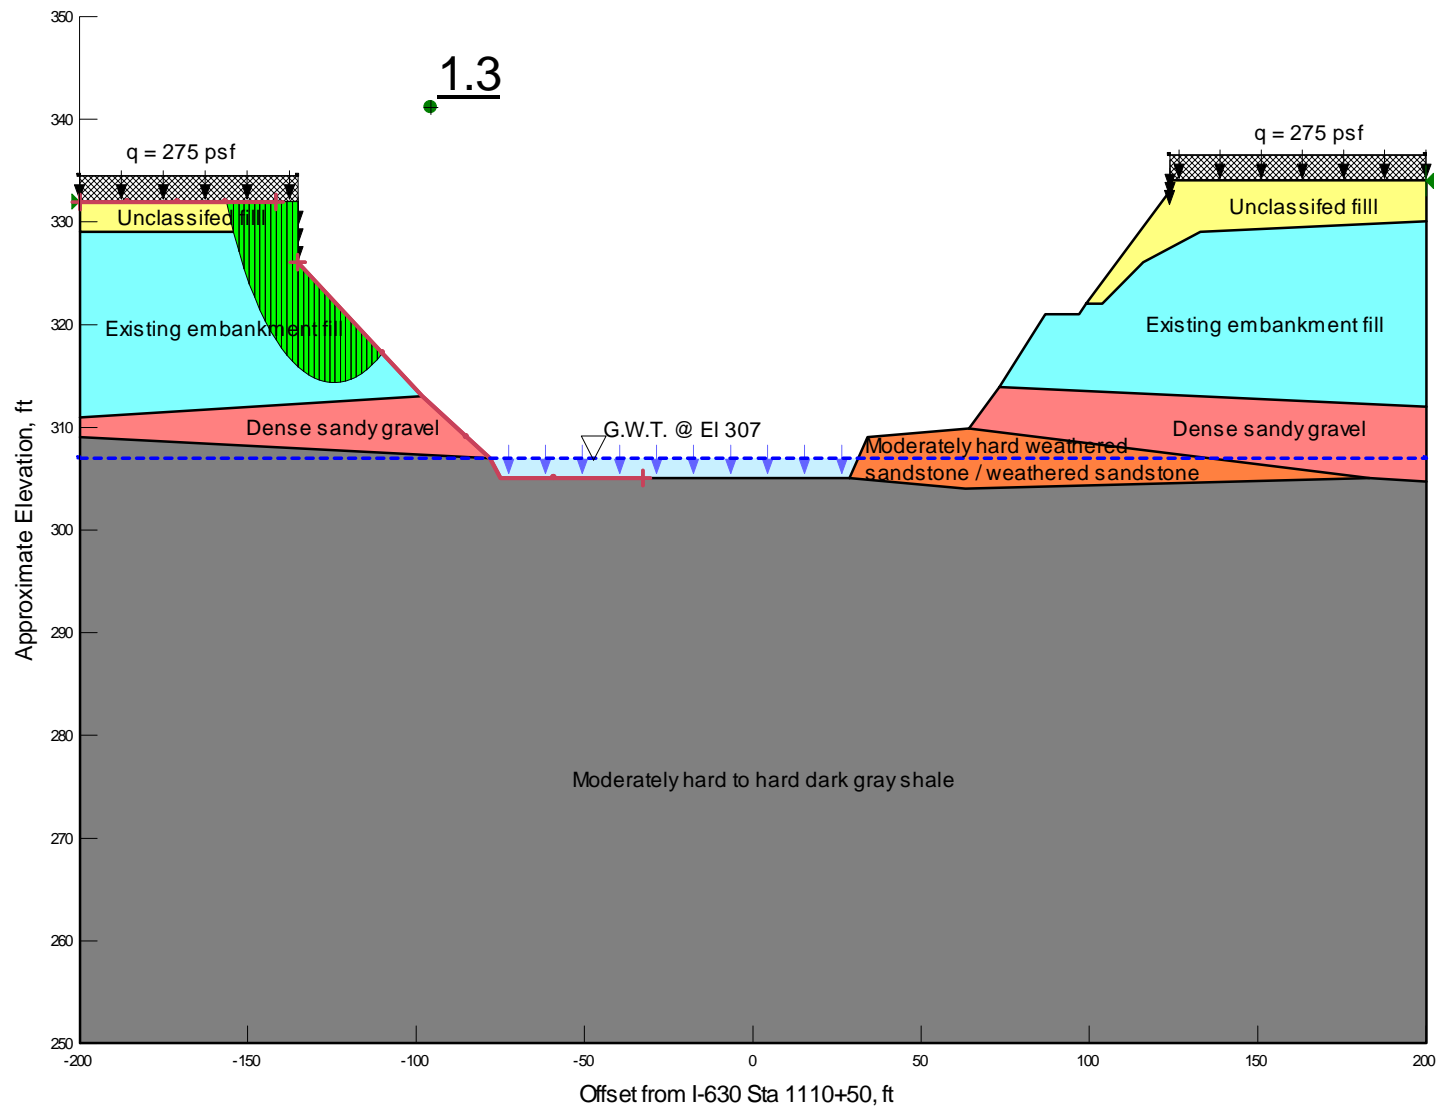
Results of Stability Analyses – Seismic Condition ($k_h = 1.0A_S = 0.13$)
 Groundwater @ El 307±
 End Slope @ West Bridge Abutment – I-630 over Rock Creek
