March 20, 2015
Job No. 14-030

**GEOTECHNICAL INVESTIGATION
BRIDGE FOUNDATIONS and EMBANKMENTS
AHTD JOB CA0608
BAPTIST HOSPITAL-UNIVERSITY AVENUE (WIDENING)(S)
LITTLE ROCK, PULASKI COUNTY, ARKANSAS**

Submitted herein are foundation recommendations for bridge structures included in the I-630 widening project in Little Rock, Pulaski County, Arkansas. This project is designated as AHTD Job CA0608: Baptist Hospital-University Avenue (Widening)(S). Results of stability analyses performed for the plan embankments at the Rock Creek Bridge location are also included in this submittal. Interim foundation recommendations for the bridges were provided on February 4 and February 7, 2015. Recommendations related to the roadway and retaining walls are provided in other report submittals under separate covers.

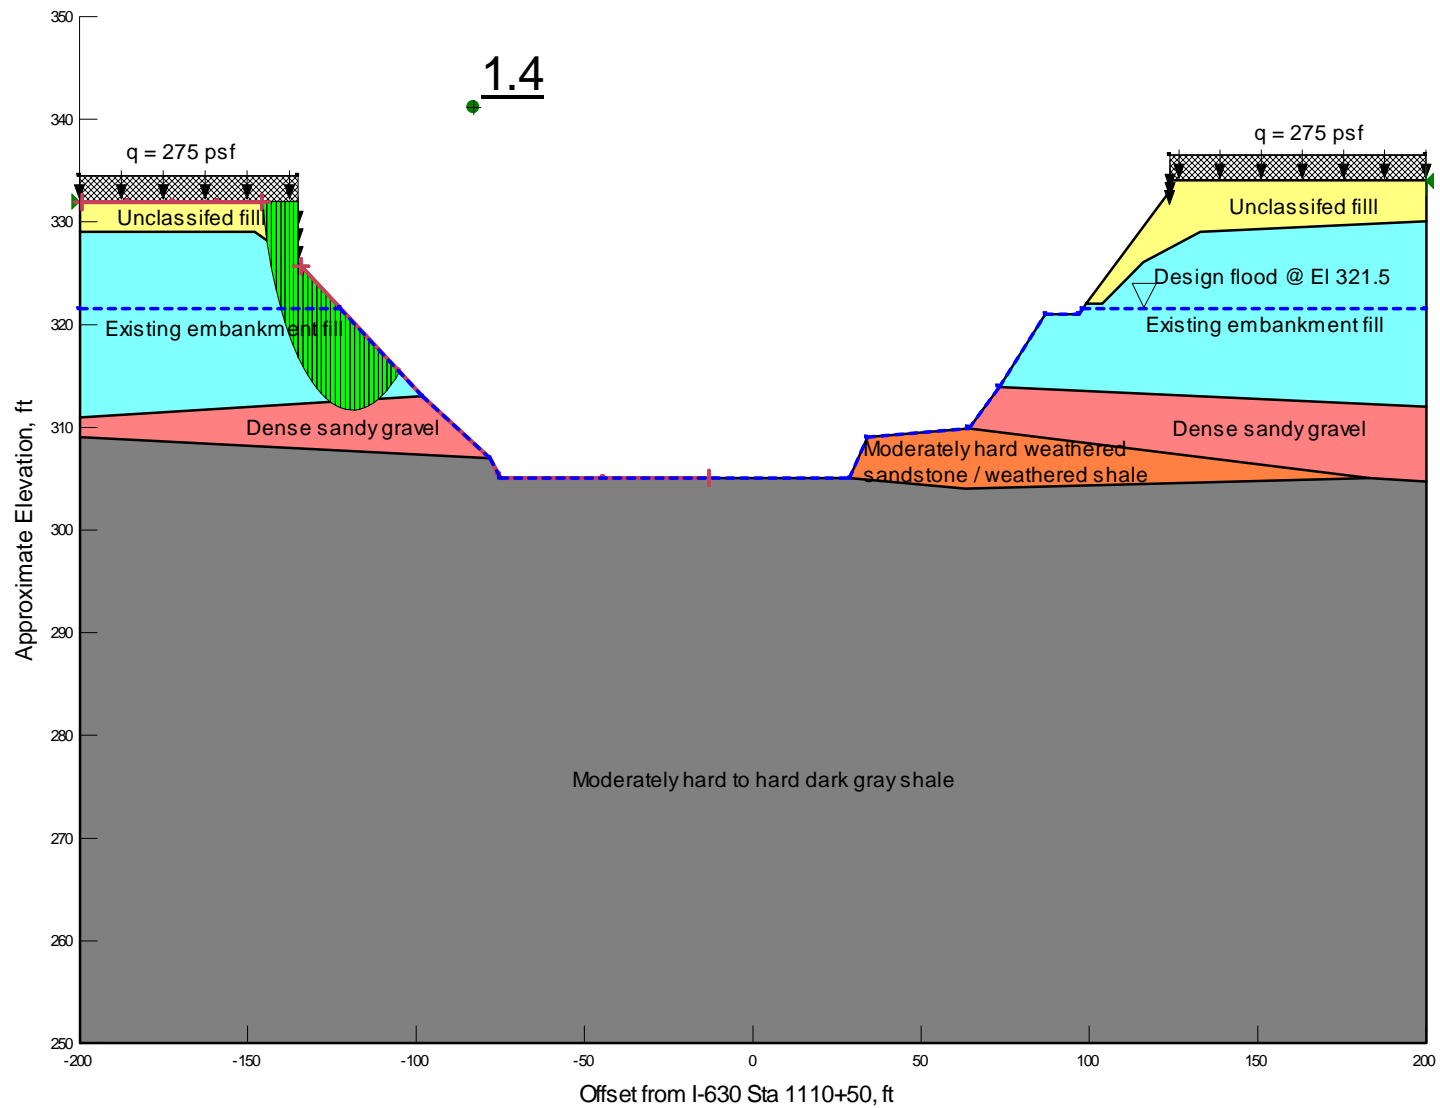
Results of Stability Analyses – Rapid Drawdown Condition
 Drawdown from Design Flood to Embankment Toe
 End Slope @ West Bridge Abutment – I-630 over Rock Creek

Design Loading Condition	Design Water Condition	Calculated Minimum Factor of Safety
End of Construction	Groundwater @ El 307±	3.8
Long Term	Groundwater @ El 307±	1.6
	Design flood @ El 321.5	1.5
Seismic ($k_h = 1.0A_s = 0.13$)	Groundwater @ El 307±	1.3
Rapid Drawdown	Drawdown from design flood to embankment toe	1.4

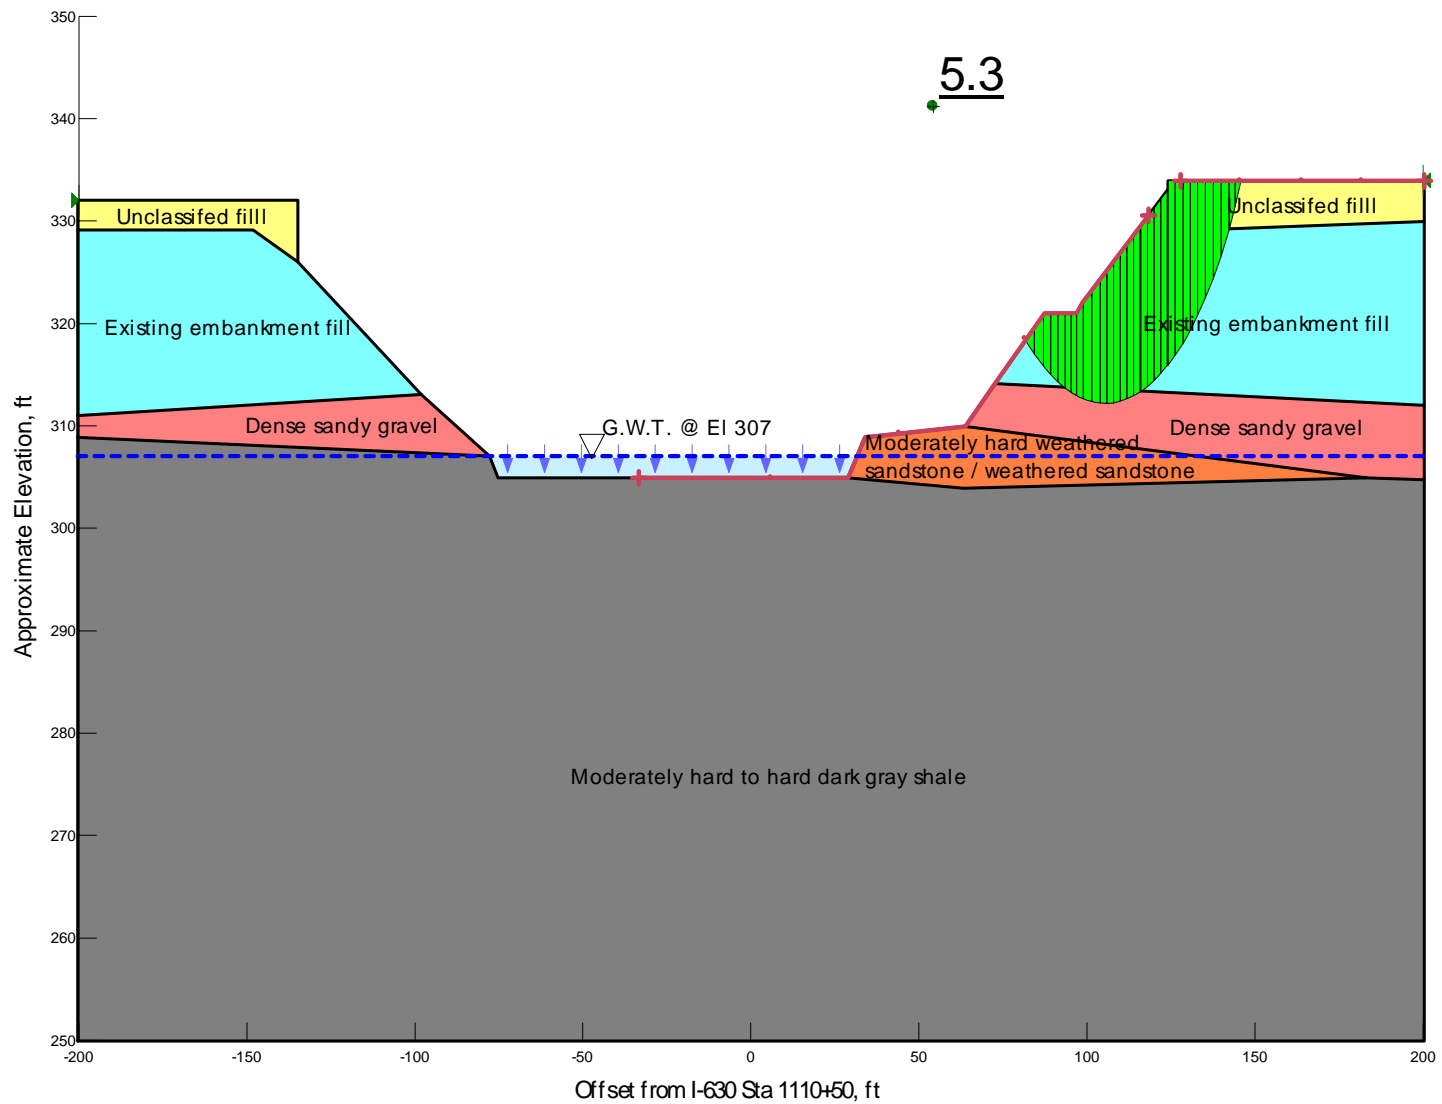
Results of Stability Analyses – End of Construction Condition
 Groundwater @ El 307±
 End Slope @ East Bridge Abutment – I-630 over Rock Creek

Design Loading Condition	Design Water Condition	Calculated Minimum Factor of Safety
End of Construction	Groundwater @ El 307±	5.3
Long Term	Groundwater @ El 307±	2.1
	Design flood @ El 321.5	2.0
Seismic ($k_h = 1.0A_s = 0.13$)	Groundwater @ El 307±	1.5
Rapid Drawdown	Drawdown from design flood to embankment toe	1.9

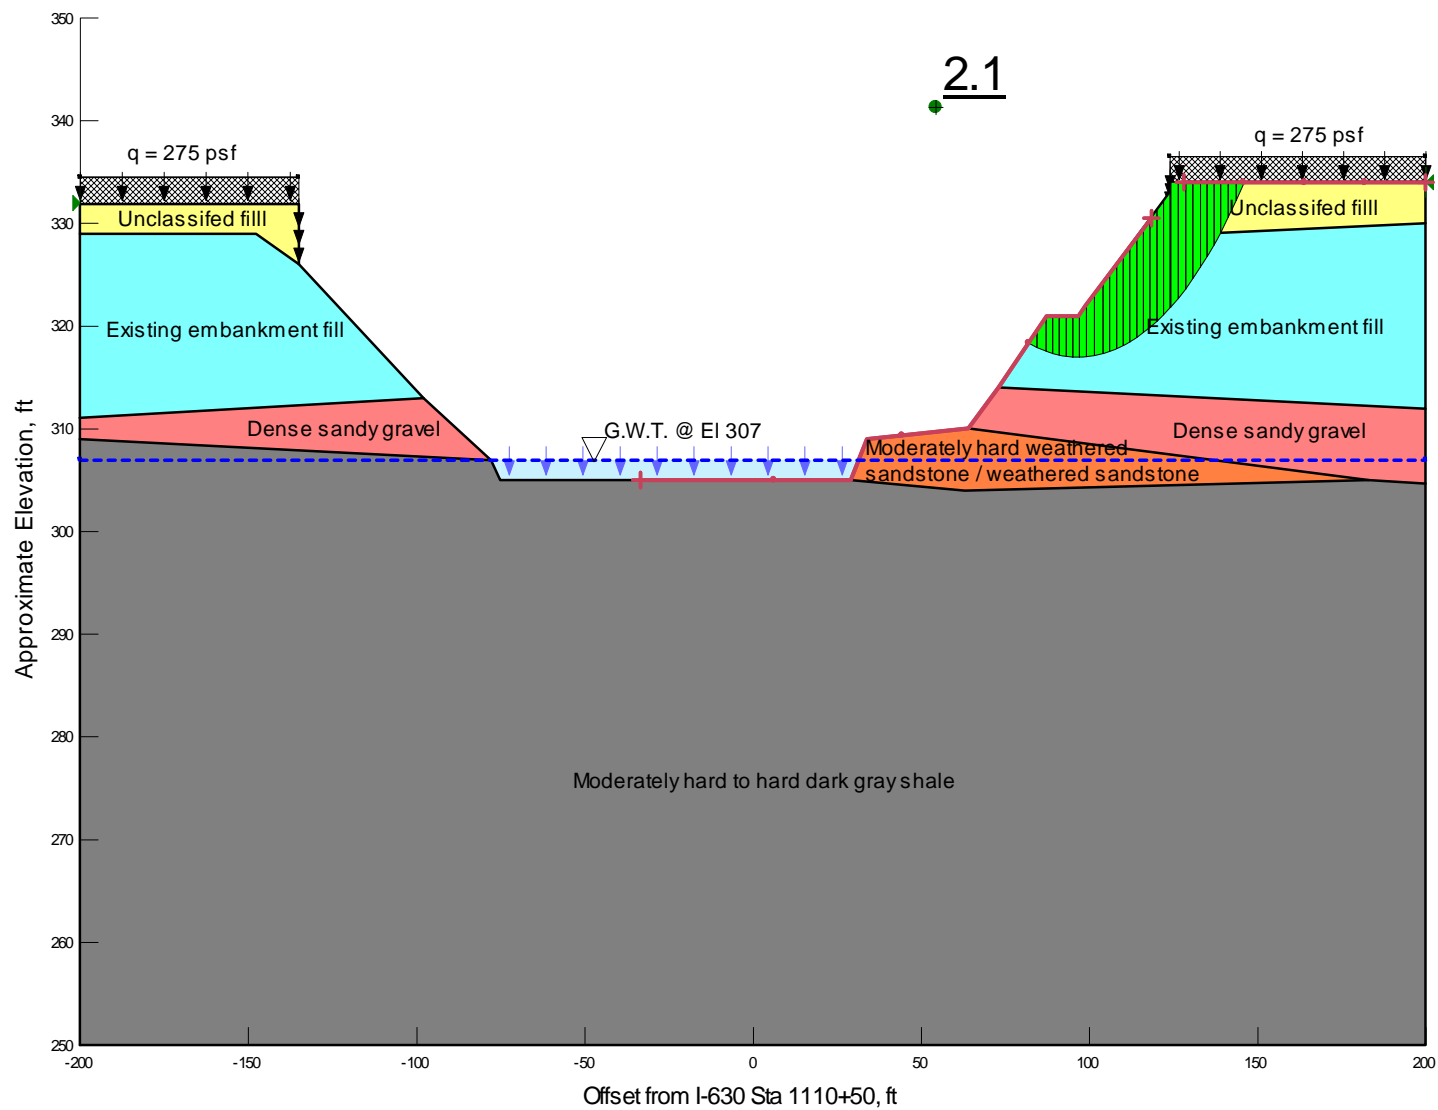
Results of Stability Analyses – Long Term Condition
 Groundwater @ $\text{El } 307 \pm$
 End Slope @ East Bridge Abutment – I-630 over Rock Creek

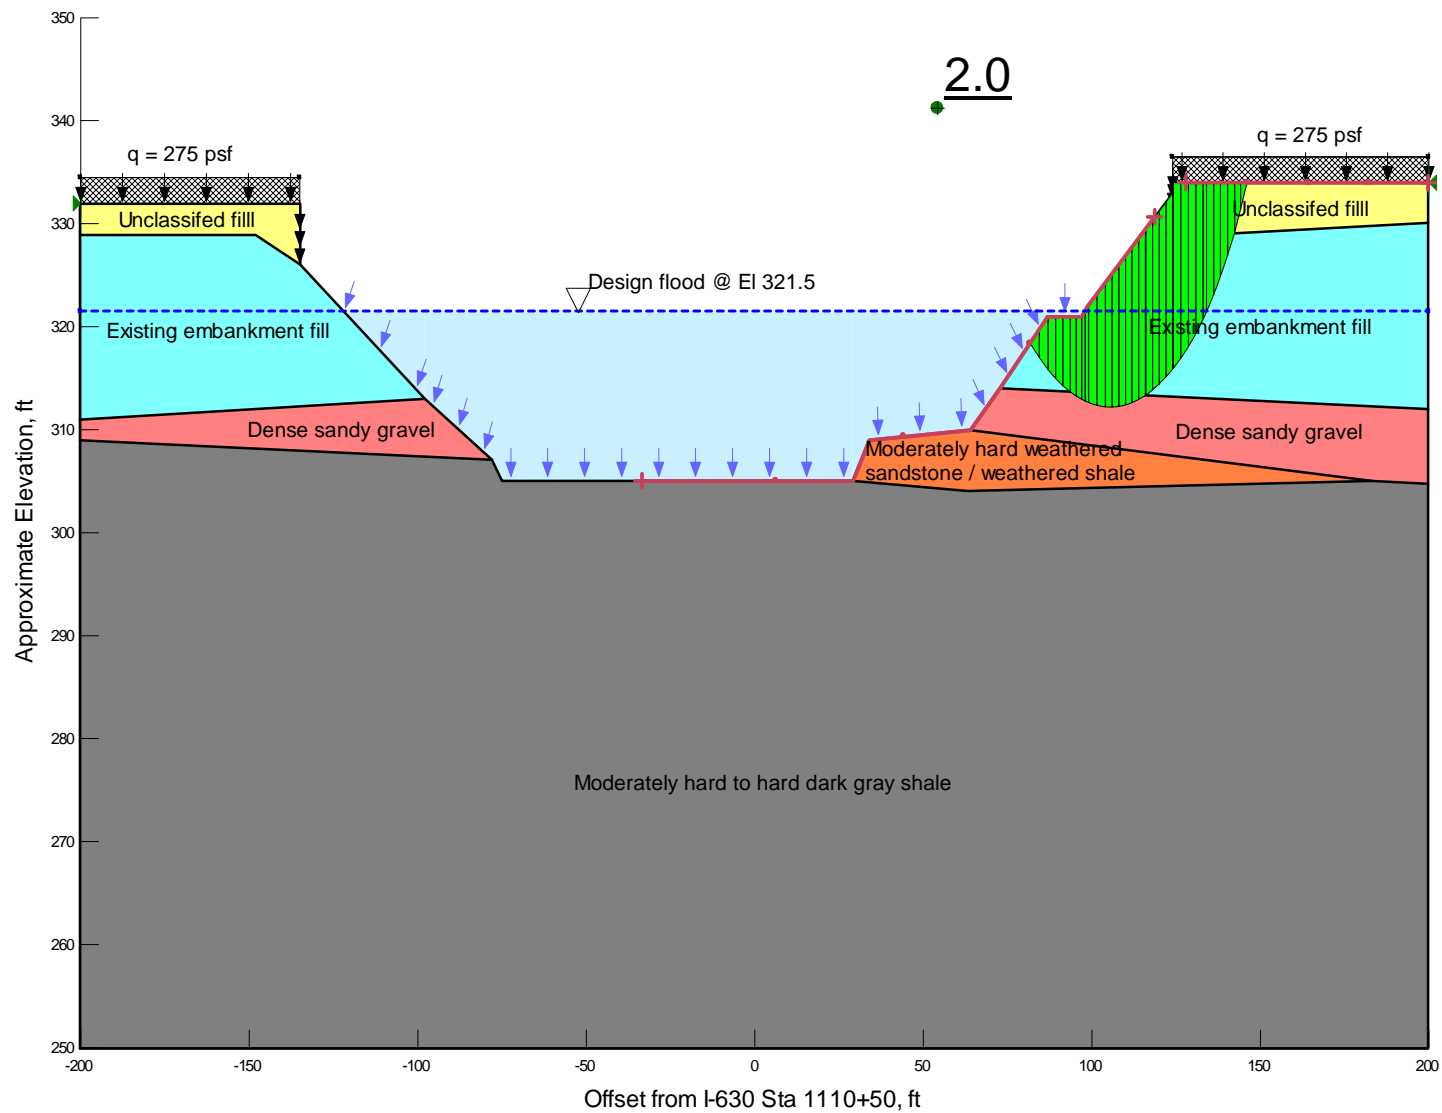
Results of Stability Analyses – Long Term Condition
 Design Flood @ El 321.5
 End Slope @ East Bridge Abutment – I-630 over Rock Creek

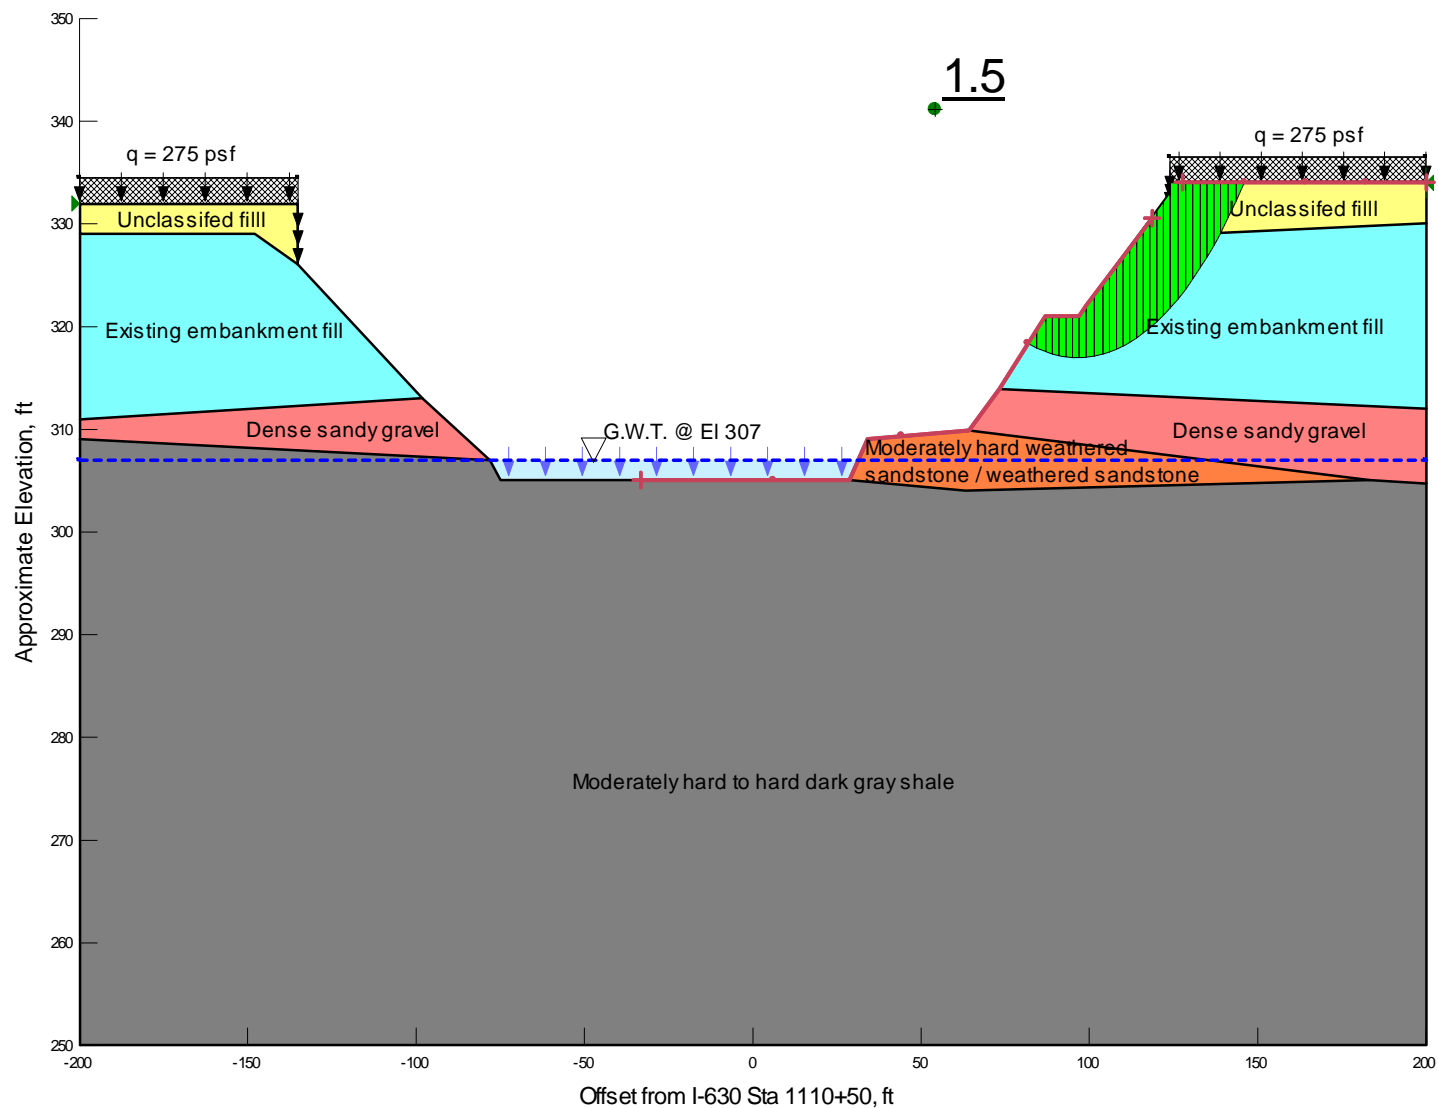
Results of Stability Analyses – Seismic Condition ($k_h = 1.0A_S = 0.13$)
 Groundwater @ El 307±
 End Slope @ East Bridge Abutment – I-630 over Rock Creek

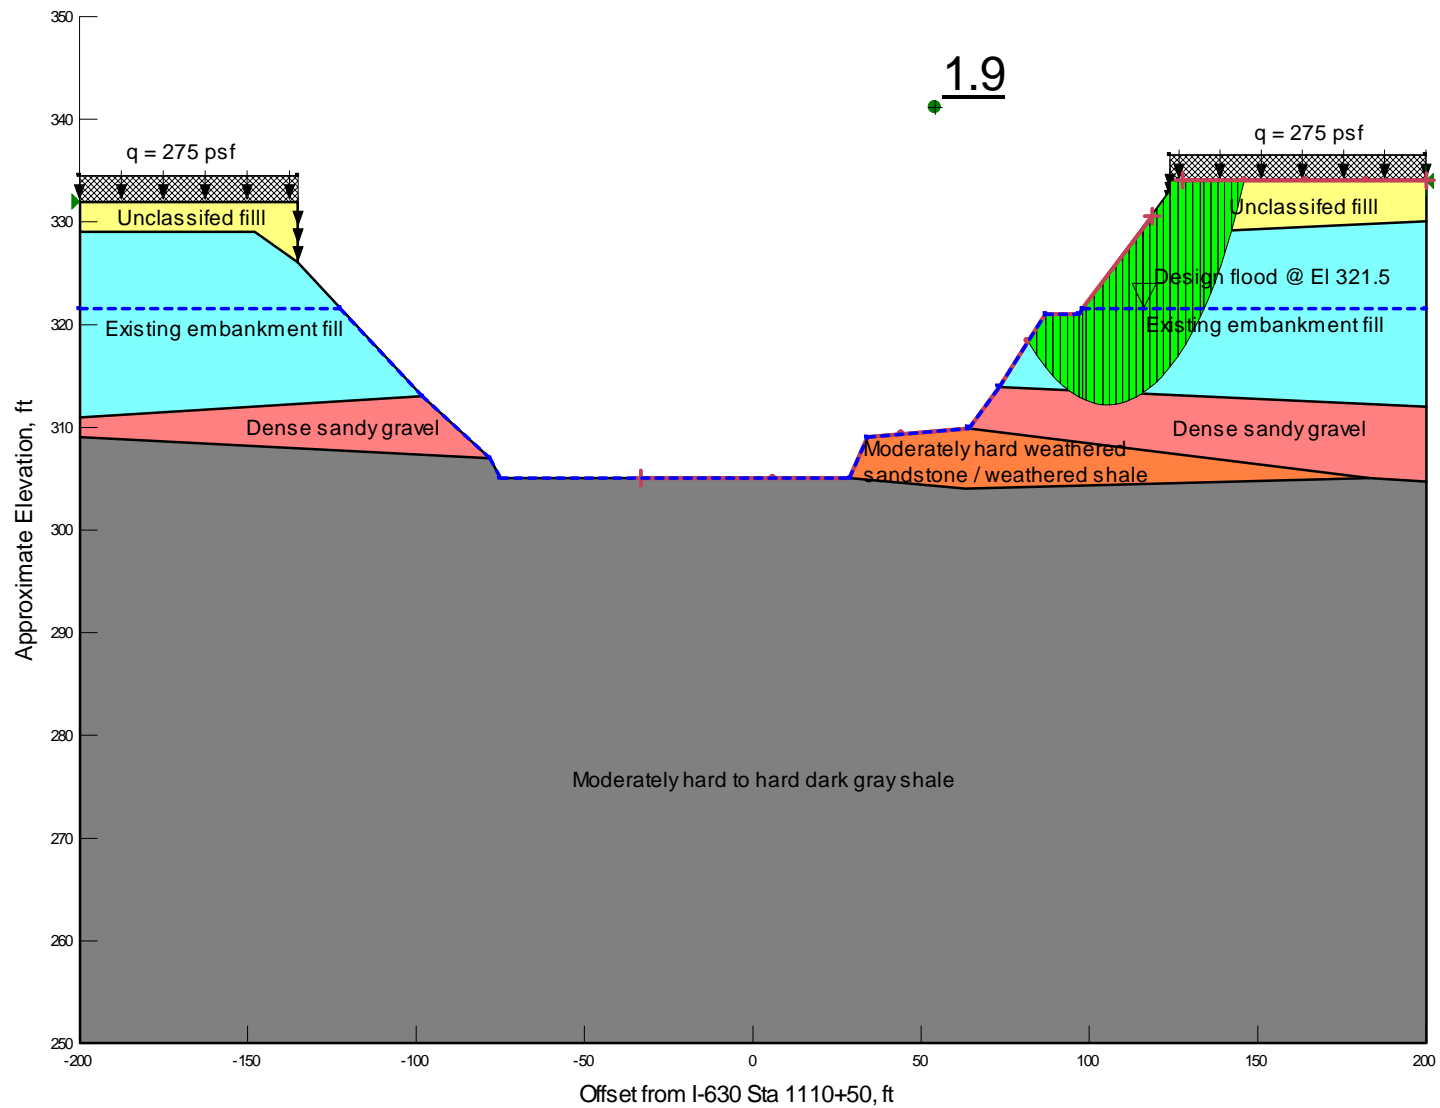
Results of Stability Analyses – Rapid Drawdown Condition
 Drawdown from Design Flood to Embankment Toe
 End Slope @ East Bridge Abutment – I-630 over Rock Creek

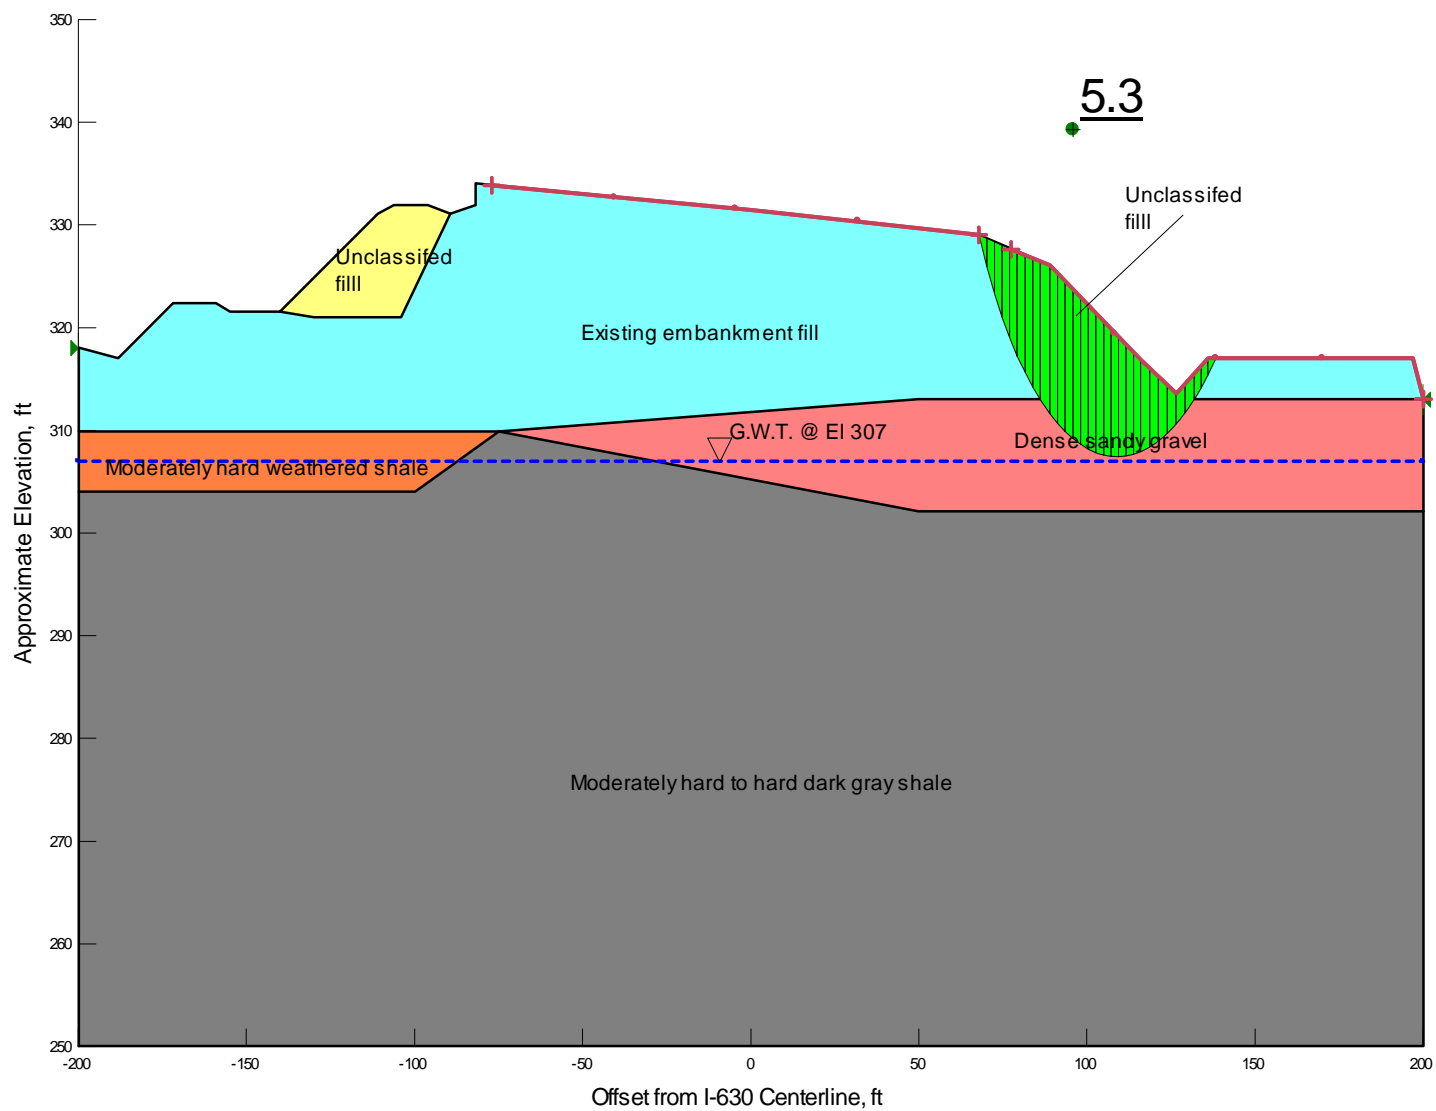
Results of Stability Analyses – End of Construction Condition
 Groundwater @ El 307±
 Side Slope @ West Bridge Abutment – I-630 over Rock Creek

Design Loading Condition	Design Water Condition	Calculated Minimum Factor of Safety
End of Construction	Groundwater @ El 307±	5.3
Long Term	Groundwater @ El 307±	2.5
	Design flood @ El 321.5	2.6
Seismic ($k_h = 1.0A_s = 0.13$)	Groundwater @ El 307±	1.7
Rapid Drawdown	Drawdown from design flood to embankment toe	2.1

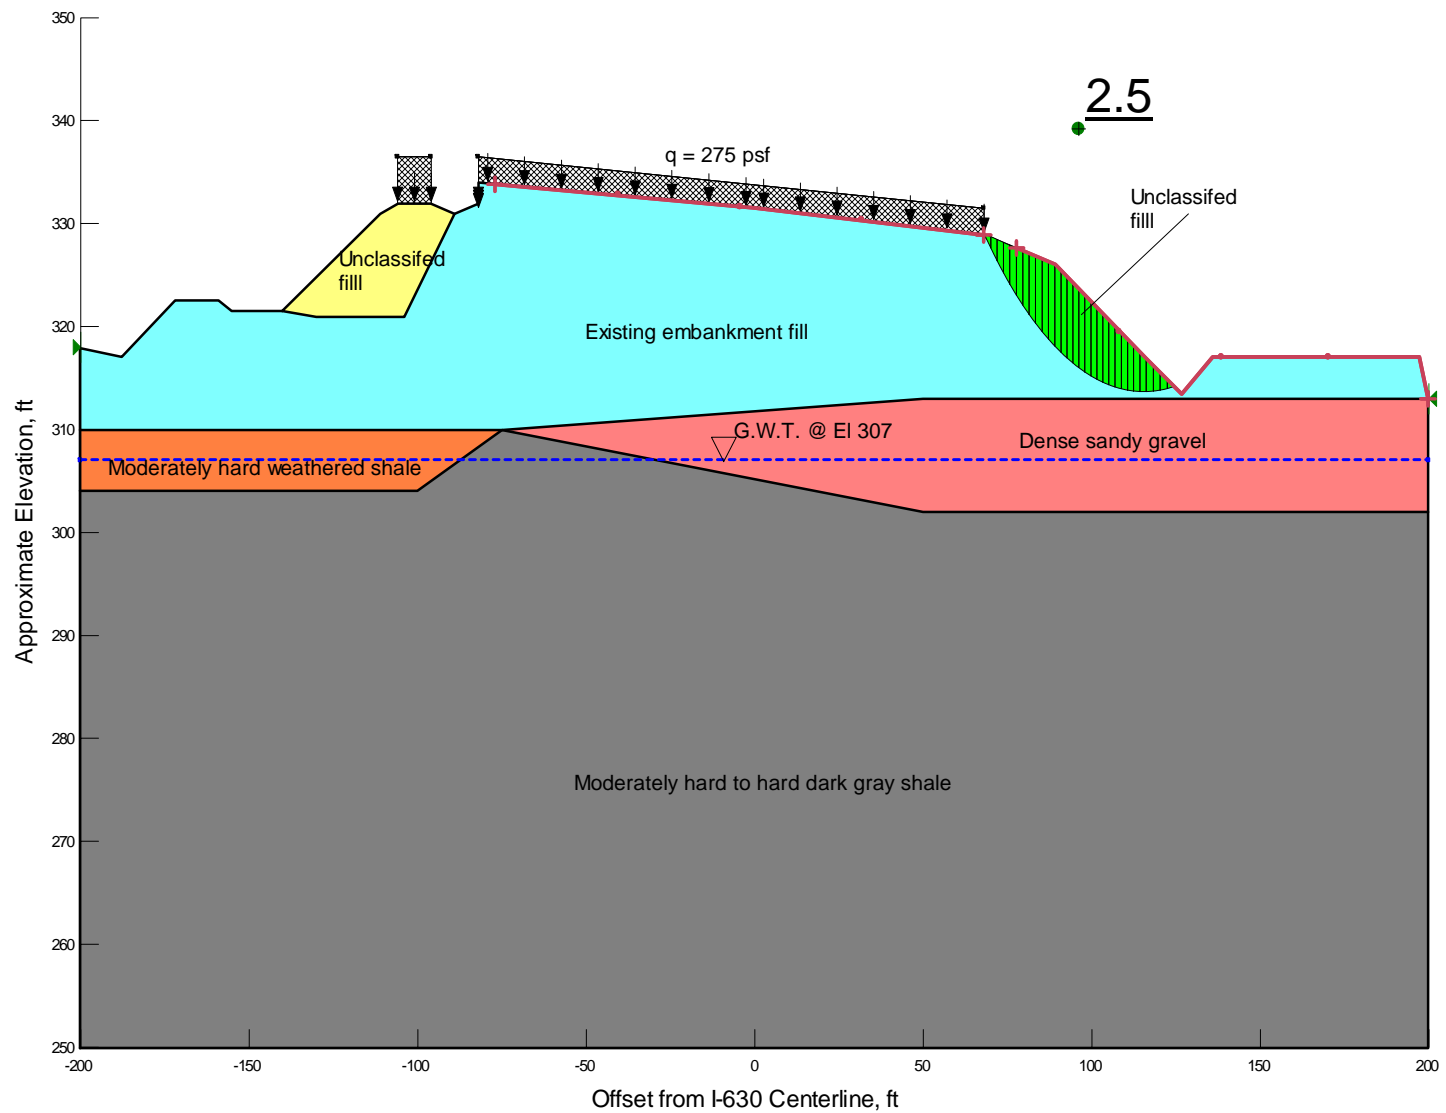
Results of Stability Analyses – Long Term Condition
 Groundwater @ El 307±
 Side Slope @ West Bridge Abutment – I-630 over Rock Creek

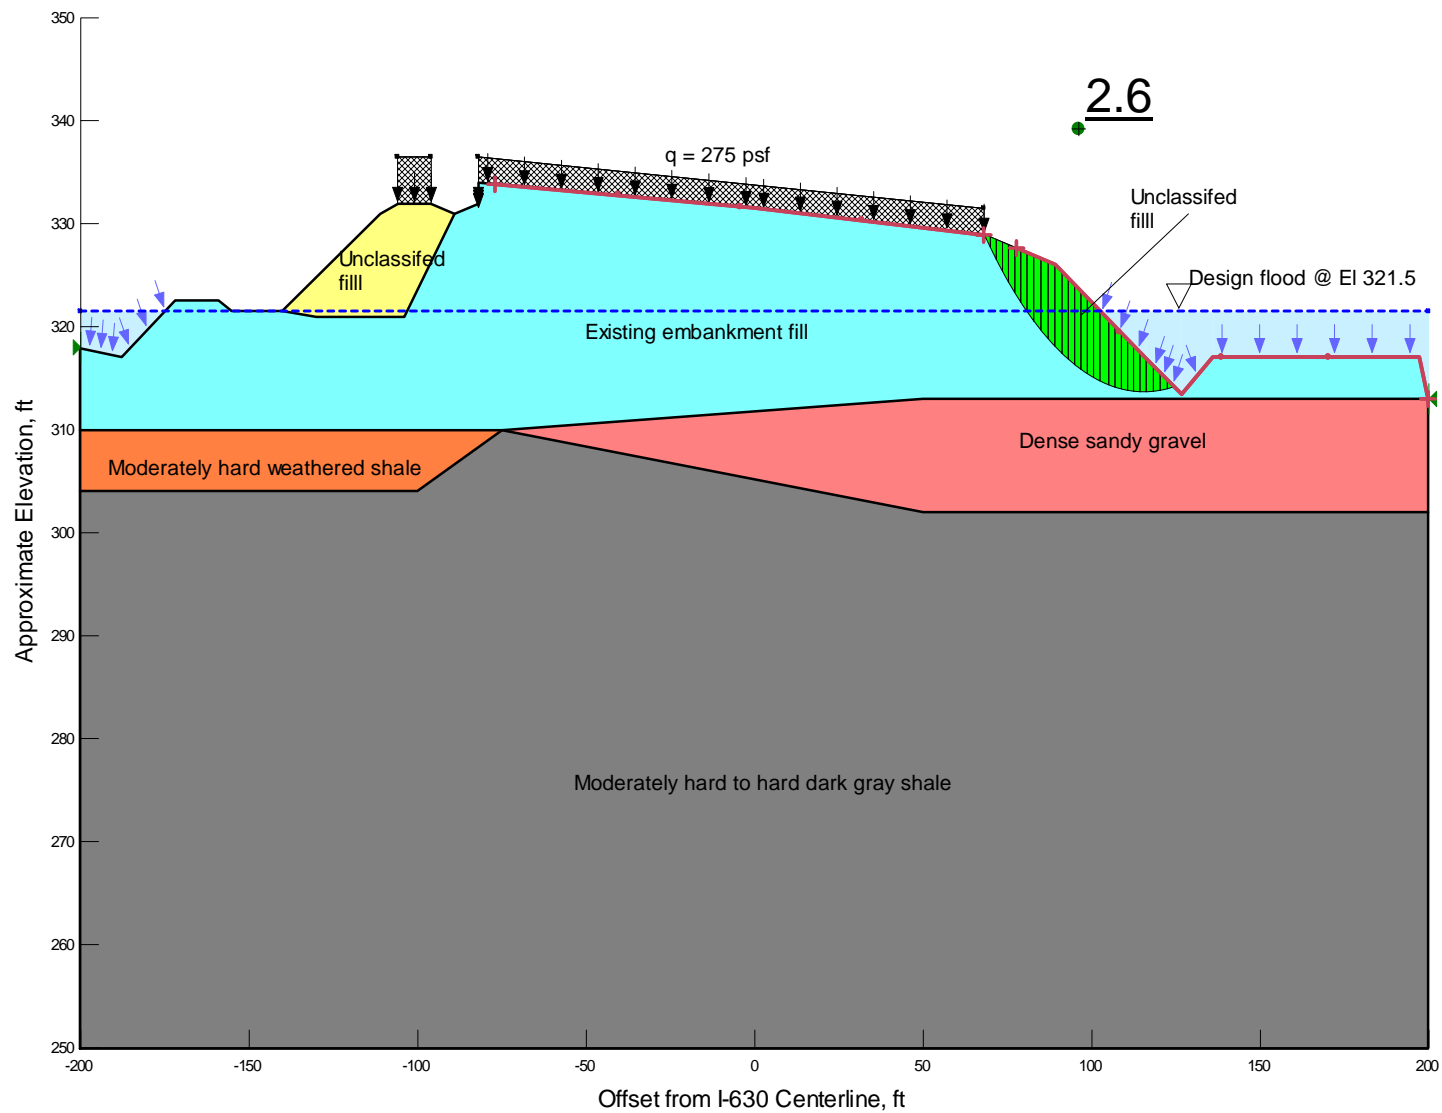
Results of Stability Analyses – Long Term Condition
 Design Flood @ El 321.5
 Side Slope @ West Bridge Abutment – I-630 over Rock Creek

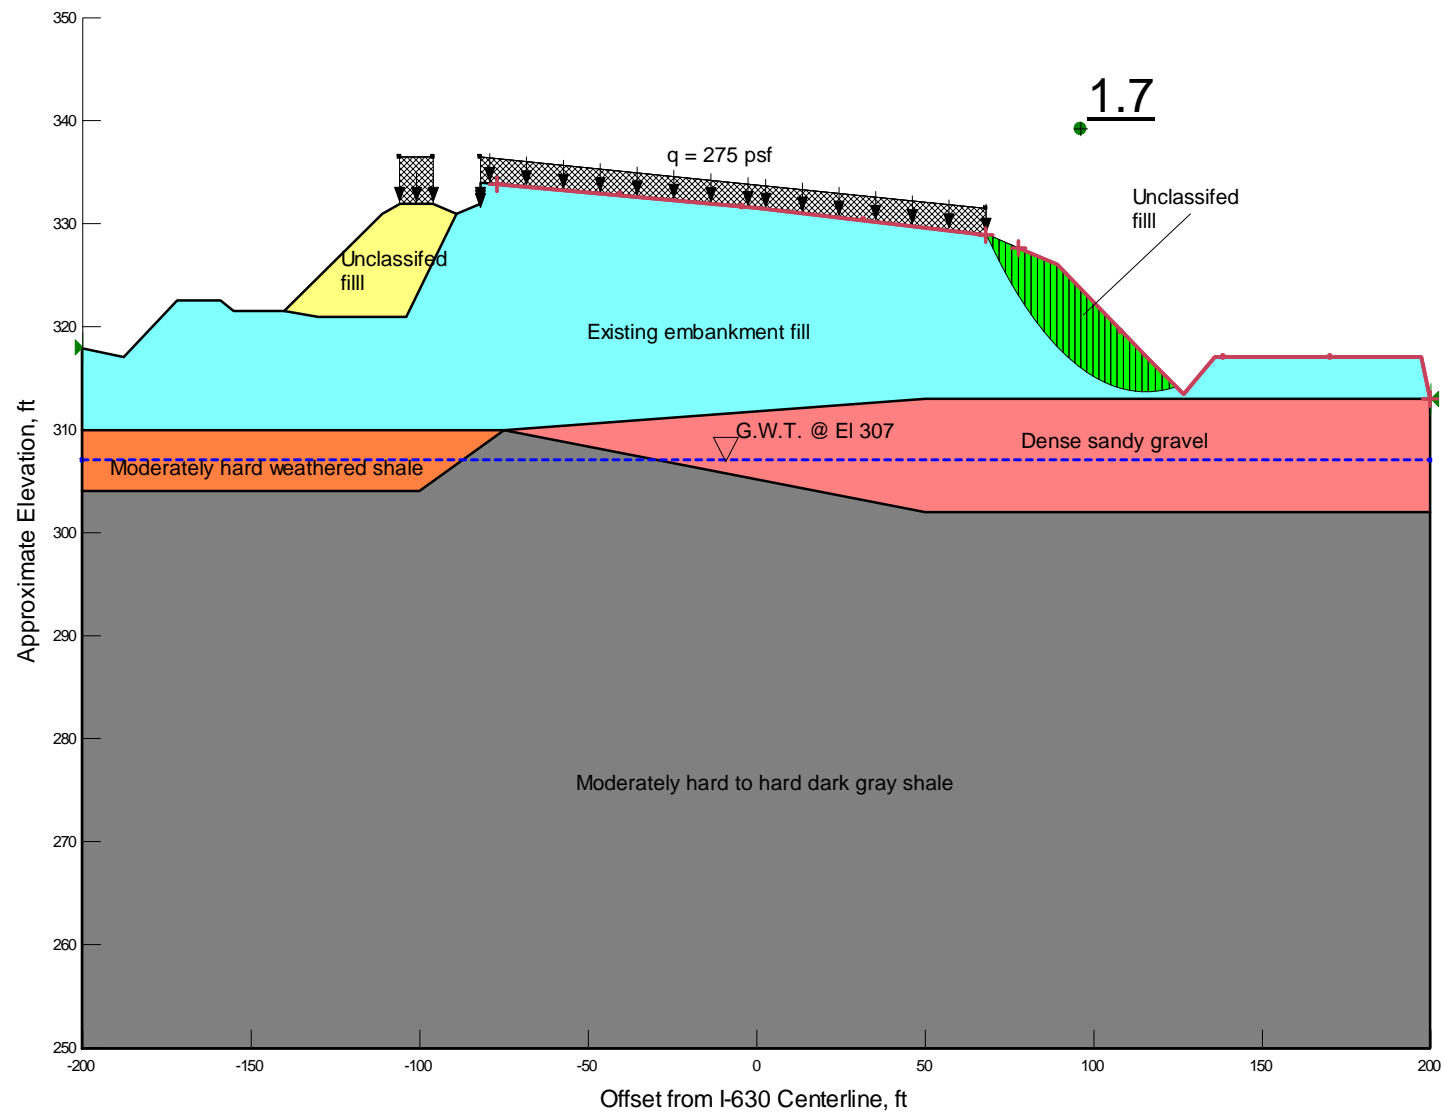
Results of Stability Analyses – Seismic Condition ($k_h = 1.0A_s = 0.13$)
 Groundwater @ El 307±
 Side Slope @ West Bridge Abutment – I-630 over Rock Creek

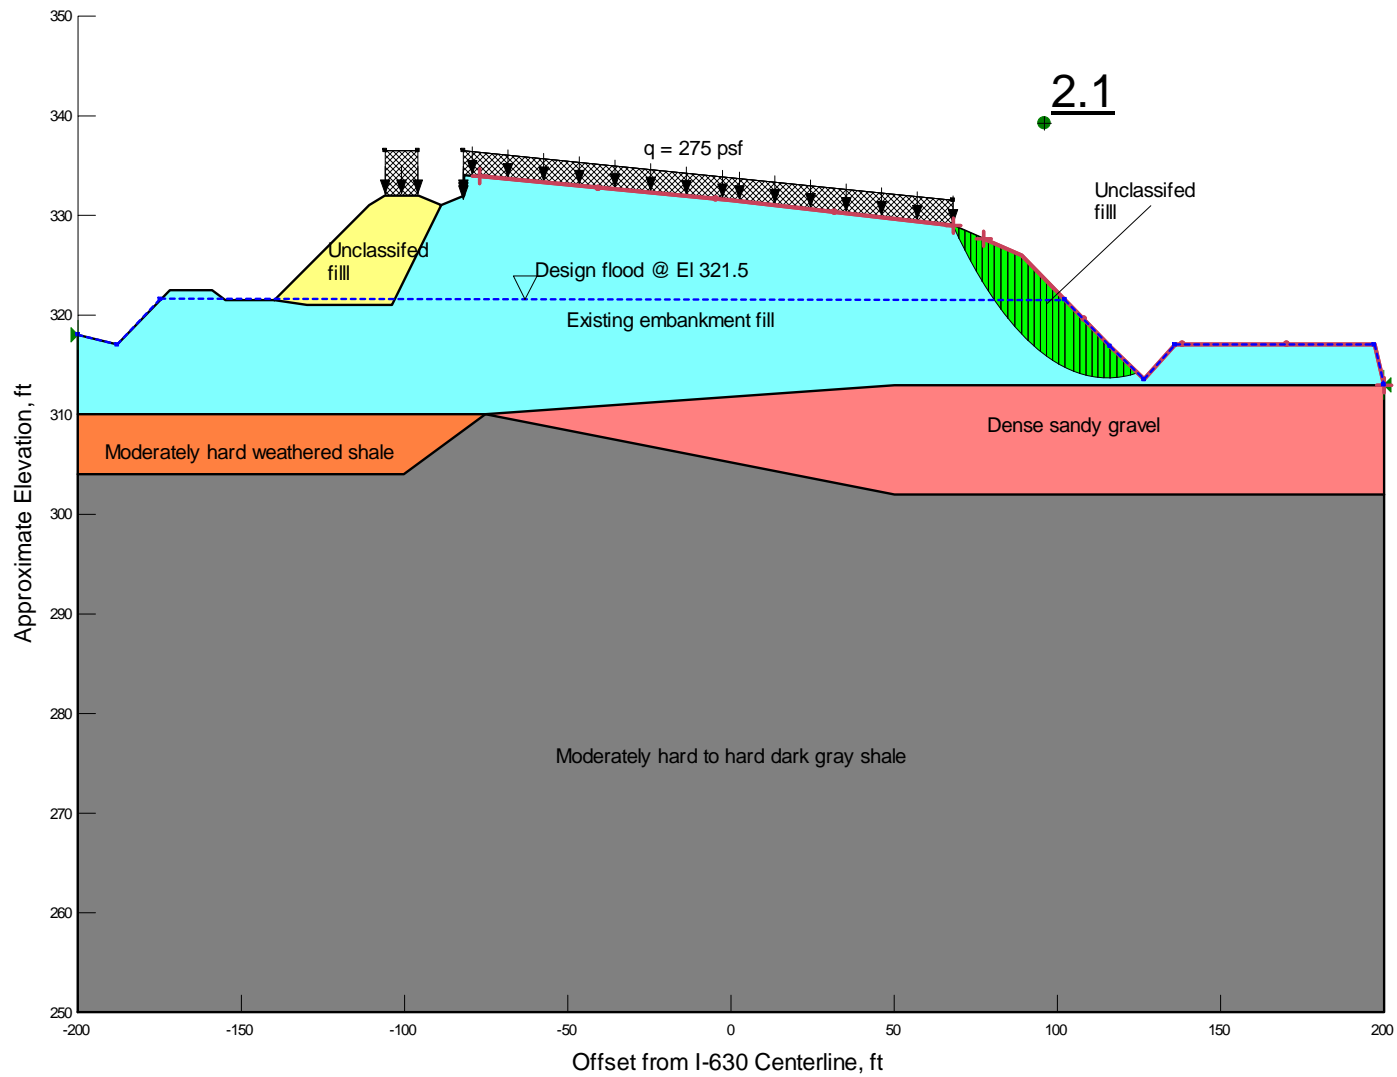
Results of Stability Analyses – Rapid Drawdown Condition
 Drawdown from Design Flood to Embankment Toe
 Side Slope @ West Bridge Abutment – I-630 over Rock Creek

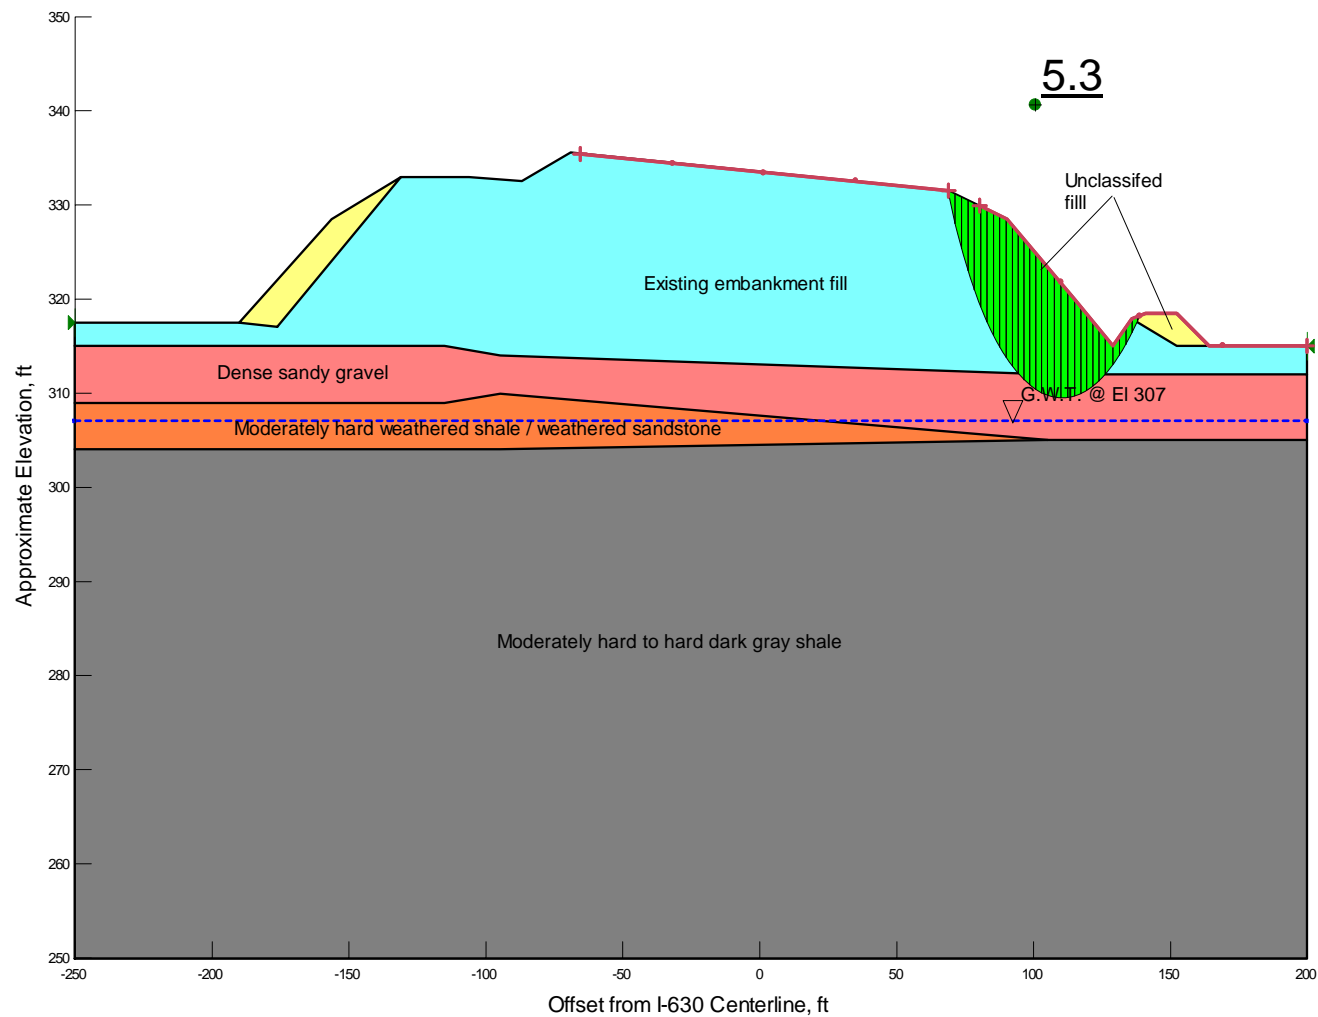
Results of Stability Analyses – End of Construction Condition
 Groundwater @ El 307±
 Side Slope @ East Bridge Abutment – I-630 over Rock Creek

Design Loading Condition	Design Water Condition	Calculated Minimum Factor of Safety
End of Construction	Groundwater @ El 307±	5.3
Long Term	Groundwater @ El 307±	2.4
	Design flood @ El 321.5	2.3
Seismic ($k_h = 1.0A_s = 0.13$)	Groundwater @ El 307±	1.6
Rapid Drawdown	Drawdown from design flood to embankment toe	2.1

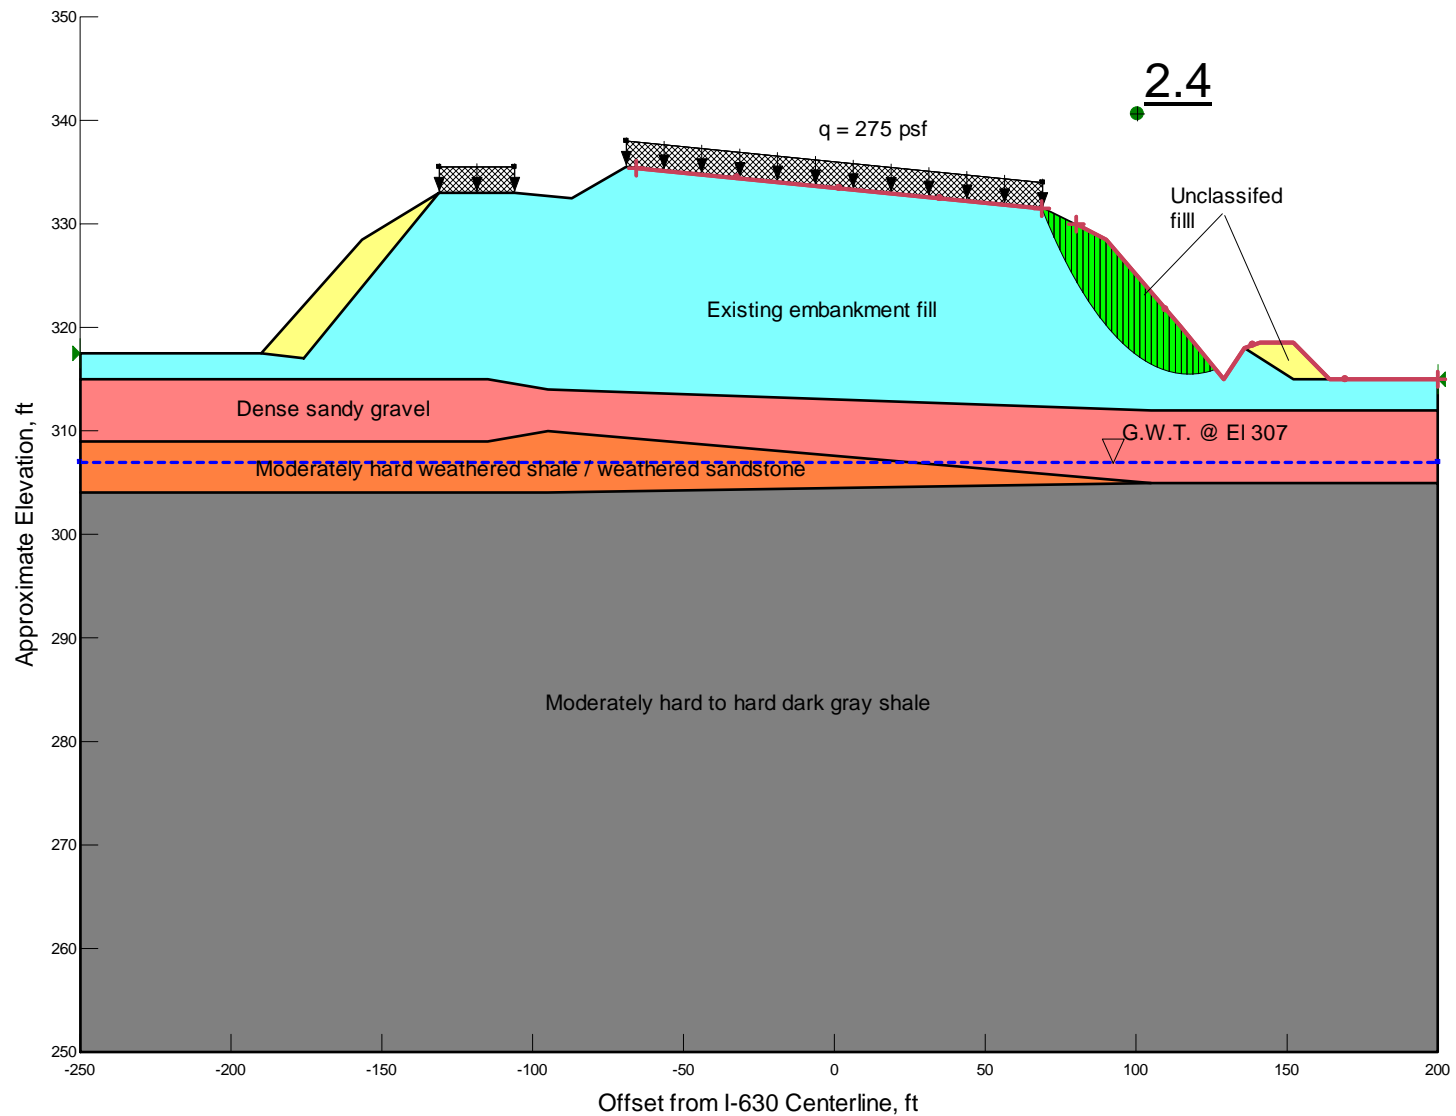
Results of Stability Analyses – Long Term Condition
 Groundwater @ El 307±
 Side Slope @ East Bridge Abutment – I-630 over Rock Creek

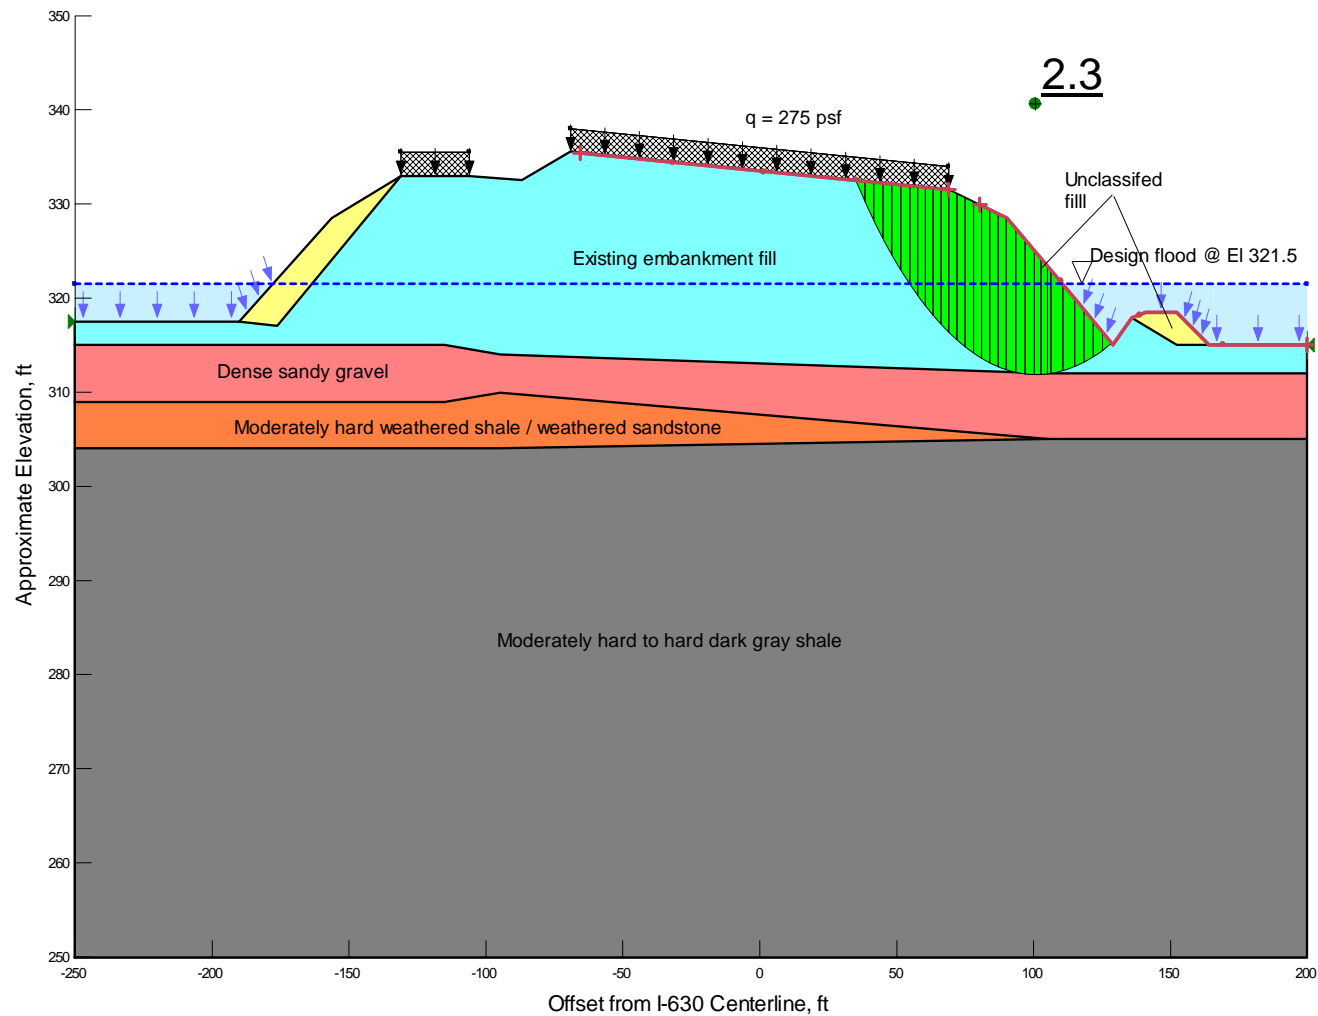
Results of Stability Analyses – Long Term Condition
 Design Flood @ El 321.5
 Side Slope @ East Bridge Abutment – I-630 over Rock Creek
