March 20, 2015
Job No. 14-030

**GEOTECHNICAL INVESTIGATION
BRIDGE FOUNDATIONS and EMBANKMENTS
AHTD JOB CA0608
BAPTIST HOSPITAL-UNIVERSITY AVENUE (WIDENING)(S)
LITTLE ROCK, PULASKI COUNTY, ARKANSAS**

Submitted herein are foundation recommendations for bridge structures included in the I-630 widening project in Little Rock, Pulaski County, Arkansas. This project is designated as AHTD Job CA0608: Baptist Hospital-University Avenue (Widening)(S). Results of stability analyses performed for the plan embankments at the Rock Creek Bridge location are also included in this submittal. Interim foundation recommendations for the bridges were provided on February 4 and February 7, 2015. Recommendations related to the roadway and retaining walls are provided in other report submittals under separate covers.

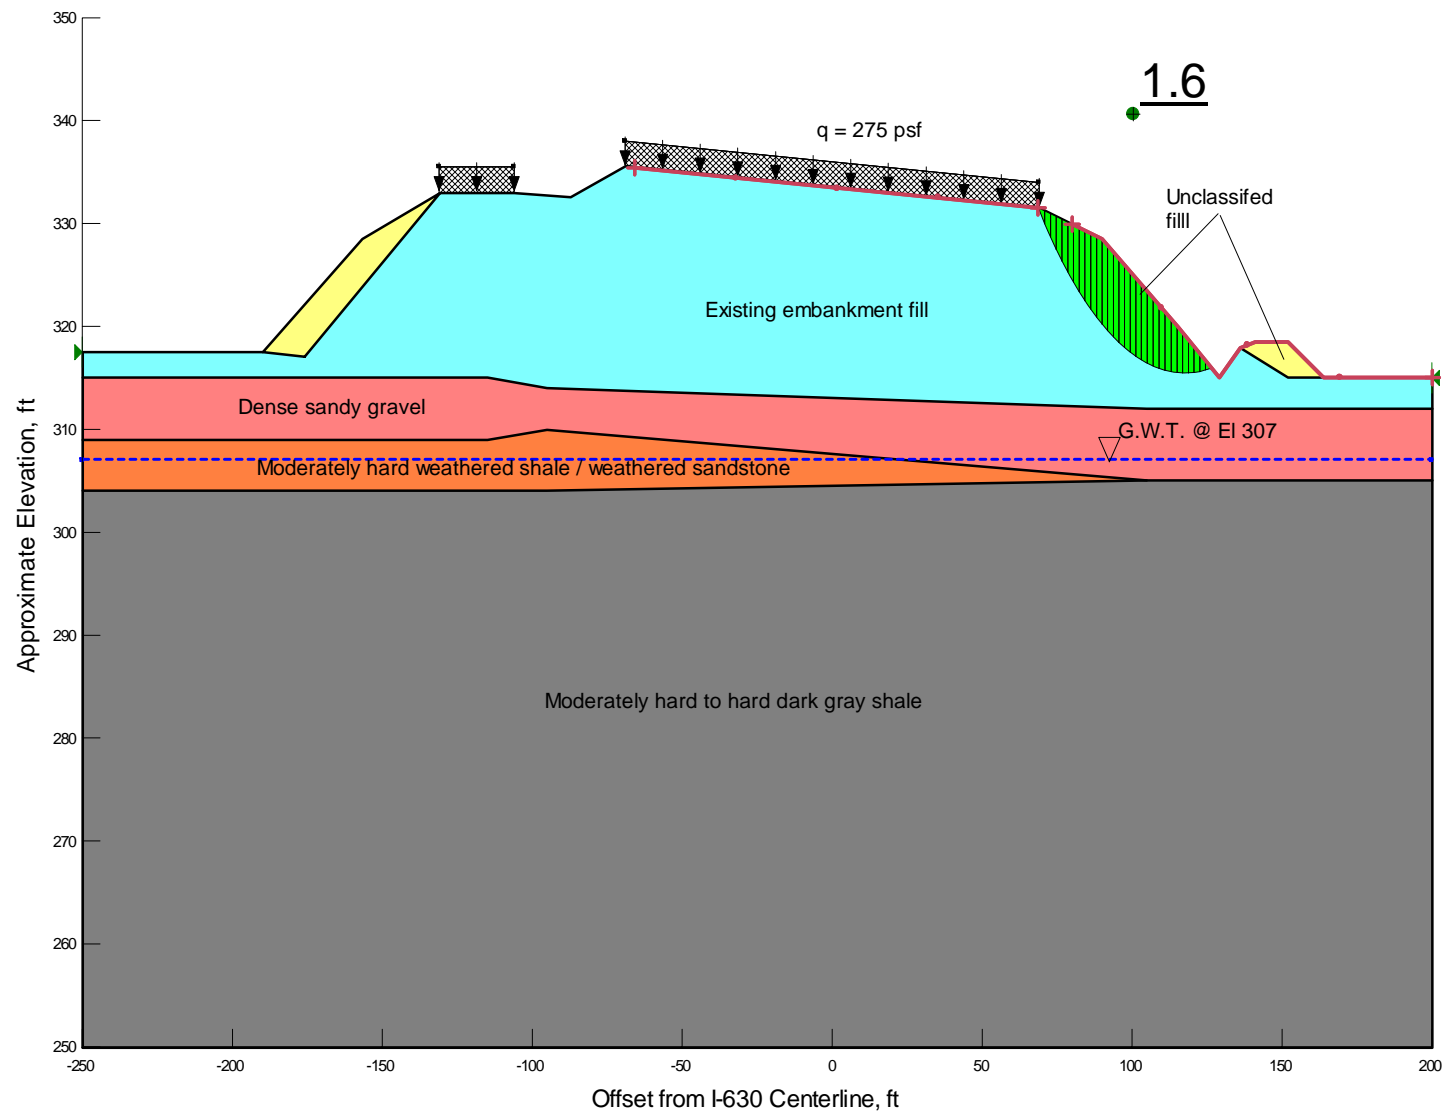
Results of Stability Analyses – Seismic Condition ($k_h = 1.0A_S = 0.13$)
 Groundwater @ El 307±
 Side Slope @ East Bridge Abutment – I-630 over Rock Creek

Design Loading Condition	Design Water Condition	Calculated Minimum Factor of Safety
End of Construction	Groundwater @ El 307±	5.3
Long Term	Groundwater @ El 307±	2.4
	Design flood @ El 321.5	2.3
Seismic ($k_h = 1.0A_s = 0.13$)	Groundwater @ El 307±	1.6
Rapid Drawdown	Drawdown from design flood to embankment toe	2.1

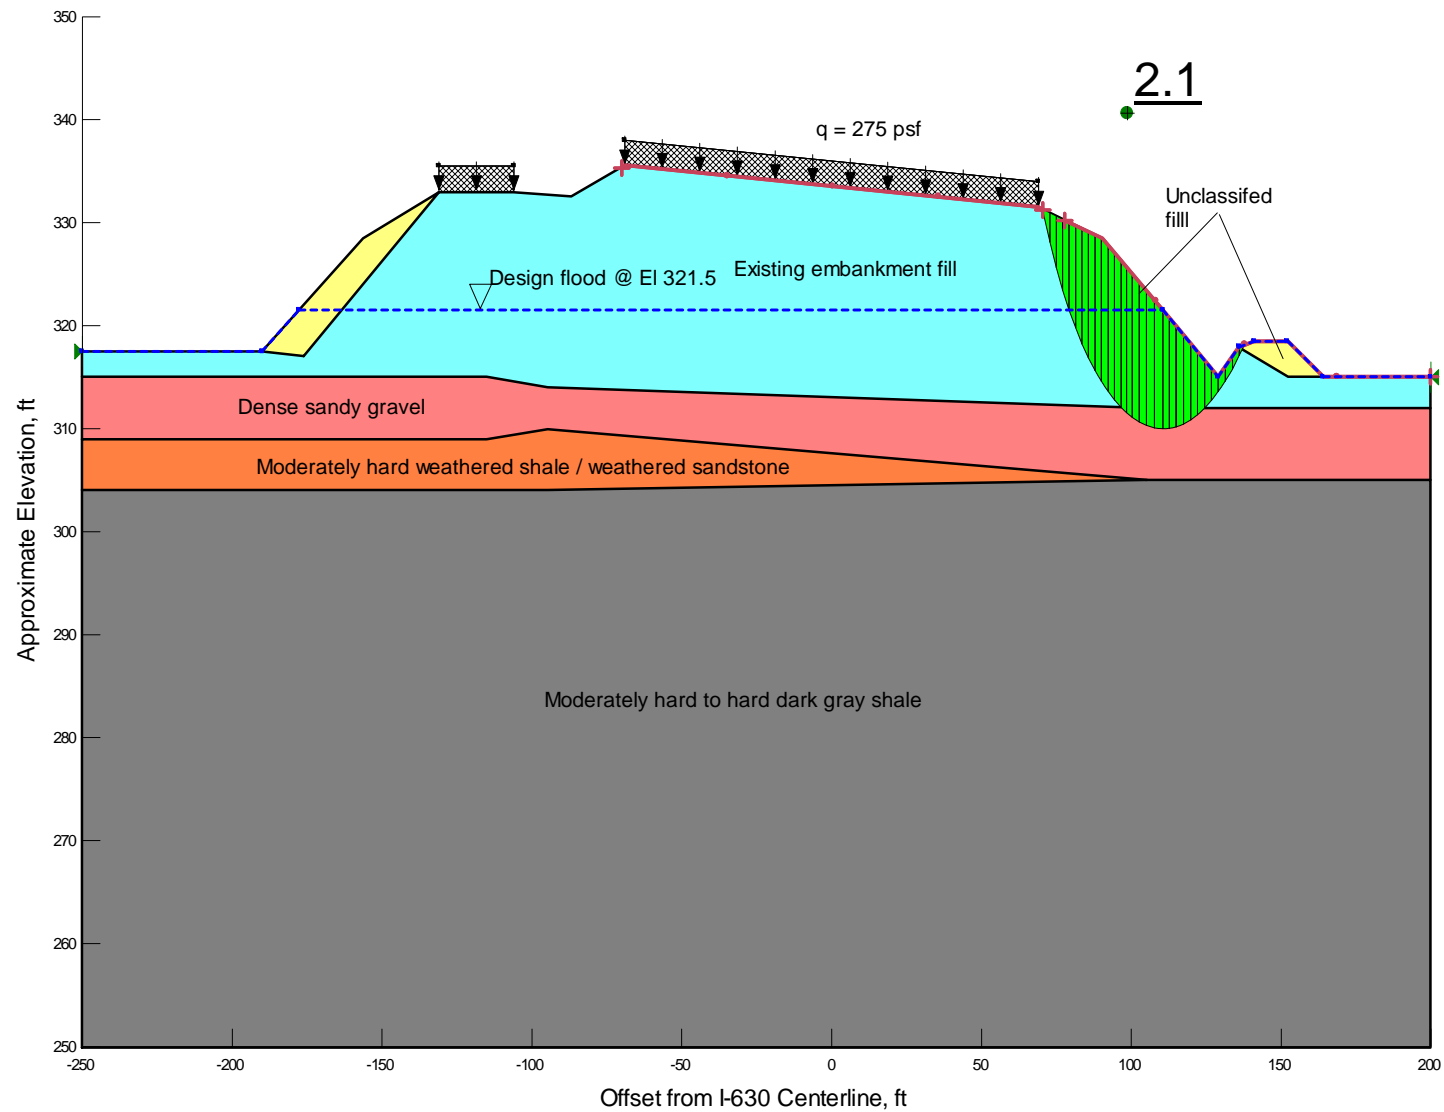
Results of Stability Analyses – Rapid Drawdown Condition
 Drawdown from Design Flood to Embankment Toe
 Side Slope @ East Bridge Abutment – I-630 over Rock Creek

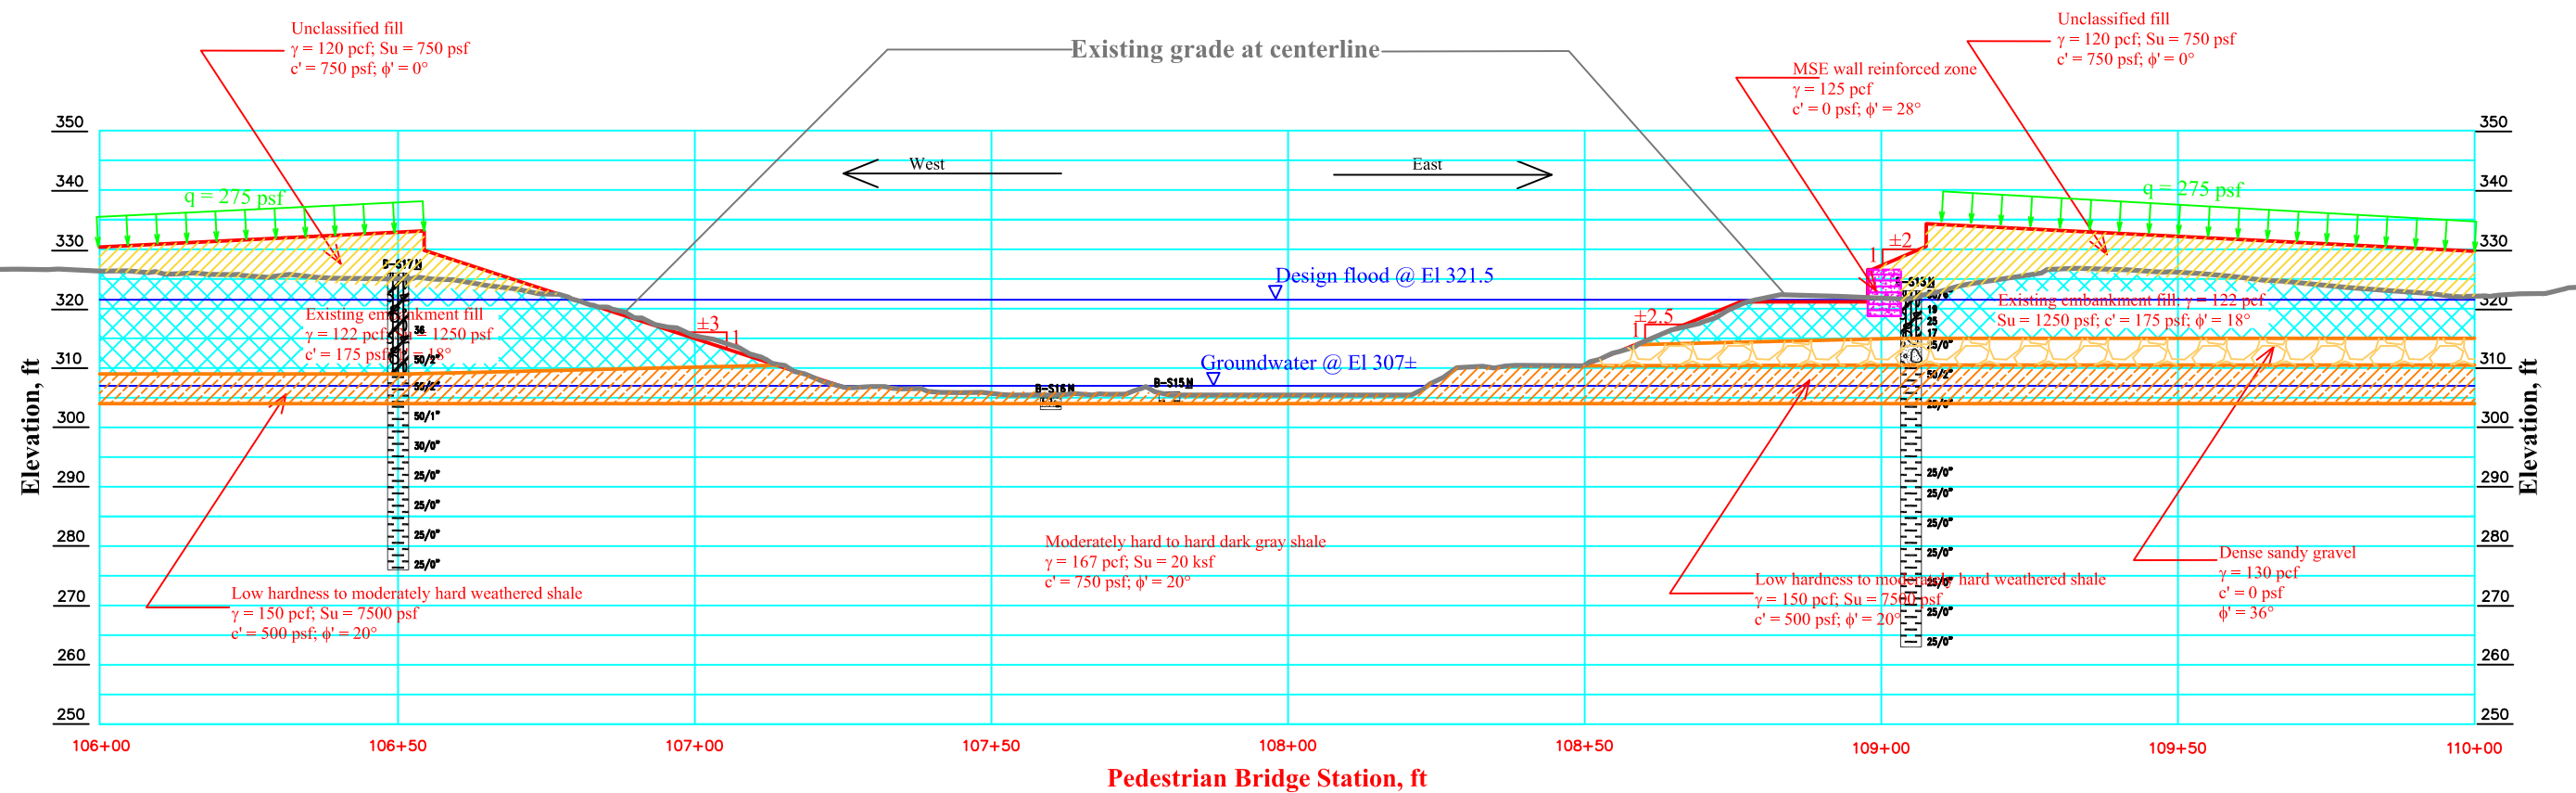
Note: Section developed for purpose of stability analysis only, not for construction.

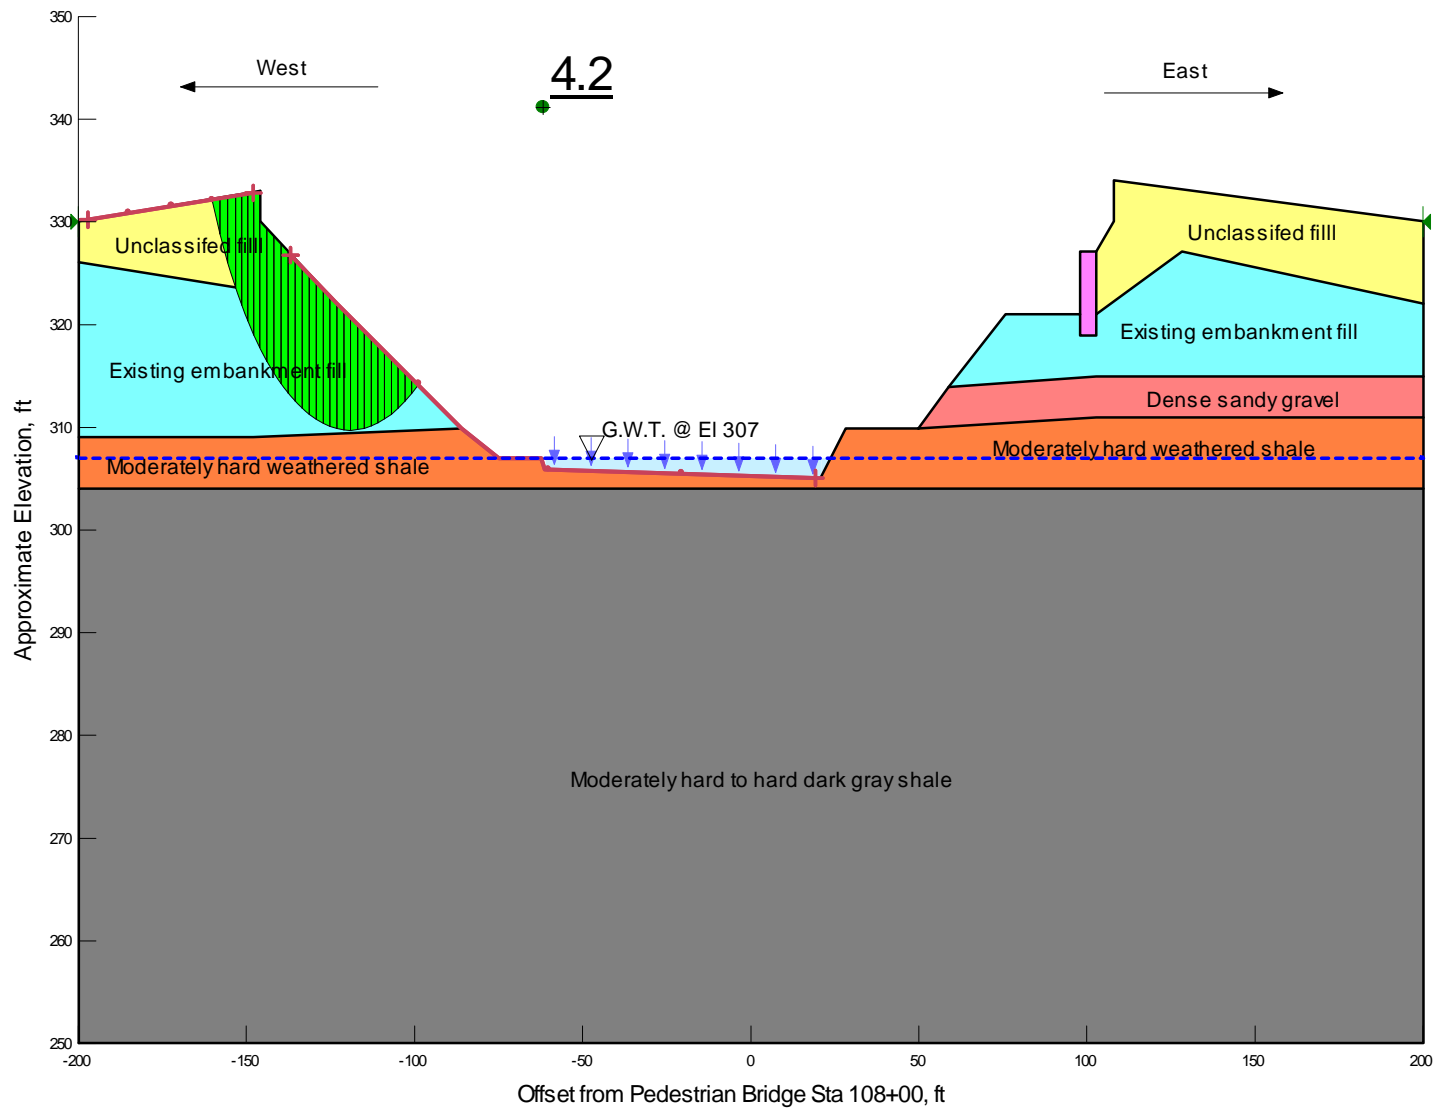
Results of Stability Analyses – End of Construction Condition
 Groundwater @ El 307±
 End Slope @ West Bridge Abutment – Pedestrian Bridge over Rock Creek

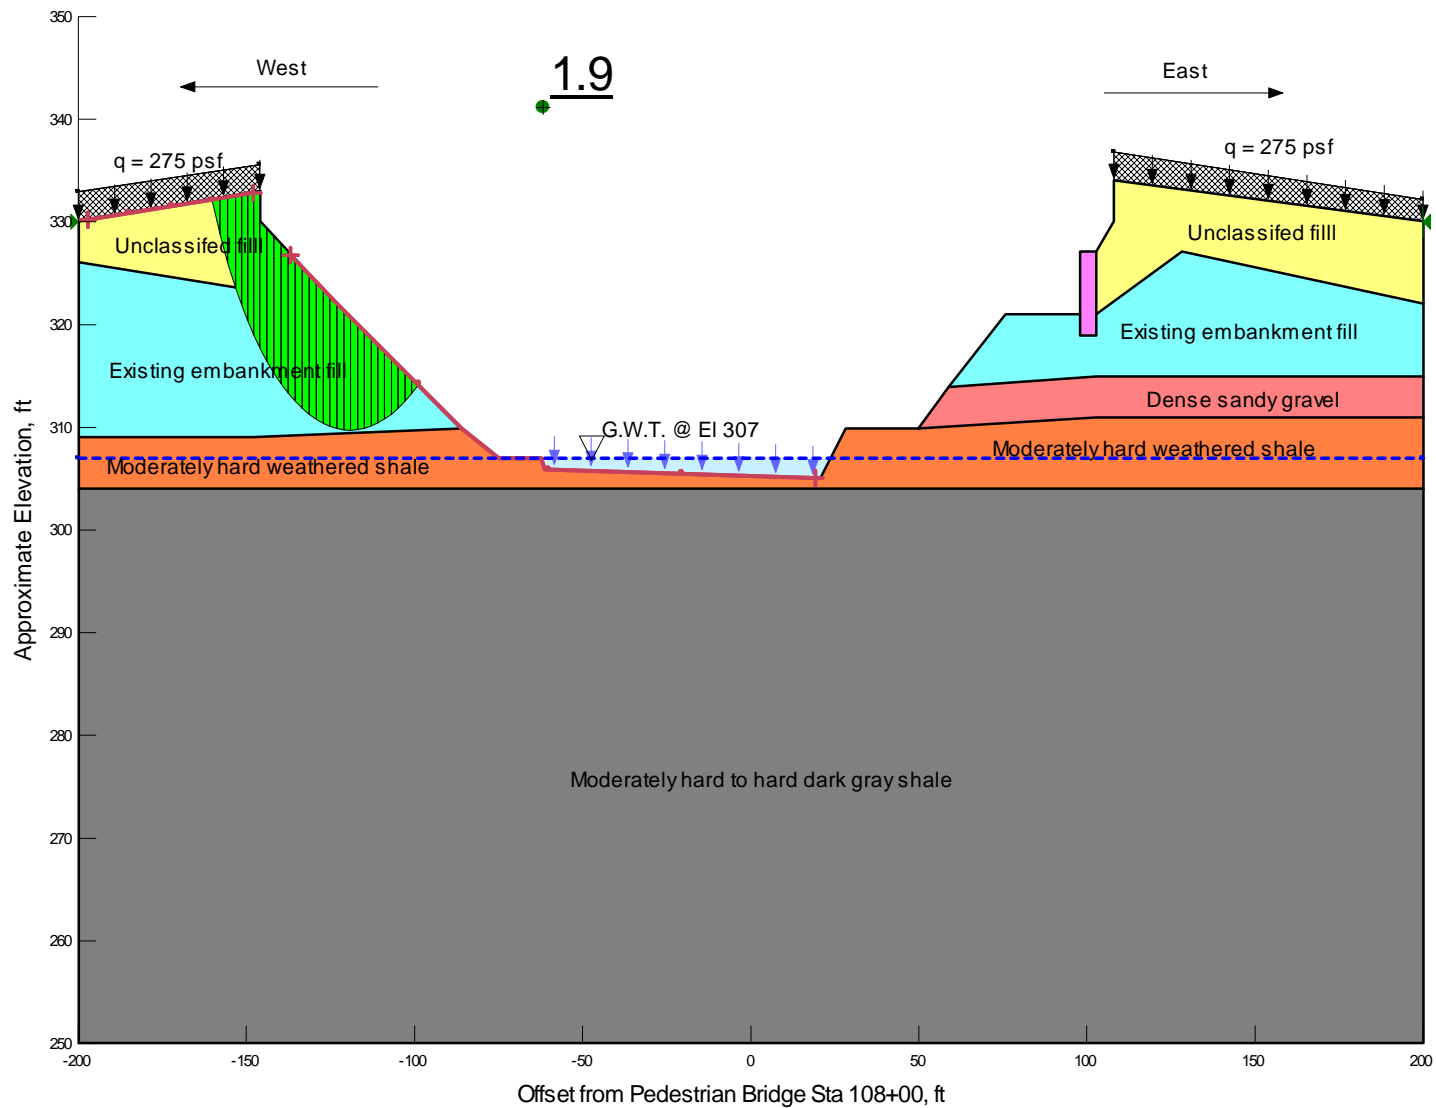
Results of Stability Analyses – Long Term Condition
 Groundwater @ El 307±
 End Slope @ West Bridge Abutment – Pedestrian Bridge over Rock Creek

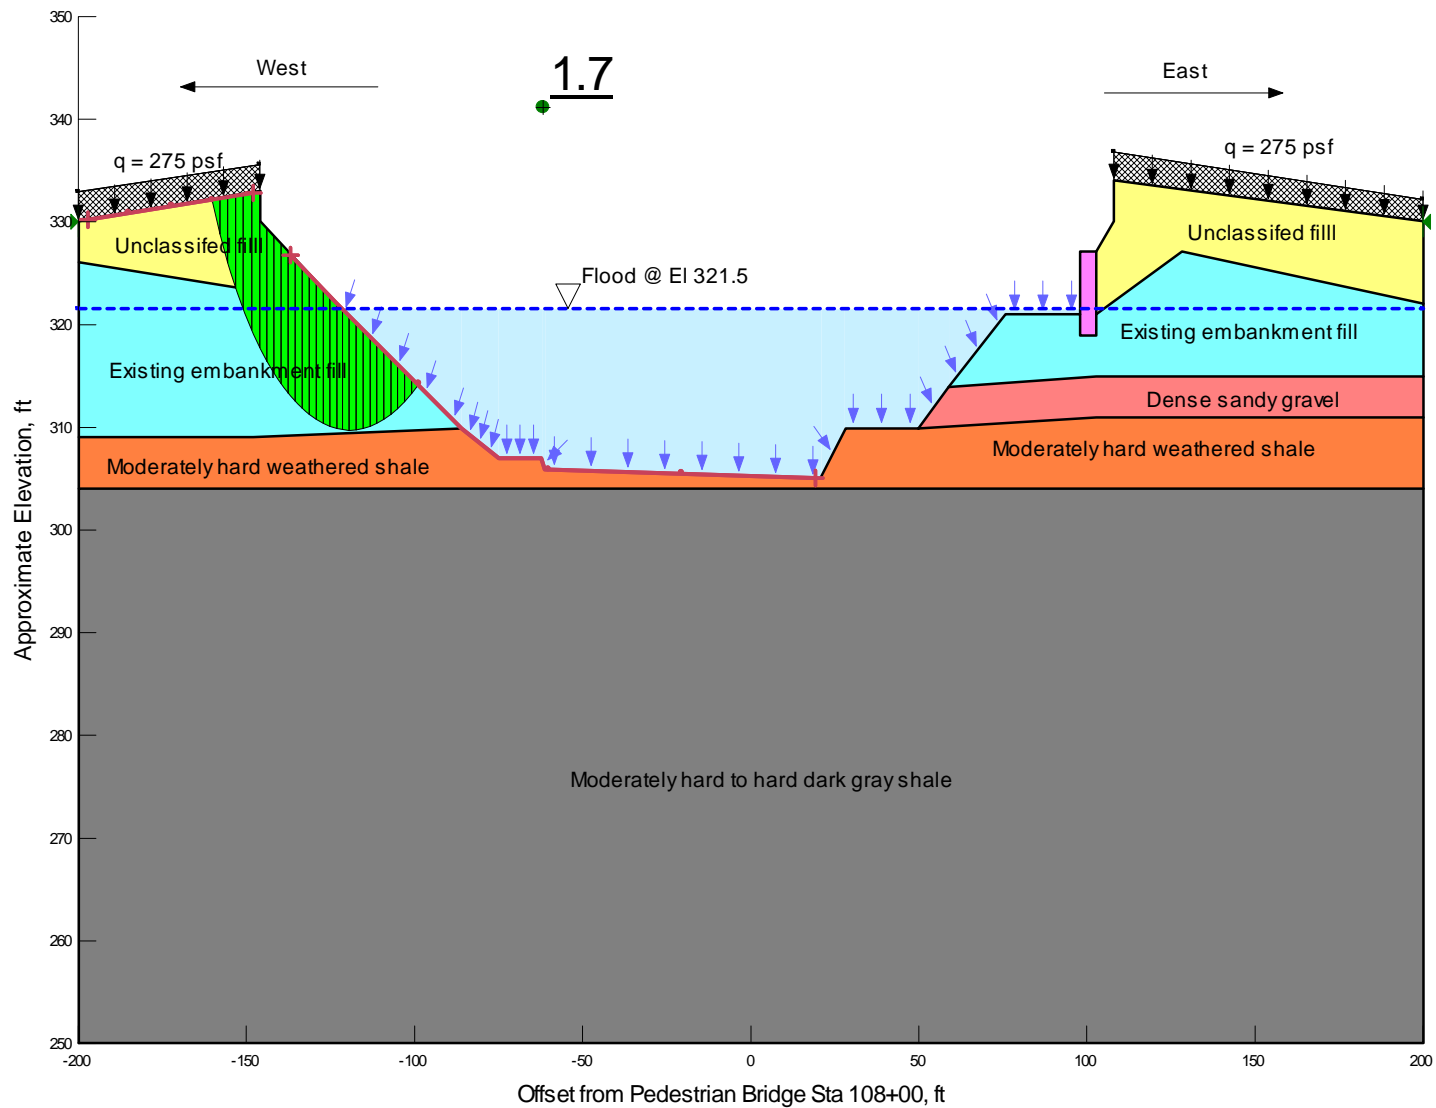
Results of Stability Analyses – Long Term Condition
 Design Flood @ El 321.5
 End Slope @ West Bridge Abutment – Pedestrian Bridge over Rock Creek

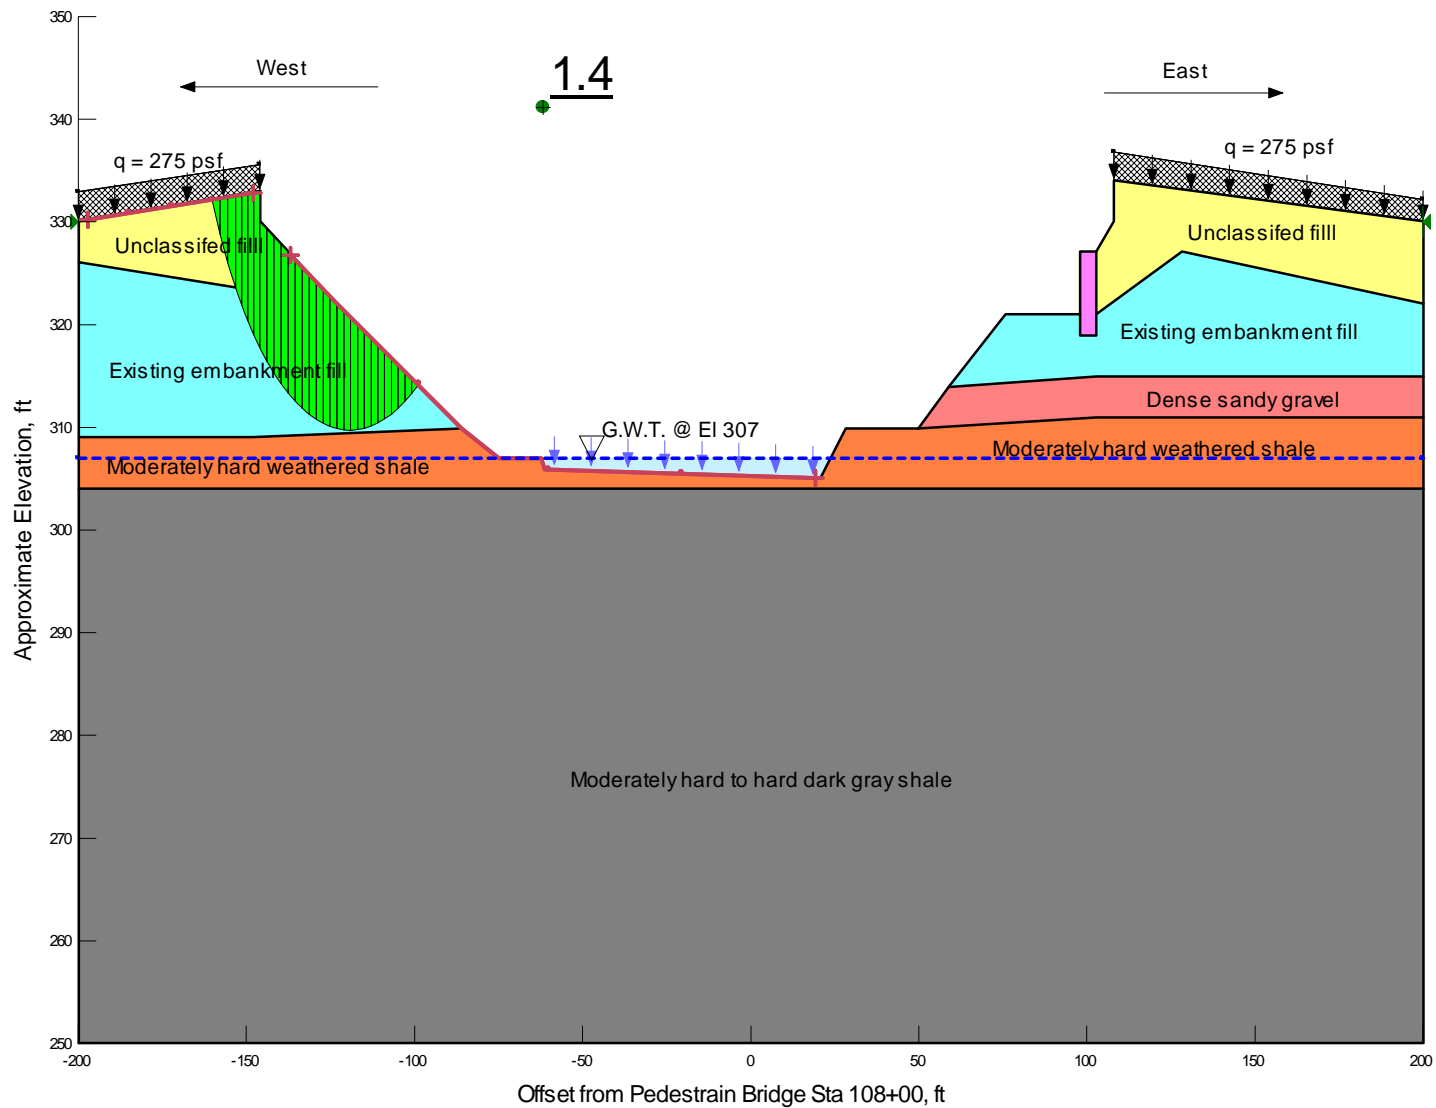
Results of Stability Analyses – Seismic Condition ($k_h = 1.0A_S = 0.13$)
 Groundwater @ El 307±
 End Slope @ West Bridge Abutment – Pedestrian Bridge over Rock Creek

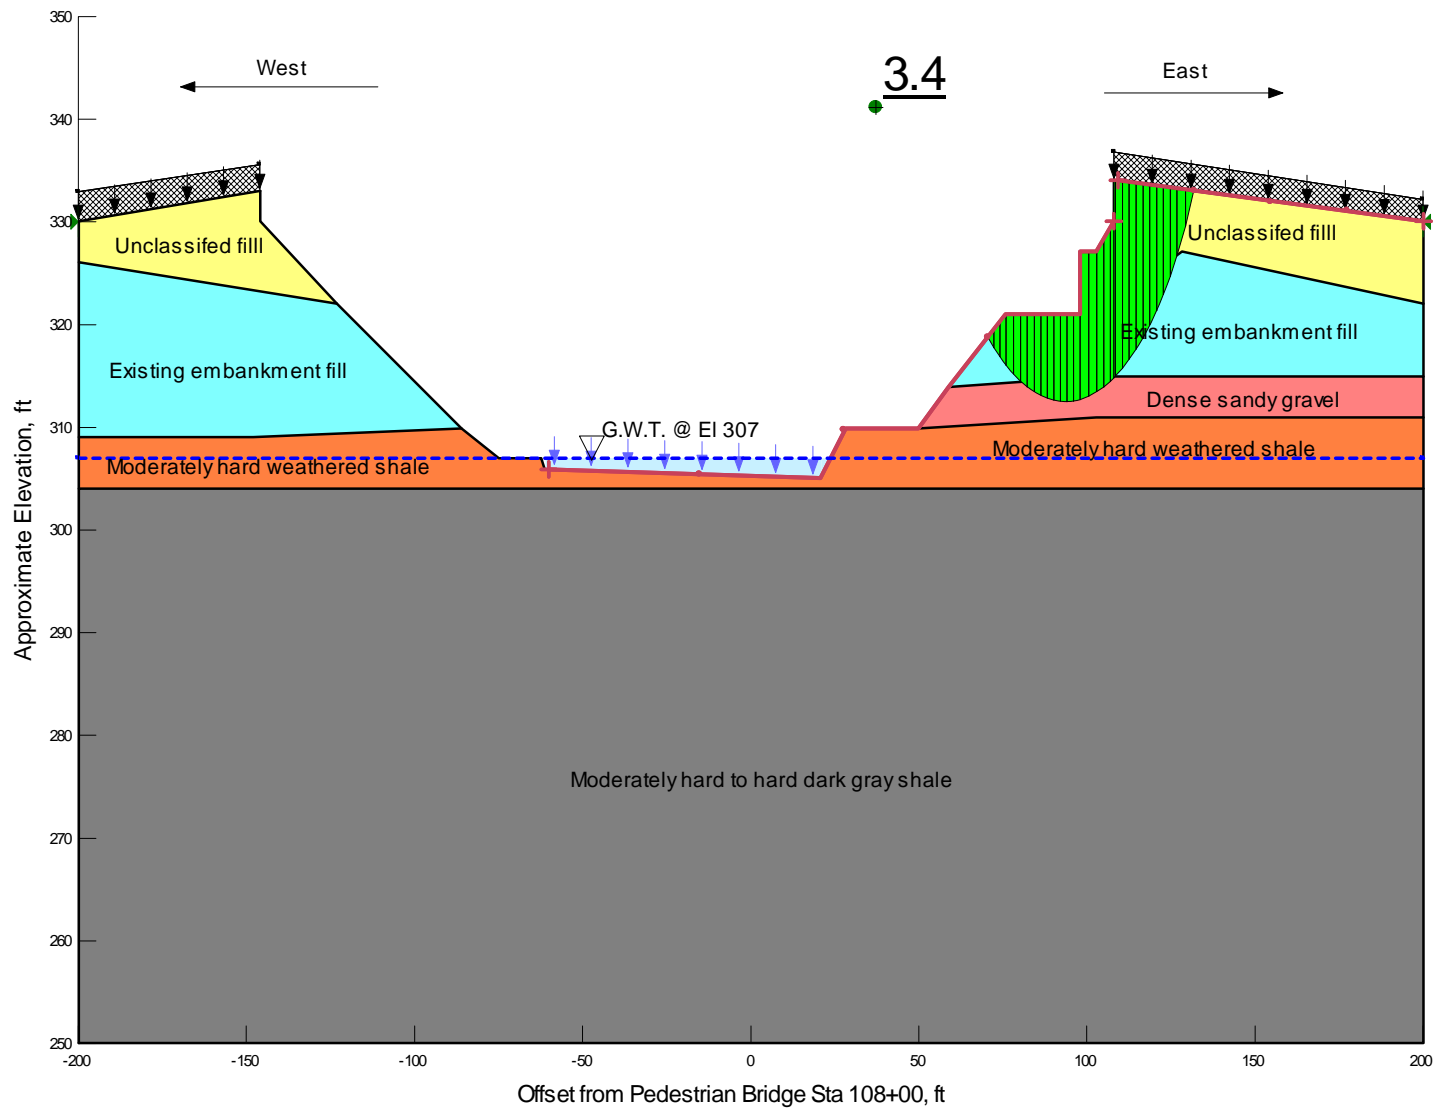
Results of Stability Analyses – End of Construction Condition
 Groundwater @ El 307±
 End Slope @ East Bridge Abutment – Pedestrian Bridge over Rock Creek

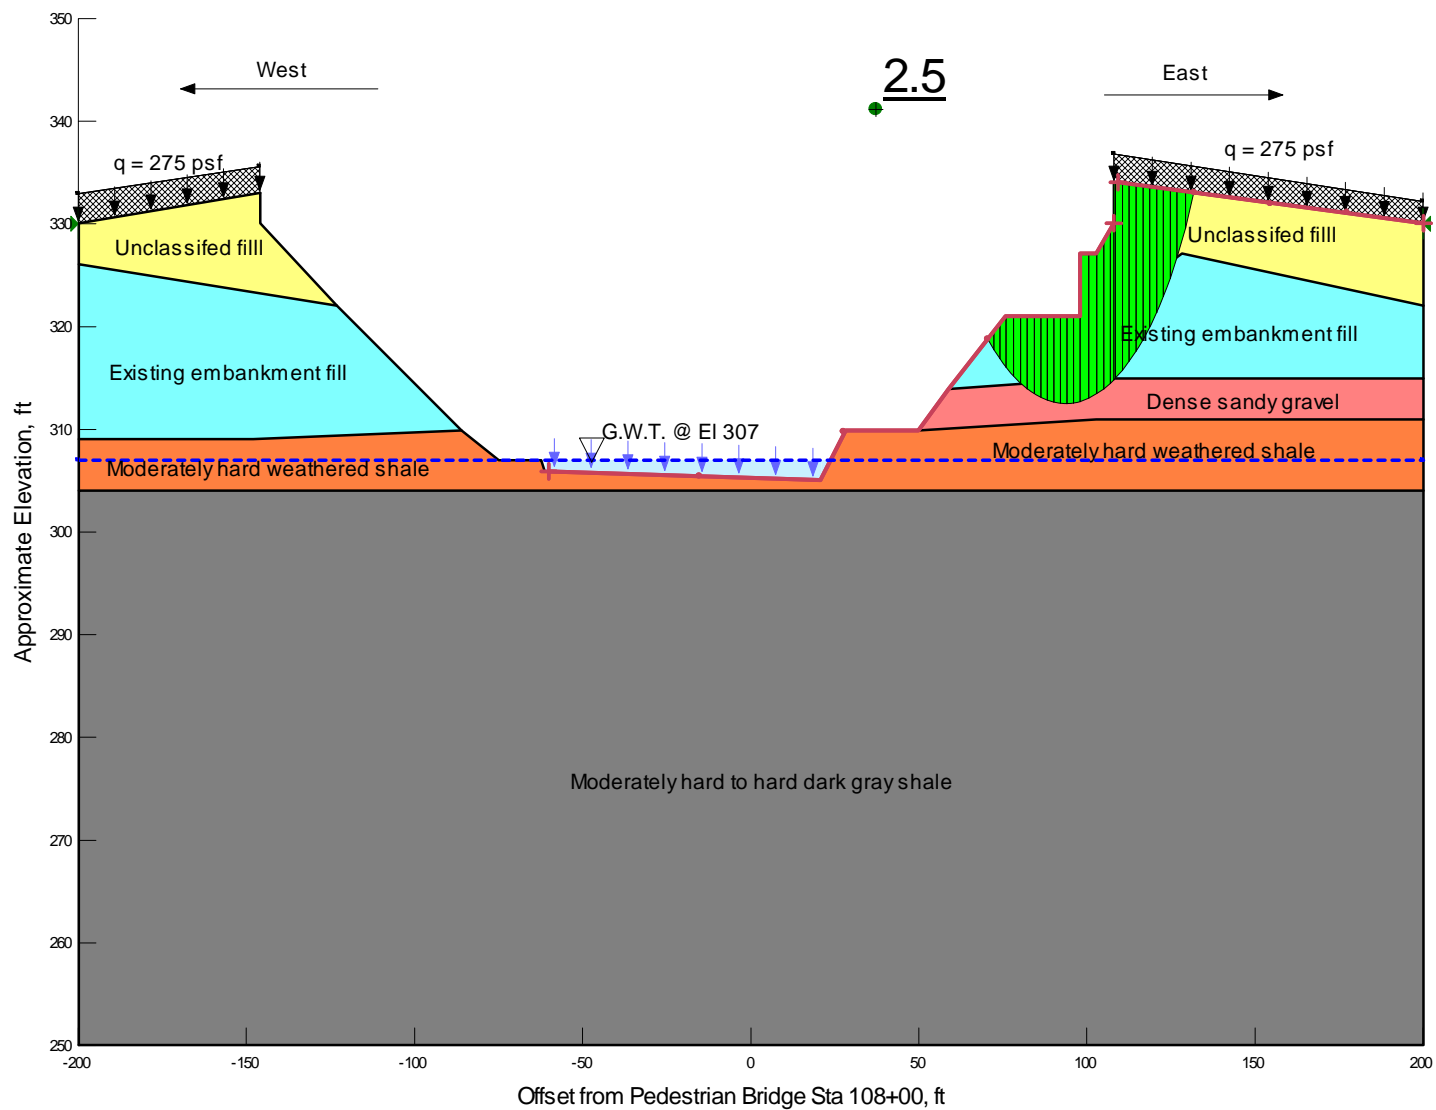
Results of Stability Analyses – Long Term Condition
 Groundwater @ El 307±
 End Slope @ East Bridge Abutment – Pedestrian Bridge over Rock Creek

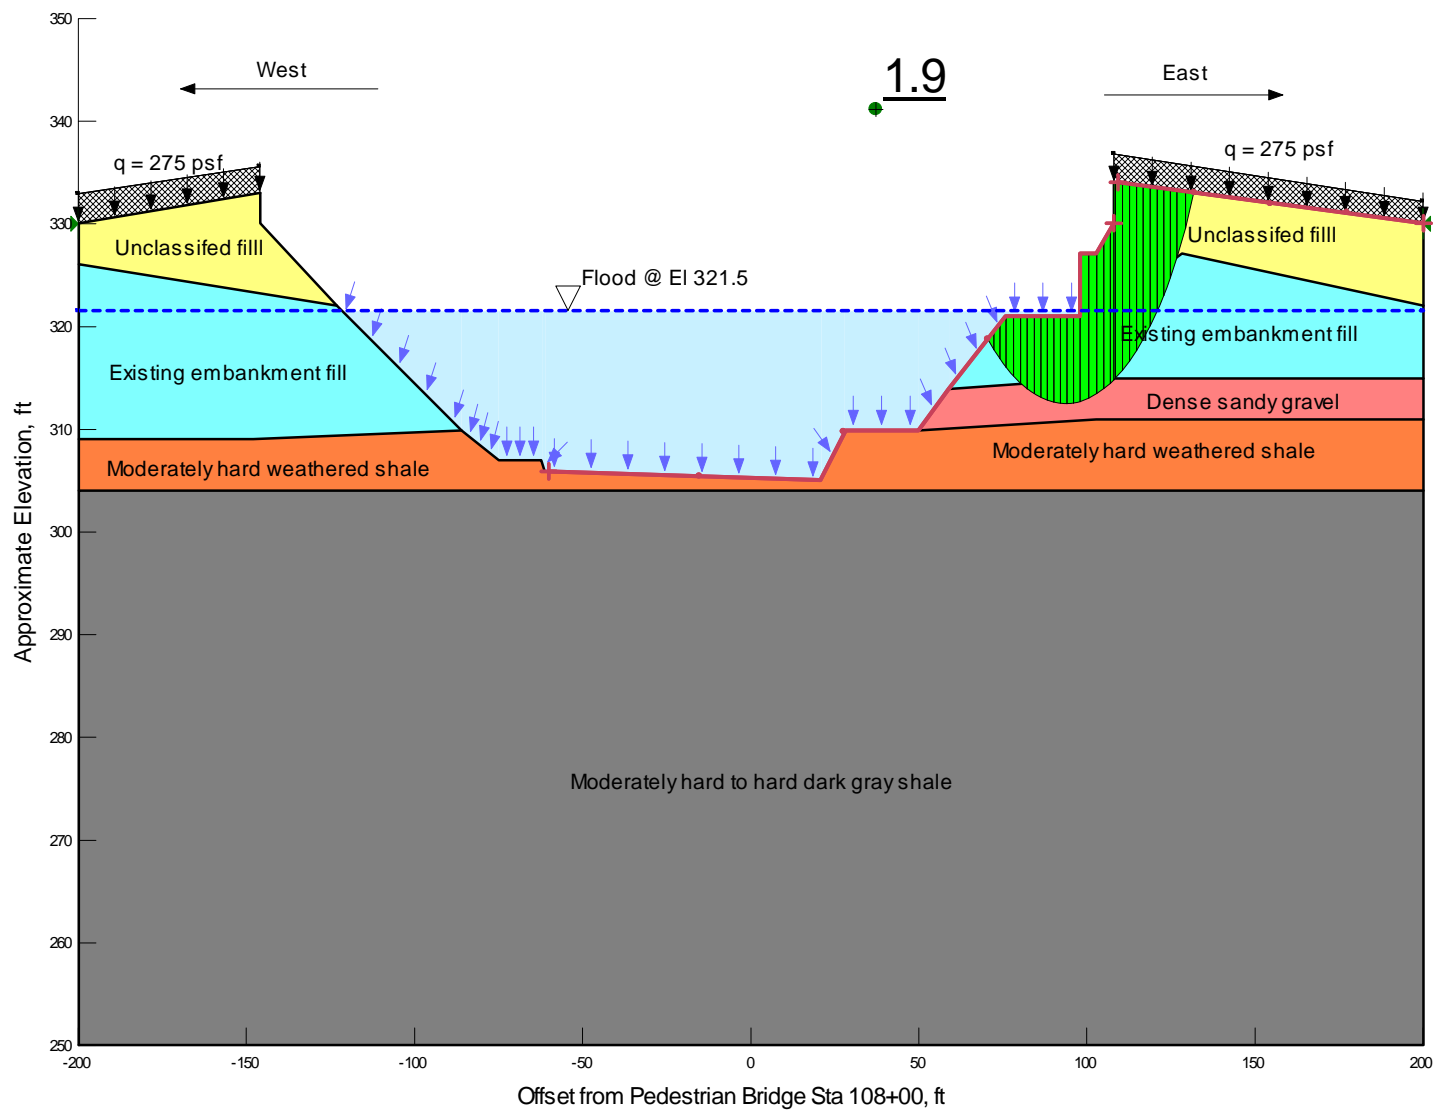
Results of Stability Analyses – Long Term Condition
 Design Flood @ El 321.5
 End Slope @ East Bridge Abutment – Pedestrian Bridge over Rock Creek

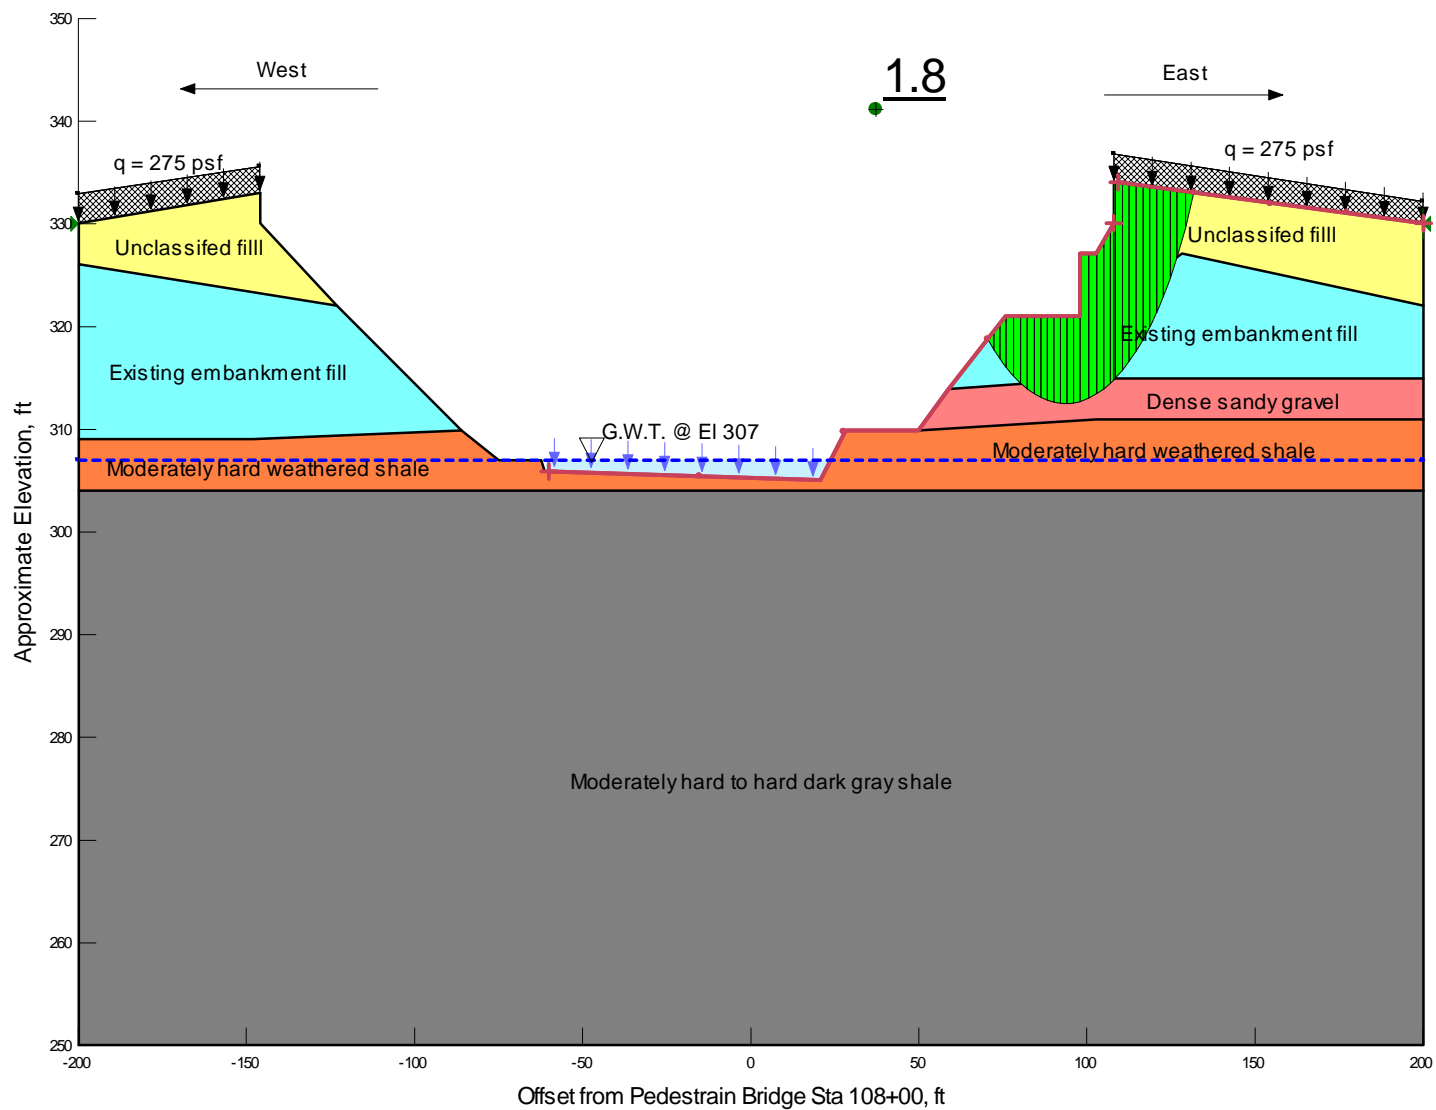
Results of Stability Analyses – Seismic Condition ($k_h = 1.0A_S = 0.13$)
 Groundwater @ El 307±
 End Slope @ East Bridge Abutment – Pedestrian Bridge over Rock Creek

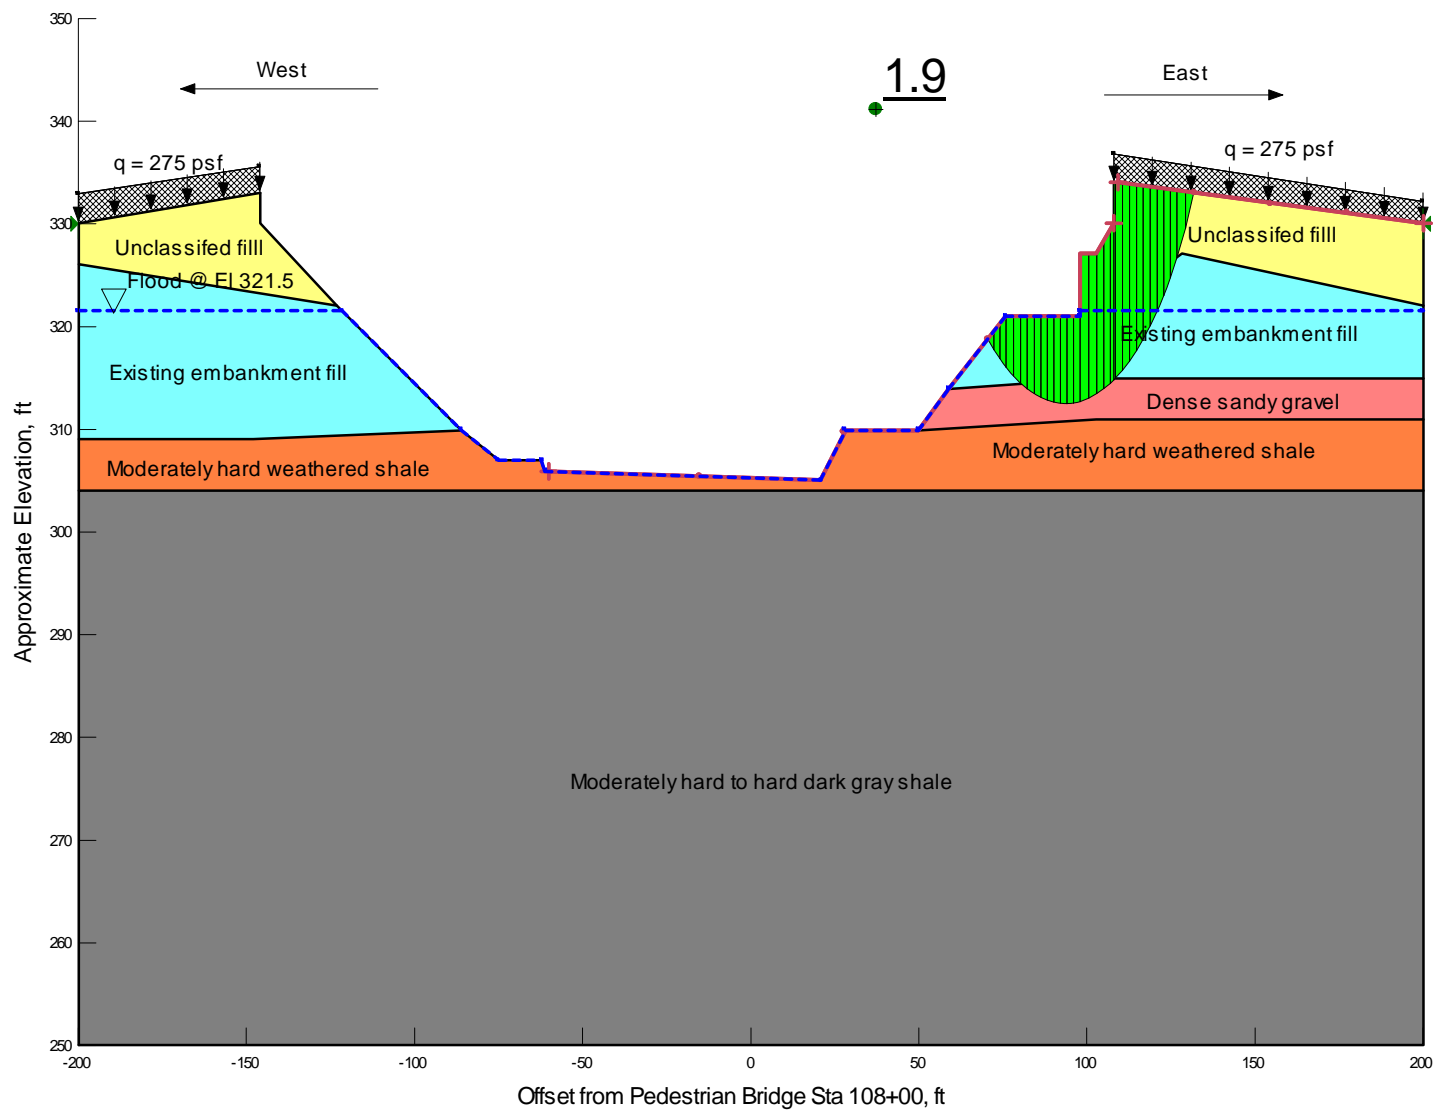
Results of Stability Analyses – Rapid Drawdown Condition
 Drawdown from Design Flood to Embankment Toe
 End Slope @ East Bridge Abutment – Pedestrian Bridge over Rock Creek

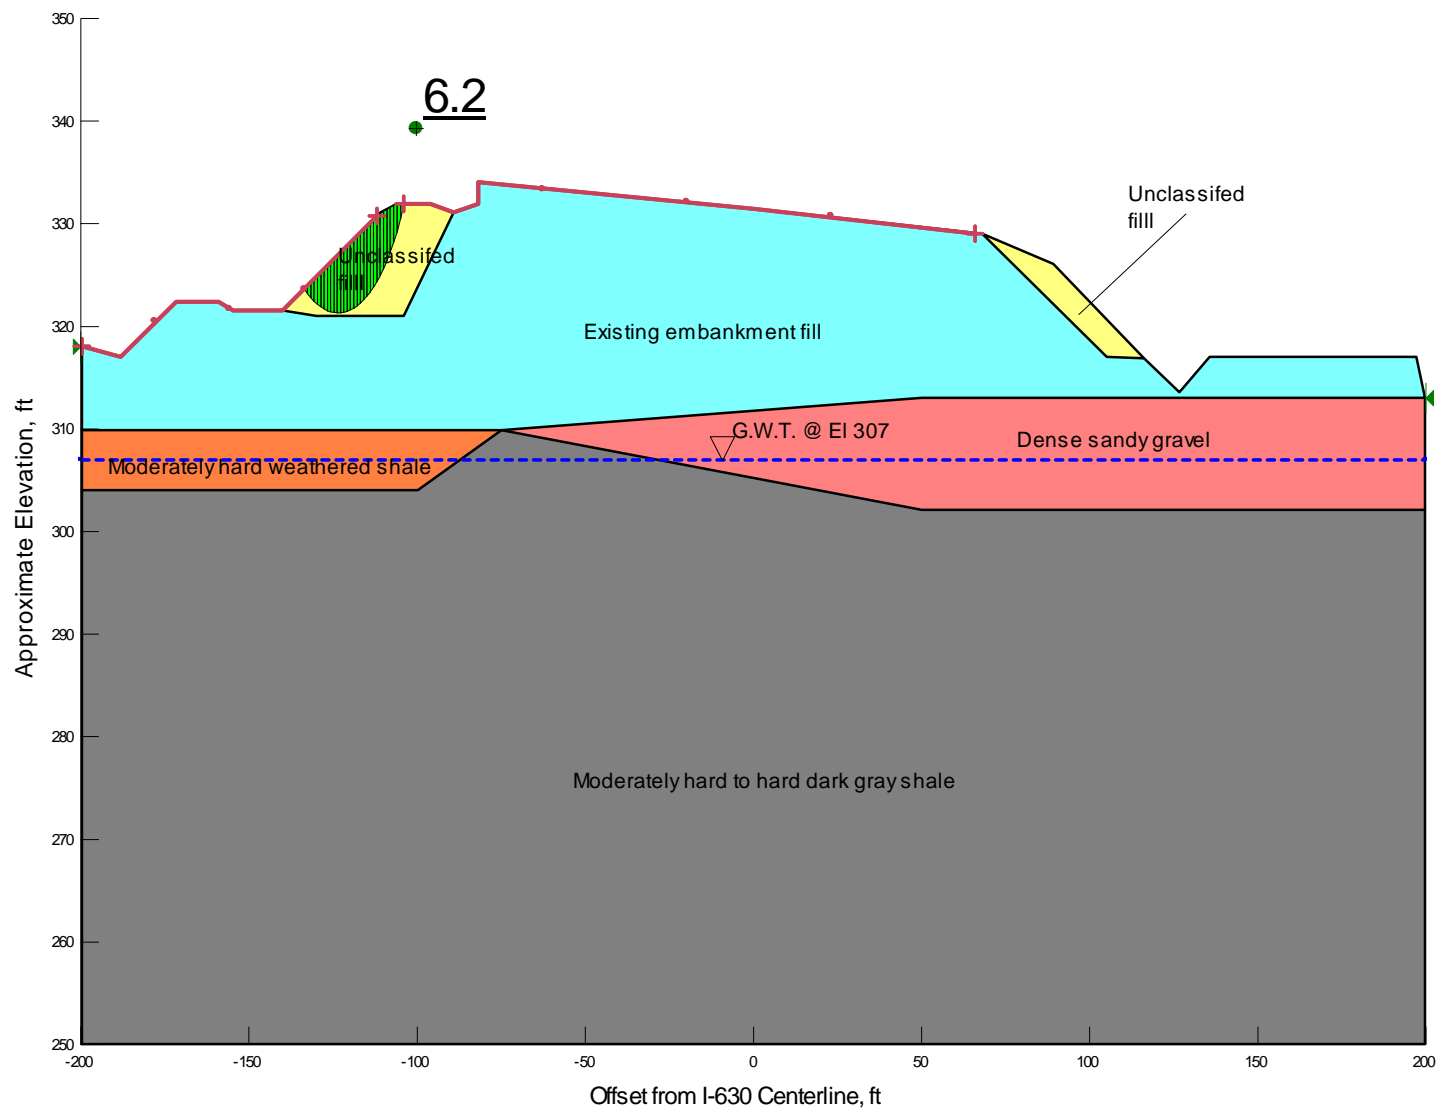
Results of Stability Analyses – End of Construction Condition
 Groundwater @ El 307±
 Side Slope @ West Bridge Abutment –Pedestrian Bridge over Rock Creek
