March 20, 2015
Job No. 14-030

**GEOTECHNICAL INVESTIGATION
BRIDGE FOUNDATIONS and EMBANKMENTS
AHTD JOB CA0608
BAPTIST HOSPITAL-UNIVERSITY AVENUE (WIDENING)(S)
LITTLE ROCK, PULASKI COUNTY, ARKANSAS**

Submitted herein are foundation recommendations for bridge structures included in the I-630 widening project in Little Rock, Pulaski County, Arkansas. This project is designated as AHTD Job CA0608: Baptist Hospital-University Avenue (Widening)(S). Results of stability analyses performed for the plan embankments at the Rock Creek Bridge location are also included in this submittal. Interim foundation recommendations for the bridges were provided on February 4 and February 7, 2015. Recommendations related to the roadway and retaining walls are provided in other report submittals under separate covers.

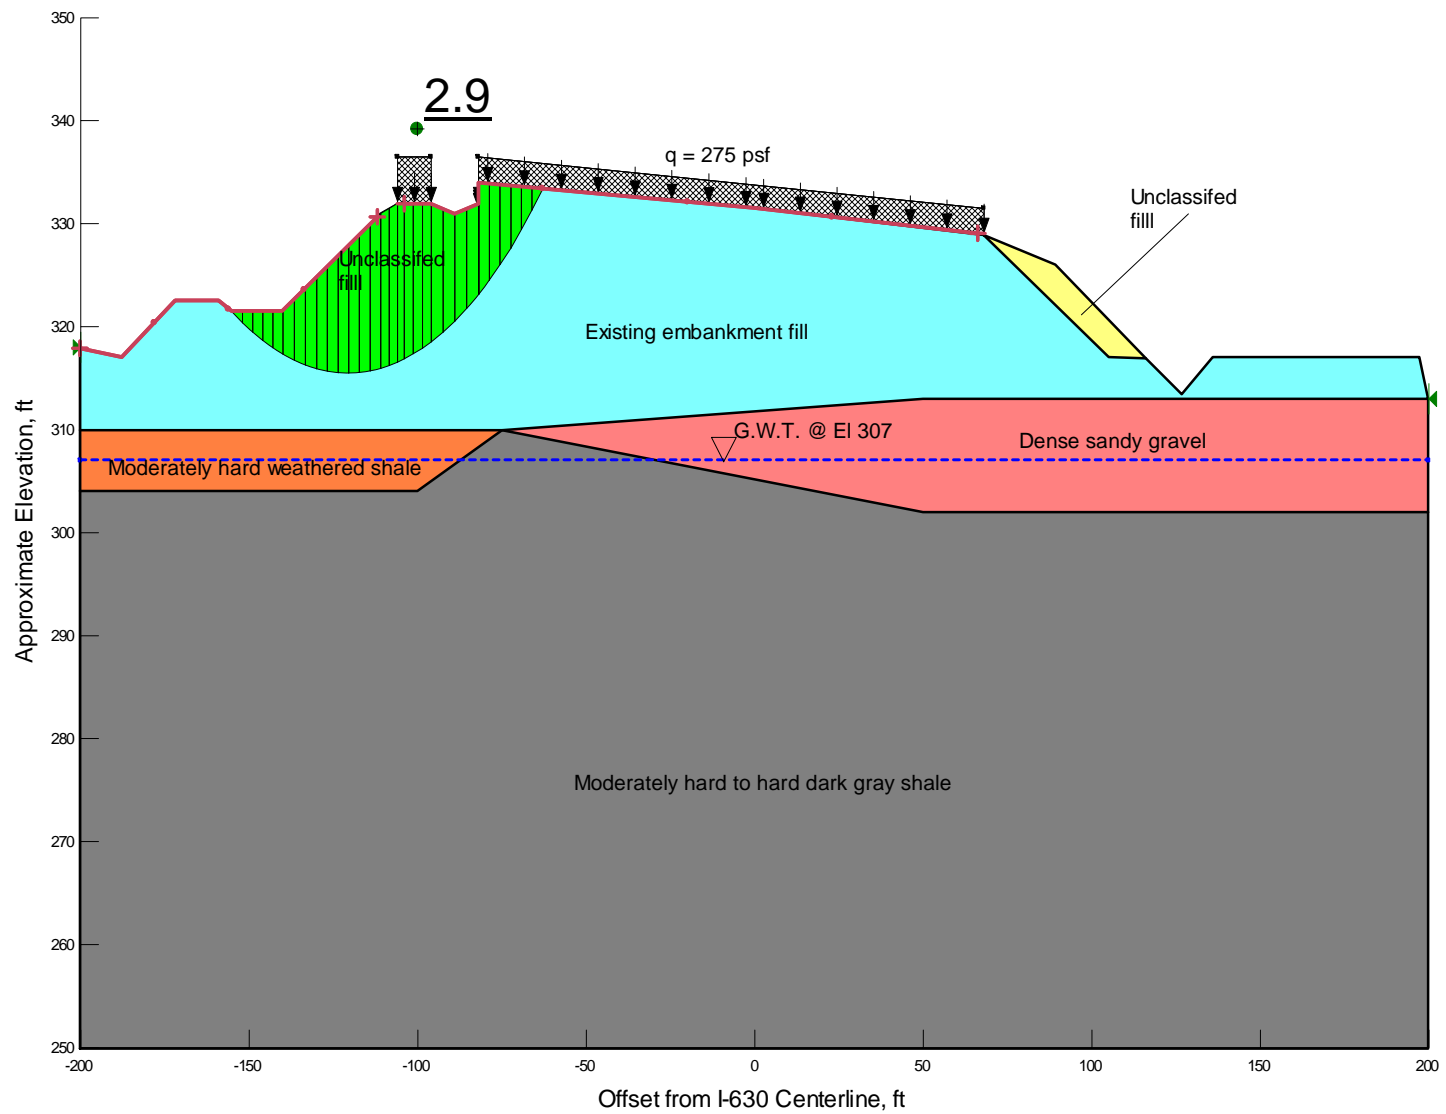
Results of Stability Analyses – Long Term Condition
 Groundwater @ El 307±
 Side Slope @ West Bridge Abutment – Pedestrian Bridge over Rock Creek

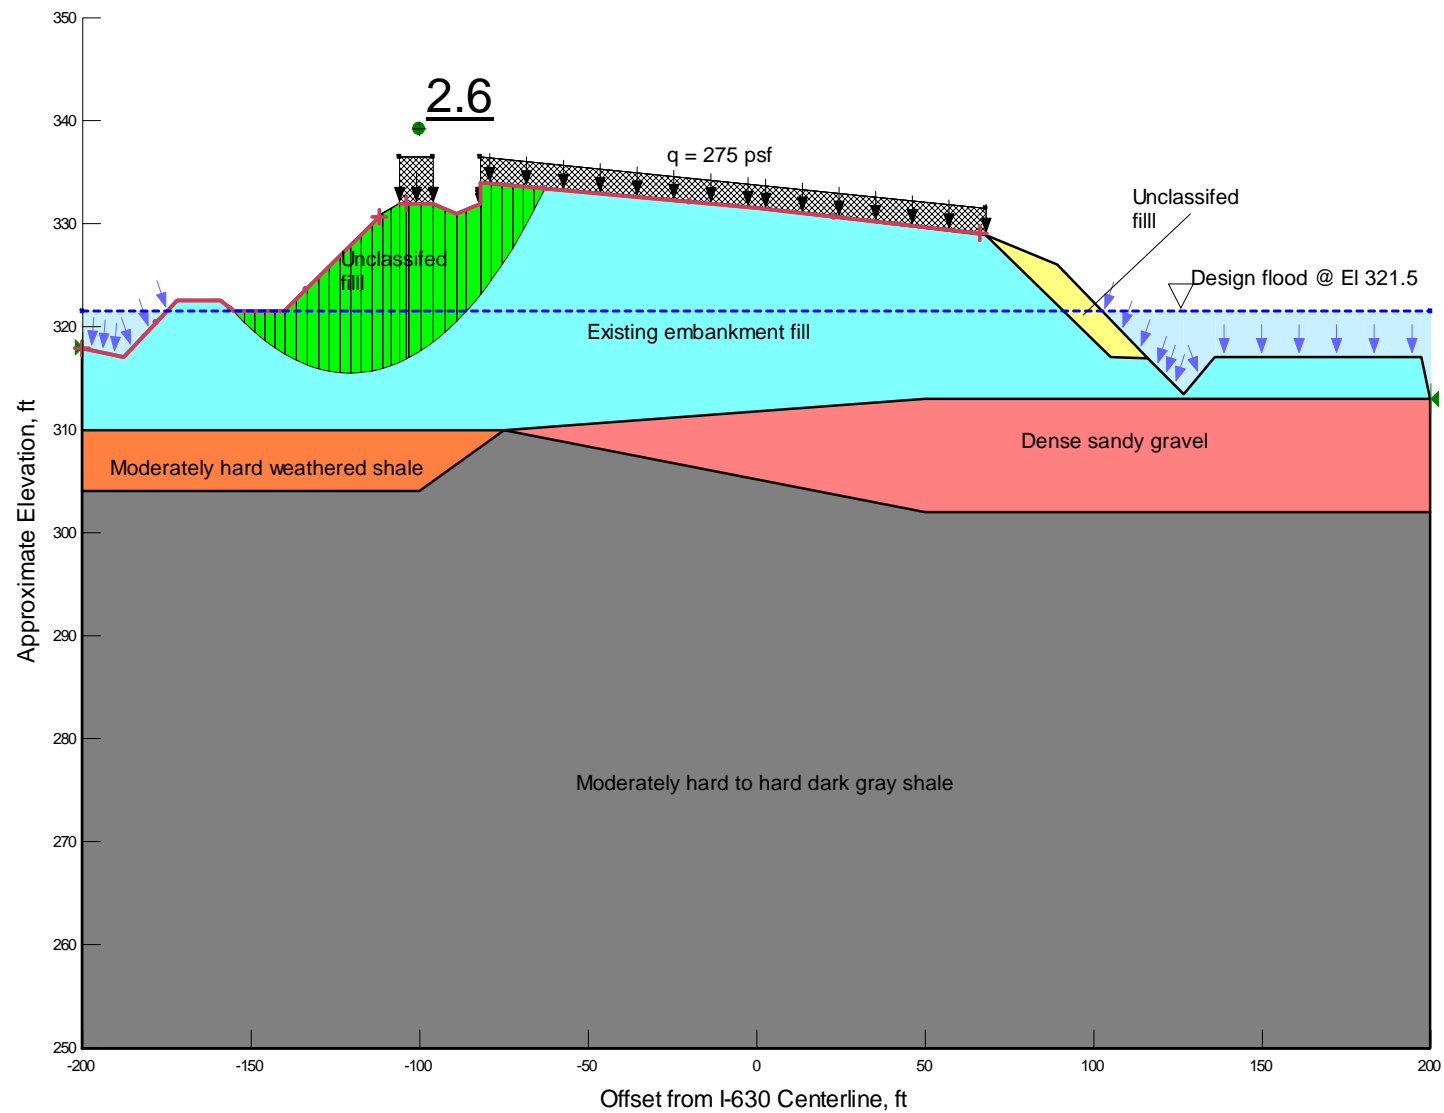
Results of Stability Analyses – Long Term Condition
 Design Flood @ El 321.5
 Side Slope @ West Bridge Abutment – Pedestrian Bridge over Rock Creek

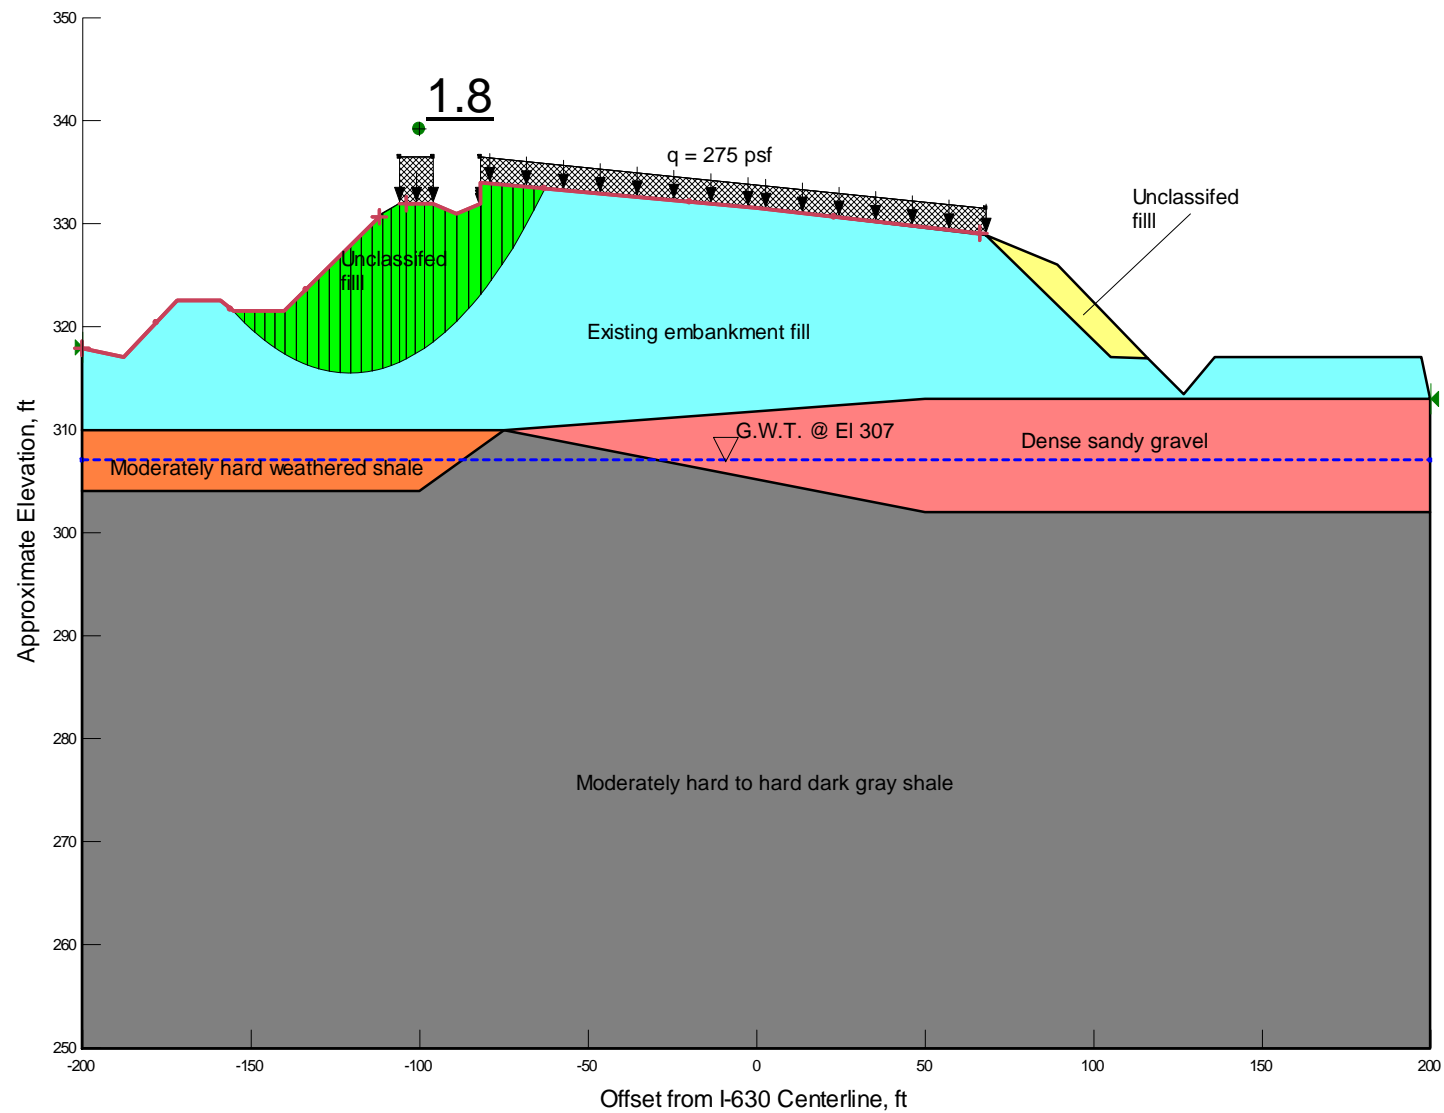
Results of Stability Analyses – Seismic Condition ($k_h = 1.0A_S = 0.13$)
 Groundwater @ El 307±
 Side Slope @ West Bridge Abutment – Pedestrian Bridge over Rock Creek

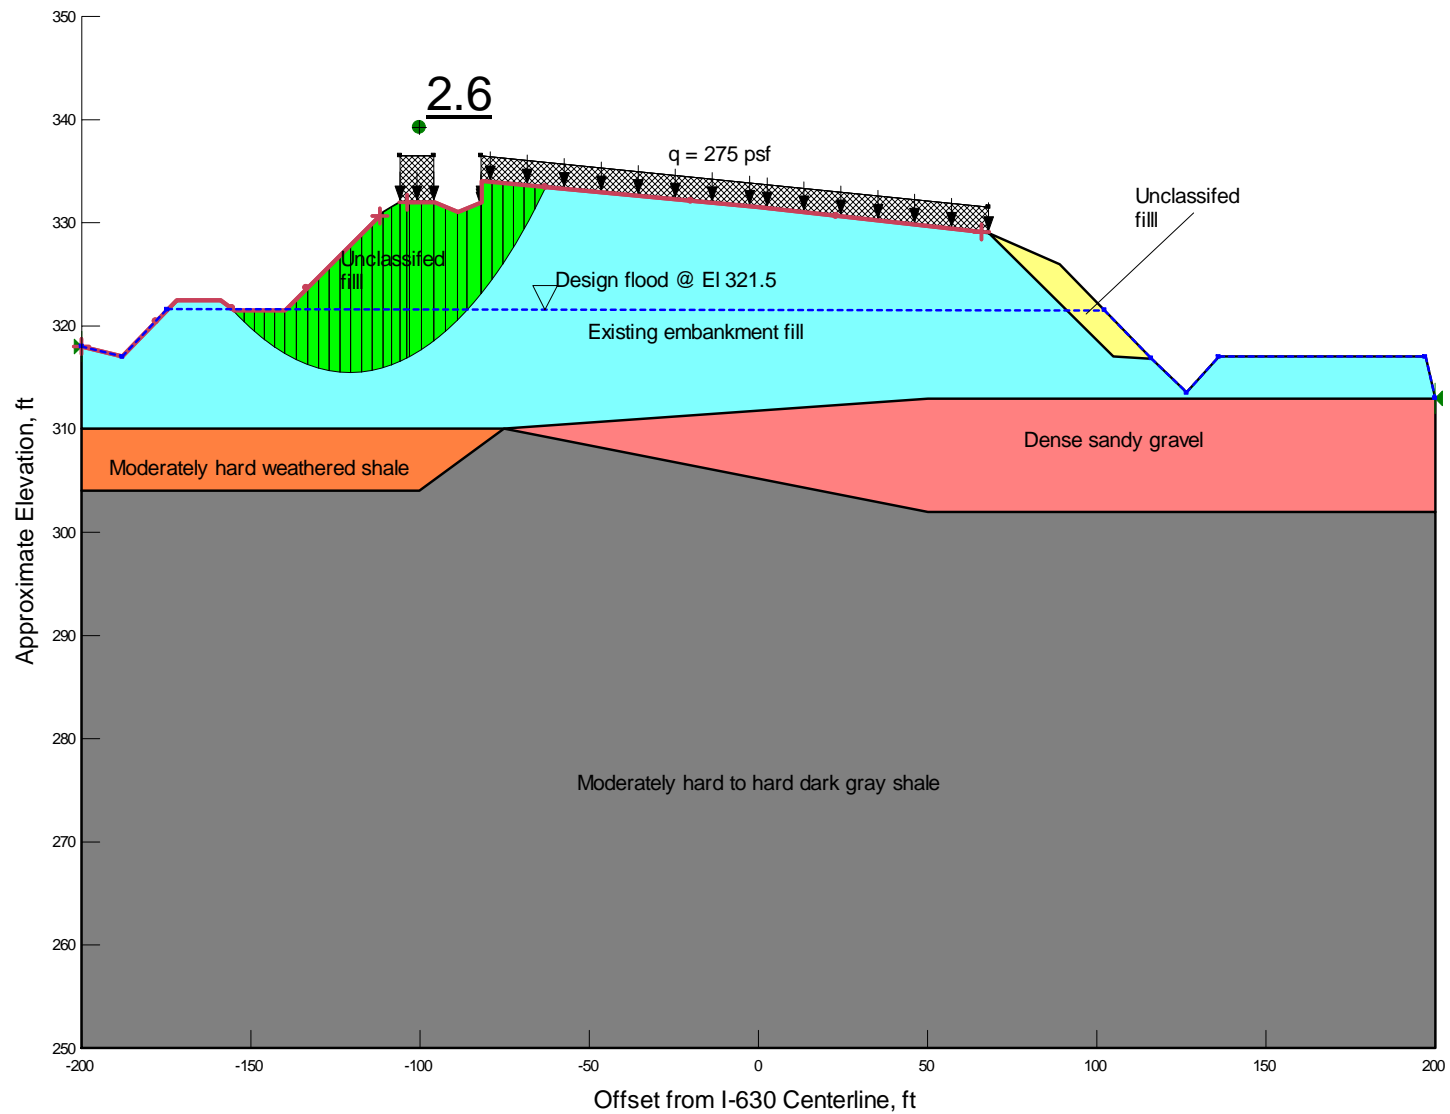
Results of Stability Analyses – Rapid Drawdown Condition
 Drawdown from Design Flood to Embankment Toe
 Side Slope @ West Bridge Abutment – Pedestrian Bridge over Rock Creek

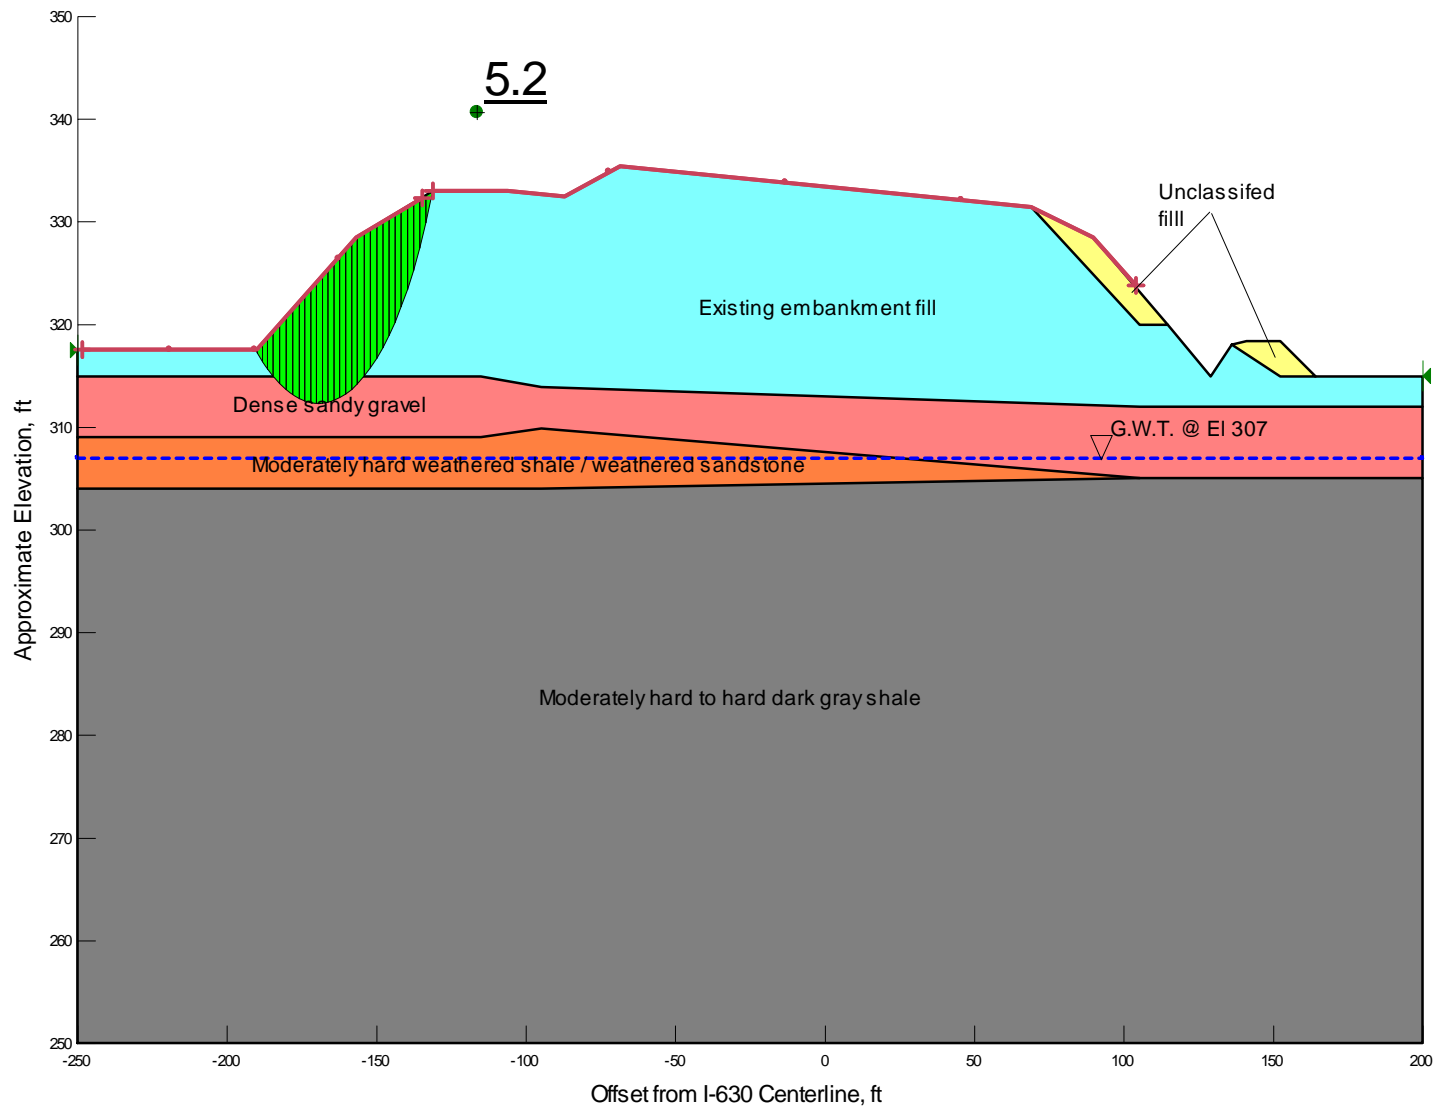
Results of Stability Analyses – End of Construction Condition
 Groundwater @ El 307±
 Side Slope @ East Bridge Abutment – Pedestrian Bridge over Rock Creek

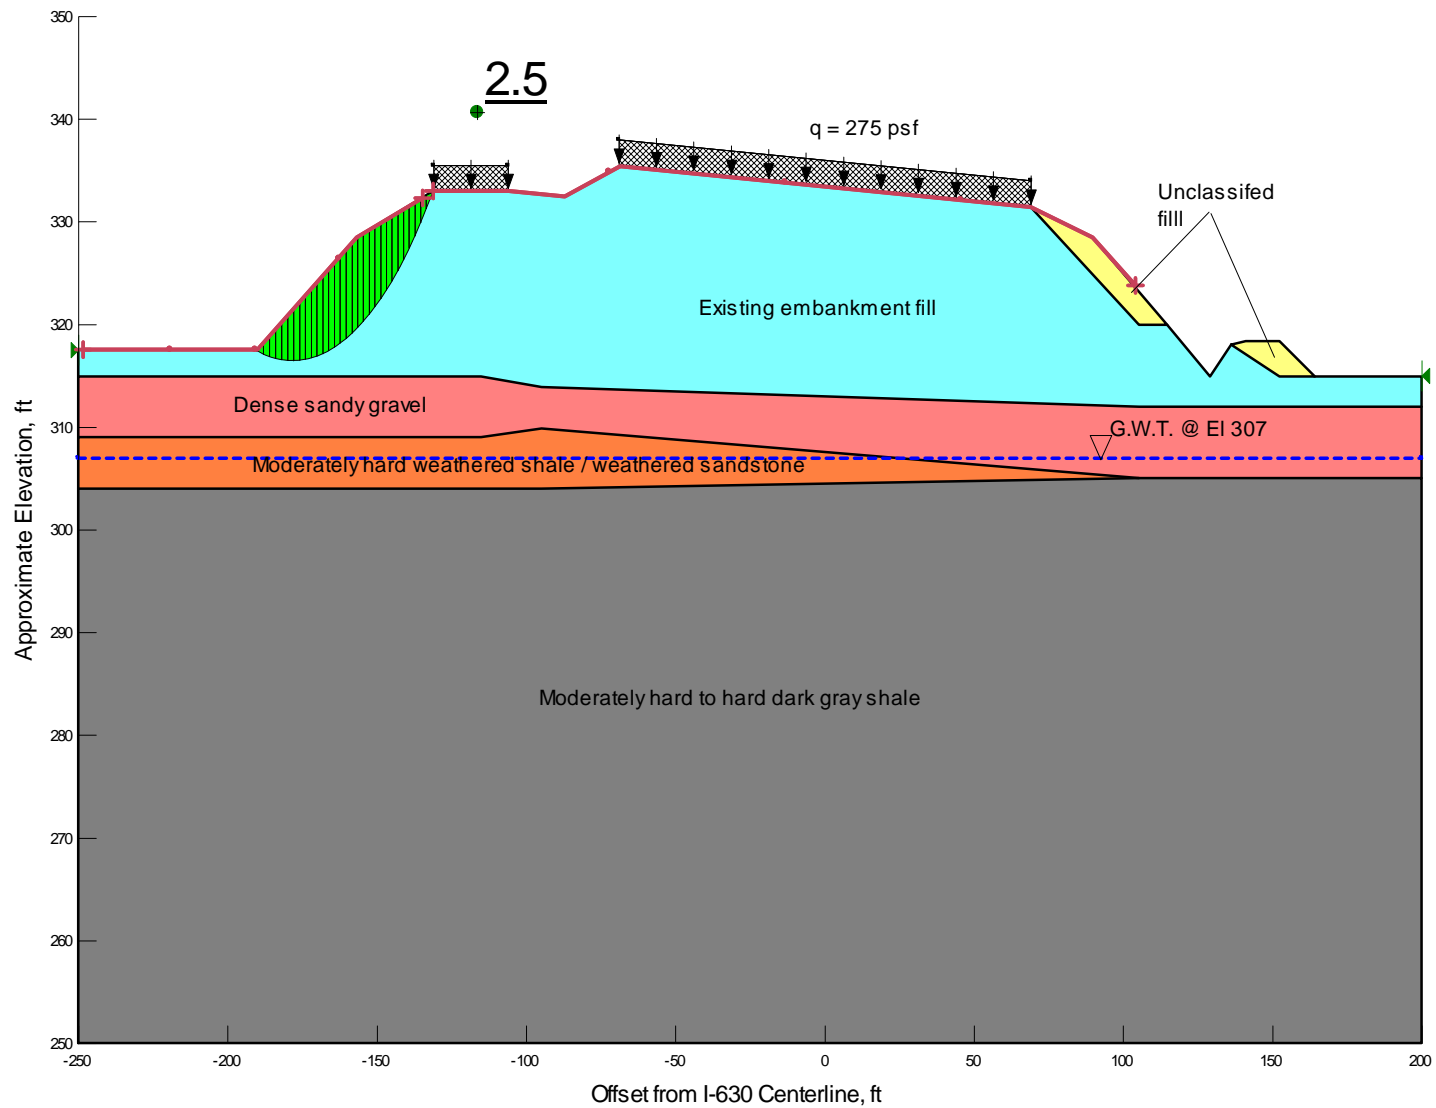
Results of Stability Analyses – Long Term Condition
 Groundwater @ El 307±
 Side Slope @ East Bridge Abutment – Pedestrian Bridge over Rock Creek

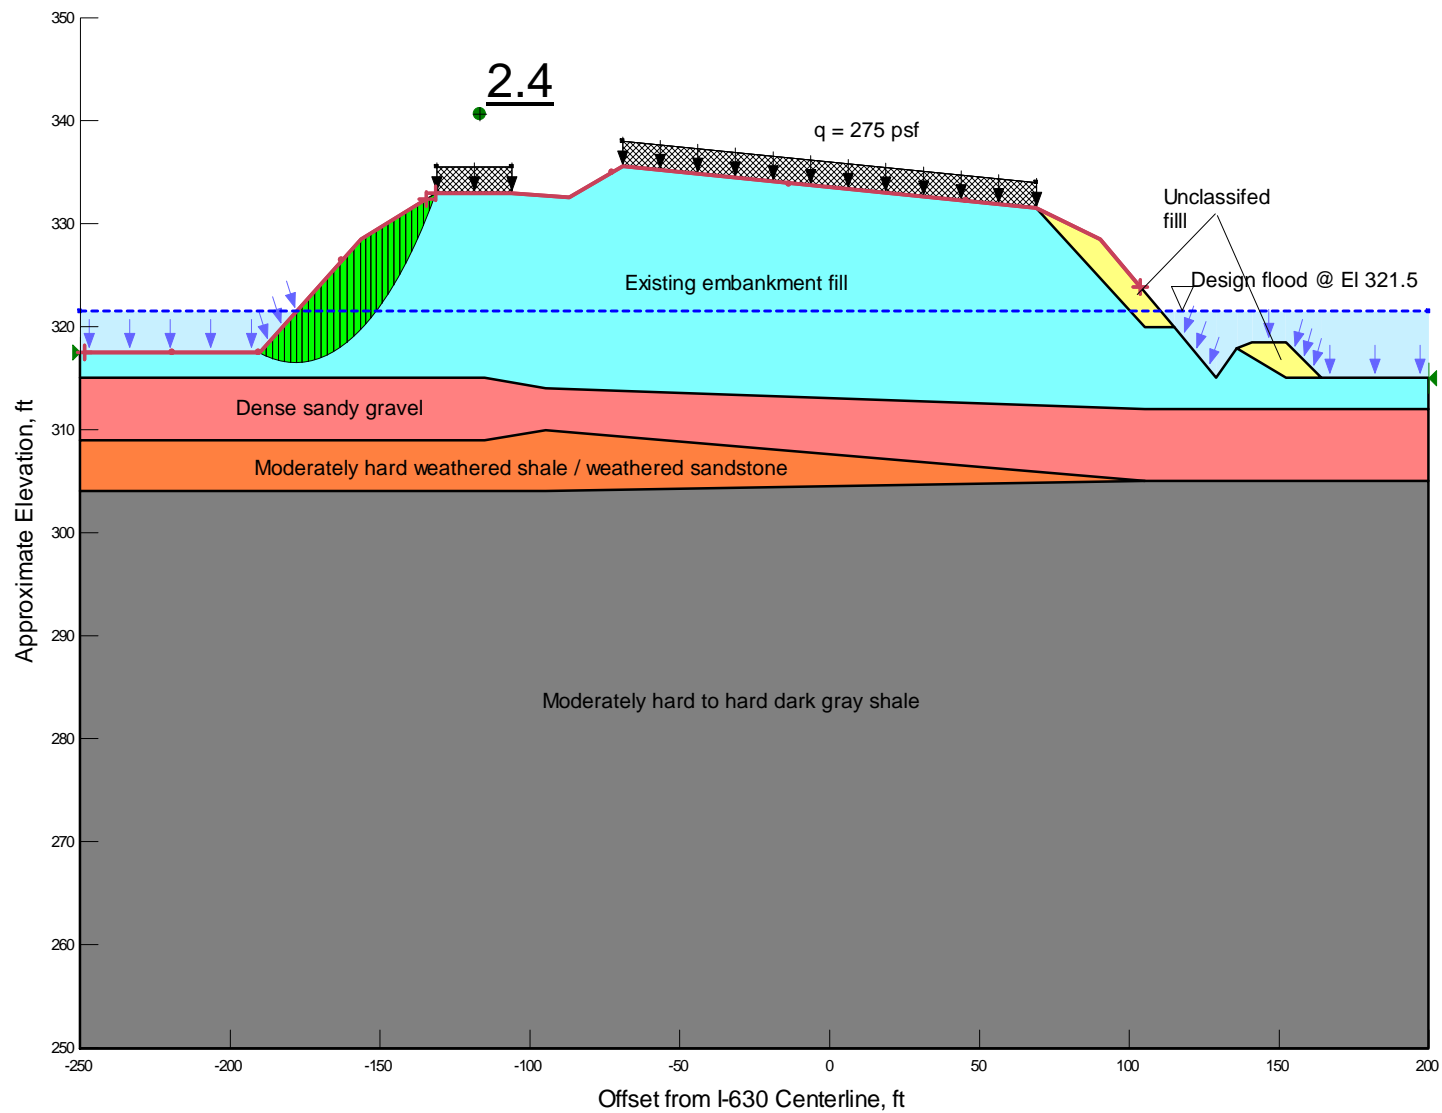
Results of Stability Analyses – Long Term Condition
 Design Flood @ El 321.5
 Side Slope @ East Bridge Abutment – Pedestrian Bridge over Rock Creek

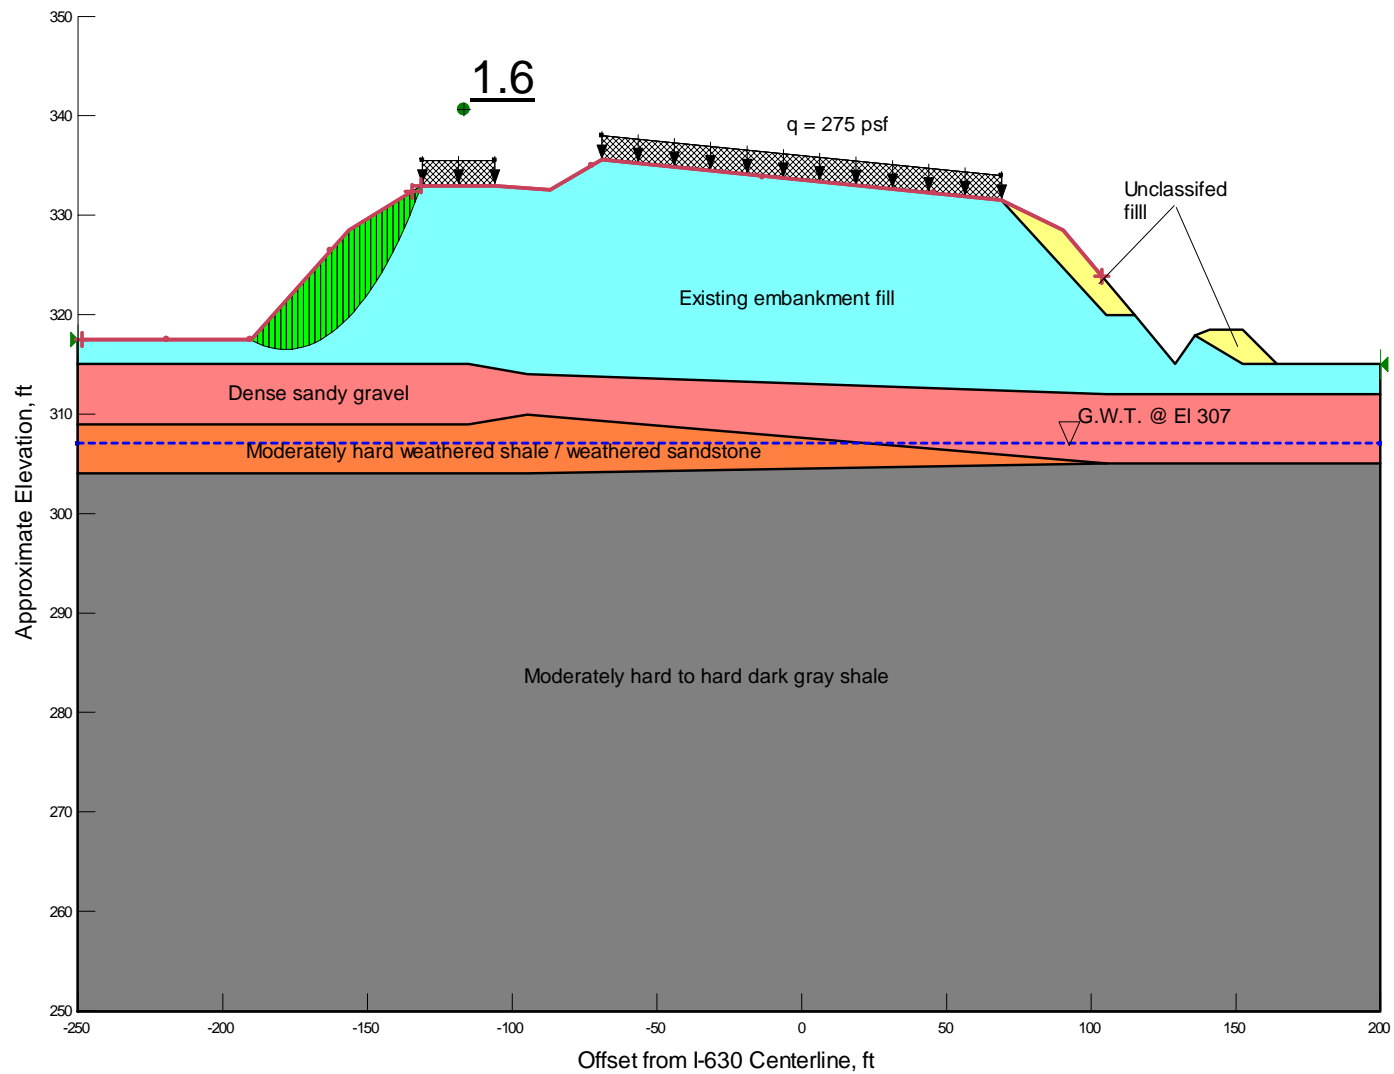
Results of Stability Analyses – Seismic Condition ($k_h = 1.0A_s = 0.13$)
 Groundwater @ El 307±
 Side Slope @ East Bridge Abutment – Pedestrian Bridge over Rock Creek

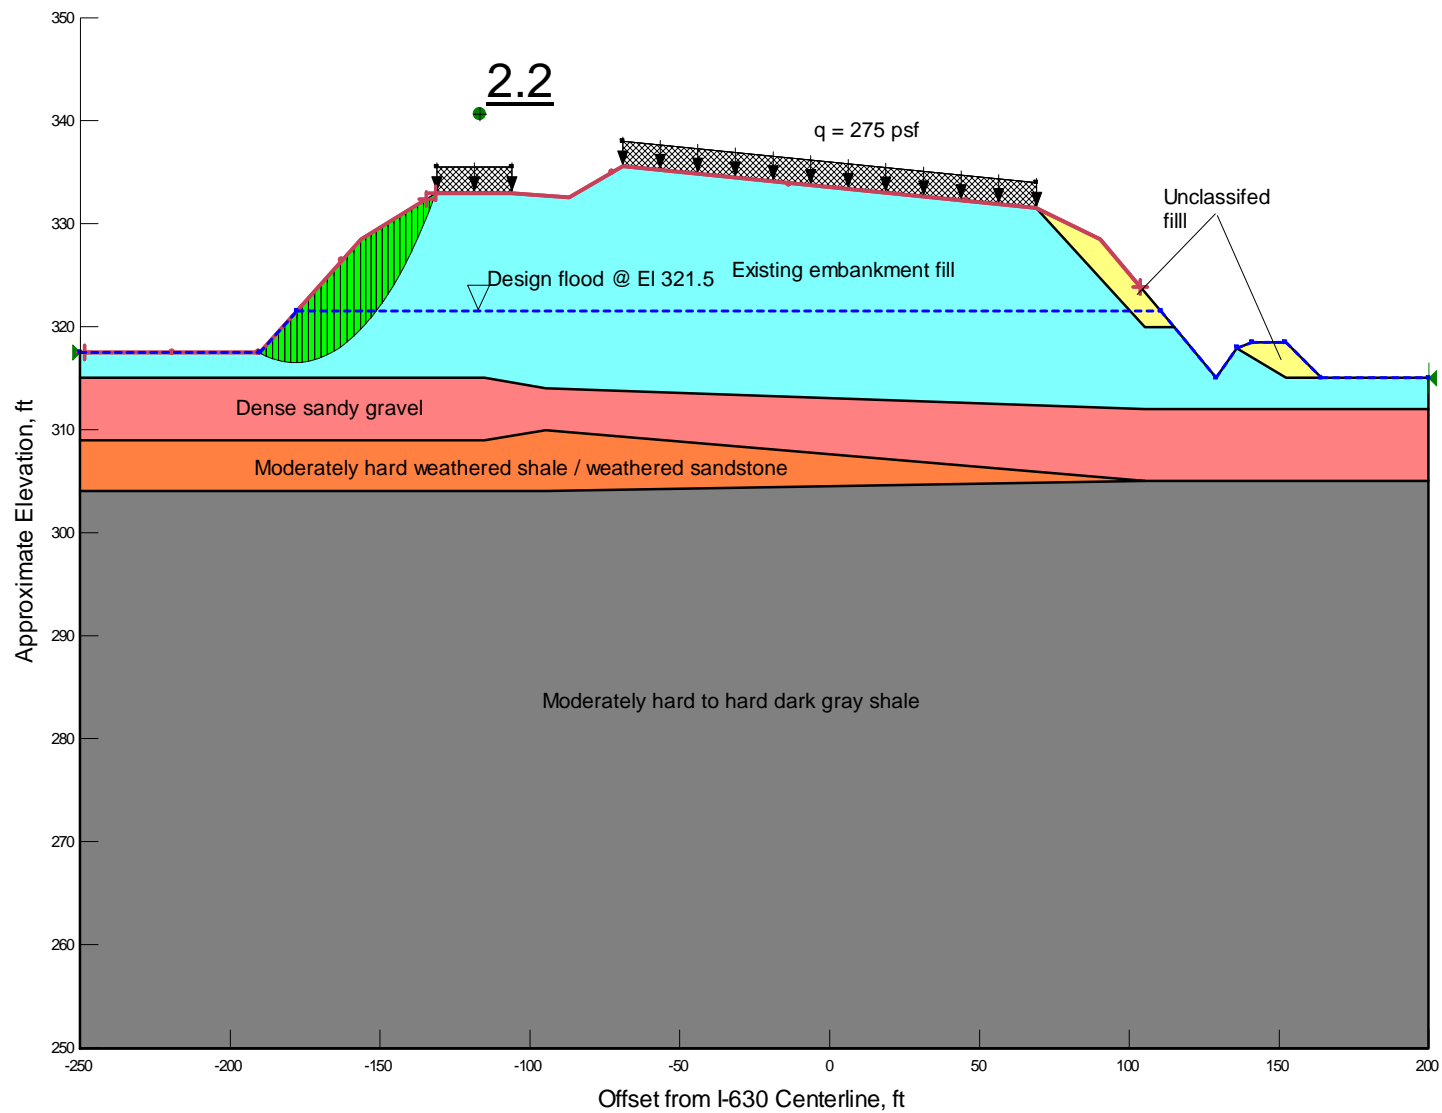
Results of Stability Analyses – Rapid Drawdown Condition
 Drawdown from Design Flood to Embankment Toe
 Side Slope @ East Bridge Abutment – Pedestrian Bridge over Rock Creek
