TRANSPORTATION SUMMIT

ATS: Scour Repair on Fourche Creek

Scour Repair
on Fourche
Creek

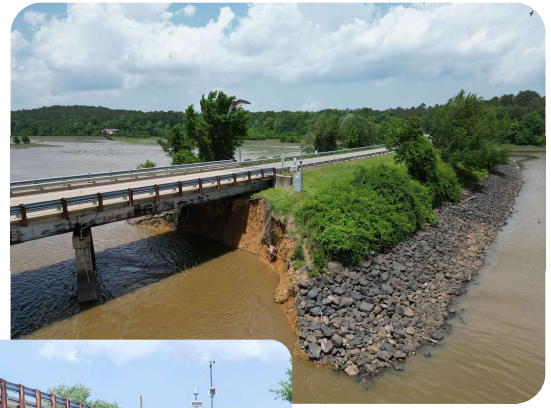
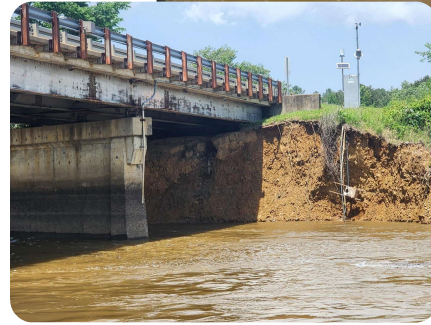
- Scour is erosion around bridge foundations (abutments and piers)
- Biggest cause of bridge failure in the US

When water flows past a bridge, it doesn't just move straight downstream. It swirls around the piers and abutments, and over time it can wash away the sand, gravel, or soil holding the bridge up. That's what we call scour. And it's a big deal — scour is actually the number one cause of bridge failures in the U.S. We've lost more bridges to scour than to earthquakes, hurricanes, or even crashes.

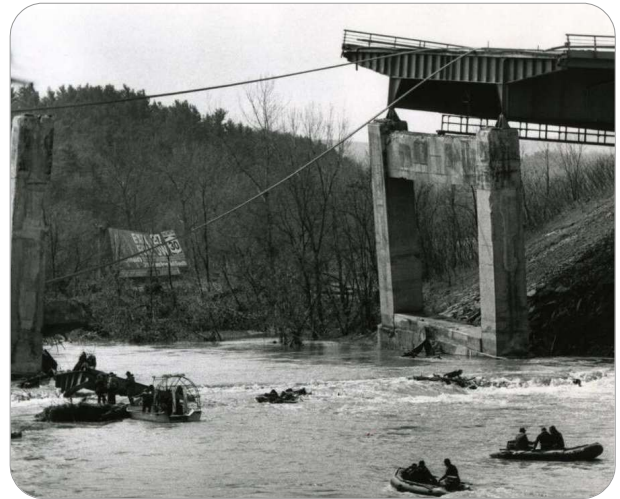
New York State Thruway Authority Bridge (I-90) over Schoharie Creek

- Bridge collapses, killing ten people in April 1987
- NTSB reported the probable cause as “...the failure of the New York State Thruway Authority to maintain adequate riprap around the bridge piers, which led to severe erosion in the soil beneath the spread footings.”

- Significant local pier scour due to angle of attack
- Piers founded on erodible soils
- Inadequate riprap protection, inspection, and maintenance

In April 1987, the Schoharie Creek Bridge on I-90 collapsed during a flood, resulting in the loss of ten lives. Vehicles on the Thruway drove into the section that failed when the bridge gave way.

The National Transportation Safety Board investigated and found that the cause wasn't a design flaw, but a maintenance issue. The protective rock, known as riprap, had been washed away and was never adequately replaced. Without that layer of protection, the fast-moving floodwaters eroded the soil beneath the bridge foundations.

The piers were also founded on erodible soils—layers of gravel, sand, and silt mixed together. These materials don't resist flowing water well. They're loose soils that can be carried away easily by a river.

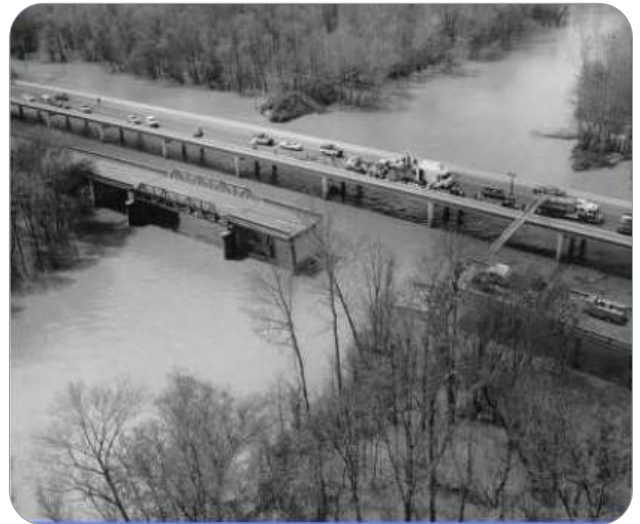
U.S. Route 51 over the Hatchie River

- Bridge collapses in April 1989 resulting in eight fatalities
- NTSB reported the probable cause as *"...the northward migration of the main river channel which the Tennessee Department of Transportation failed to evaluate and correct."*

- Lateral channel migration
- Local pier scour at location designed on the floodplain and not the main channel

The National Transportation Safety Board found that the primary cause was river channel migration. Over time, the main flow of the Hatchie River had shifted northward.

There were also other contributing factors. One pier had originally been placed in what was thought to be the floodplain, not the main channel. But once the river shifted, that pier was exposed to fast, continuous flow. This created local scour, or erosion around the pier foundation, which weakened it until it failed.

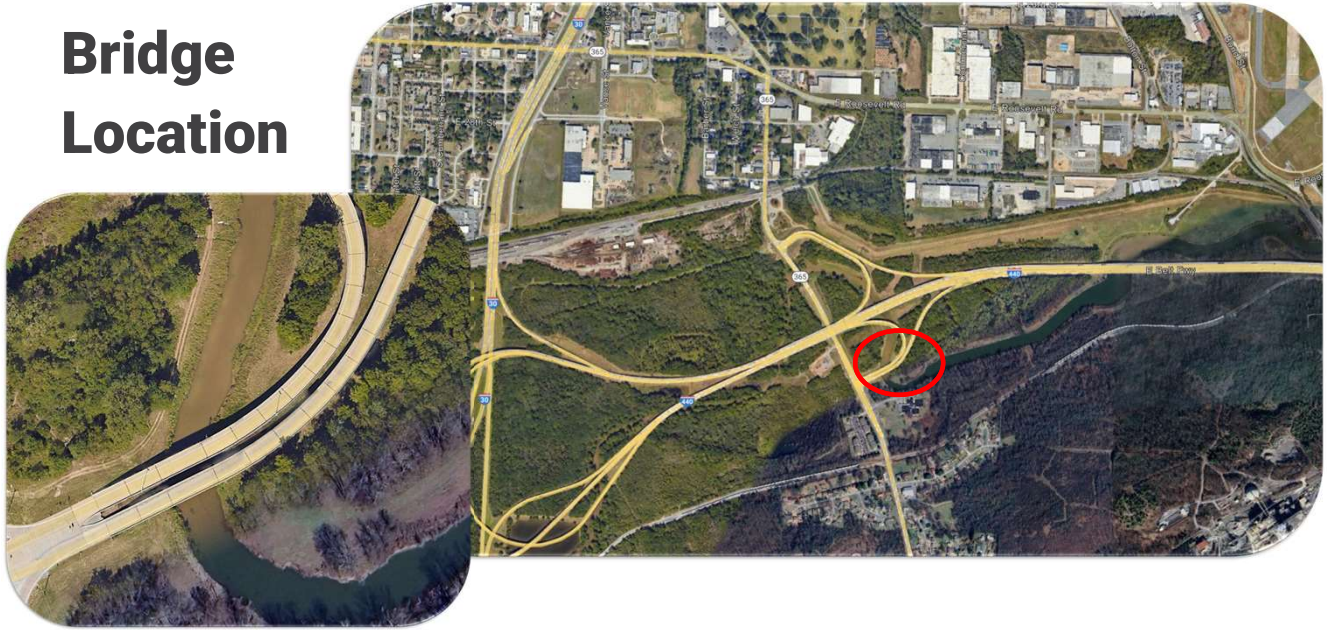
Bridge Location

This bridge at Springer Boulevard, Exit 1 off I-440, may look like a small local crossing, but it actually plays an important role in the highway system around Little Rock.

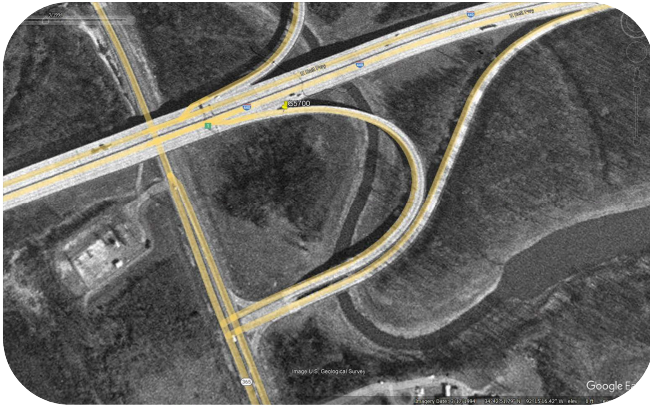
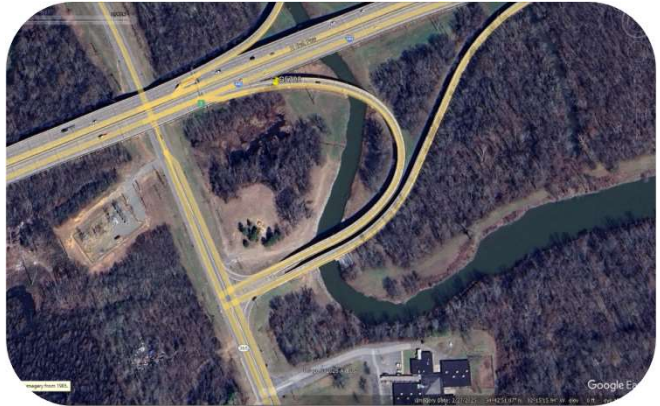
One of the key processes is channel widening. During floods, high-energy flows erode the banks, cutting them back little by little. Over years, that makes the creek wider than it was originally.

Another important process is channel migration. Instead of staying in one spot, the main flow of water gradually shifts sideways across the floodplain. That might mean the deepest part of the channel moves closer to a bridge pier or abutment that wasn't originally in the main current.

When this happens, a pier that was designed to be in calm, shallow water can suddenly find itself in the middle of the river's strongest flow. That sets up conditions for local scour — erosion right around the foundation — which can severely weaken a bridge

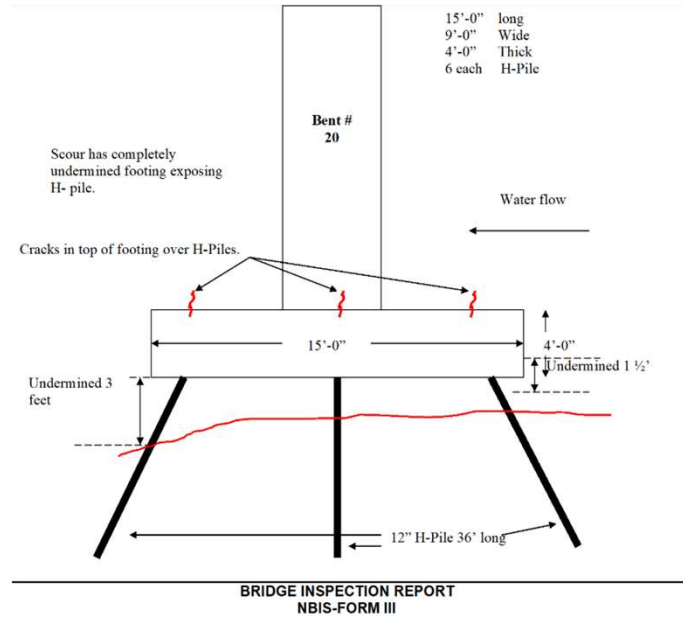
Pre-2021

- Known scour issue
- ARDOT was actively monitoring with Scour Plan of Action
- Only soundings had been taken so far

At that time, the tools available to the district were fairly basic. Inspectors could take soundings using a drop tape or a range pole — essentially measuring depths at specific points in the water.

While these methods do provide useful information, they're limited. Soundings give us only a handful of depth readings, not a full picture of the channel bed or how scour might be developing around the foundations.

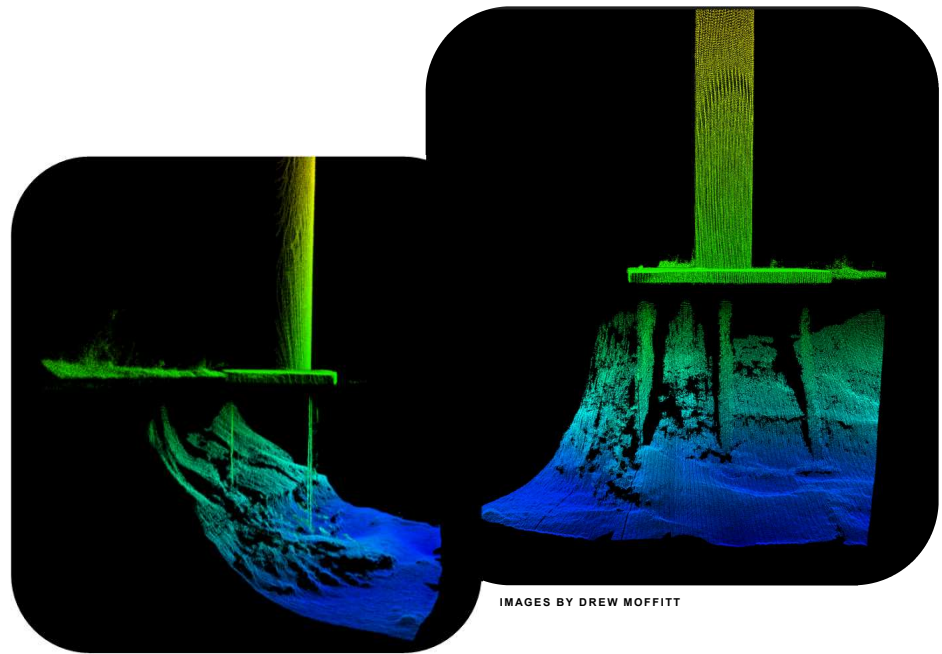
2021

This slide shows sonar images of Bent 20 on Bridge G5700. What you're looking at here is the footing being undermined and piles exposed as a result of scour. These images were generated from our sonar survey data by Drew Moffitt at Garver. The scans revealed piles sticking out of the bed up to about 9 feet. And when we measured the actual loss of supporting soil, it was closer to 20 feet — which is a significant amount of material gone from around the foundation.

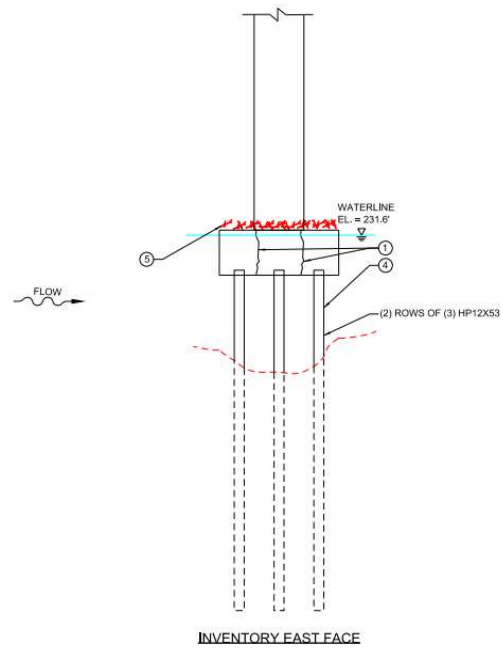
2022

- Confirmed h-pile condition and soundings by consultant divers

They confirmed the condition of the H-piles and also took soundings — depth checks around the foundation.

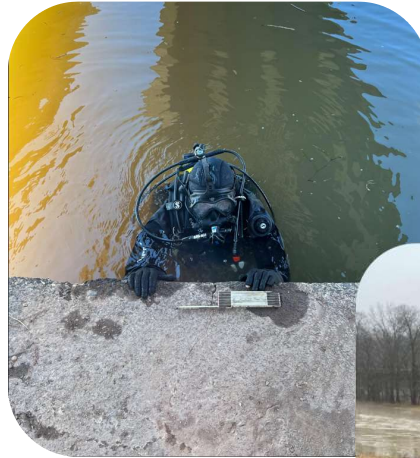
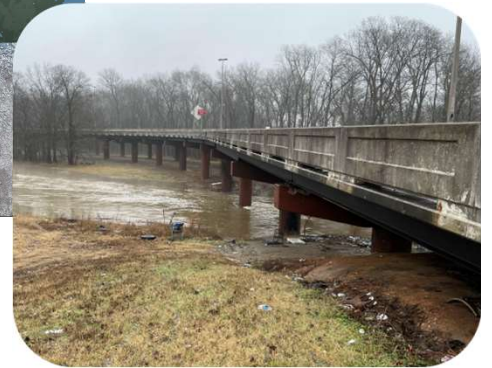
2023

- In November, Nate Brown with ARDOT dove in the cold water to place the probe
- Began live monitoring of the bridge
- In December, a storm came through and washed-out receiver/transmitter box

But just a month later, in December, a storm rolled through the area. The high water and debris were strong enough that they actually washed out the receiver/transmitter box.

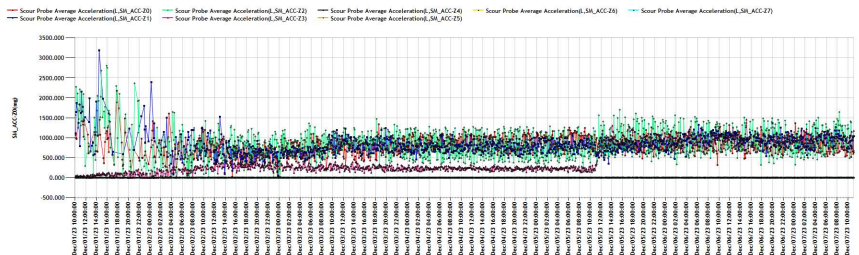
Wireless Scour Probe SenSpot™

The Resensys scour probe uses a series of sensors placed vertically in the ground near a bridge foundation. Each sensor is part of a rod that's driven into the soil.

The way it works is interesting: the probe applies small vibrations along the rod. If a section of the rod is buried in soil, the vibrations are dampened. If that section becomes exposed to water because scour has removed the soil, the vibration response changes.

By checking each sensor along the length of the rod, the system can tell us exactly how much of the foundation material has been lost — essentially mapping the depth of scour as it develops.

The data are transmitted wirelessly in real time, so engineers can monitor scour levels during a flood without having to be out on-site.
10am on 12/5 sensors became free

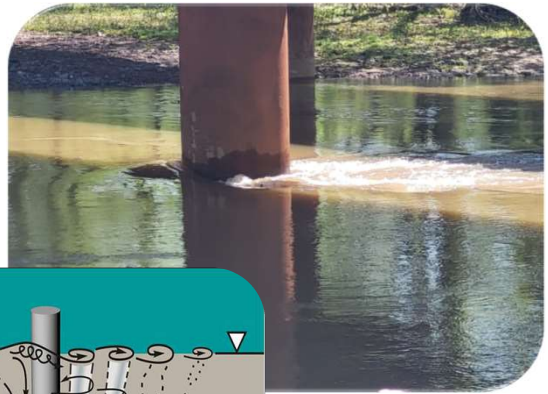
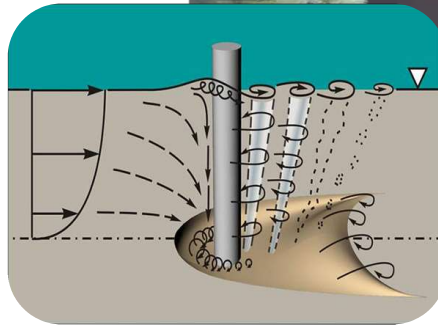
Pier Scour

- Flow vortices (horseshoe vortex) cause scour holes
- Function of depth, velocity, pier parameters, angle of flow

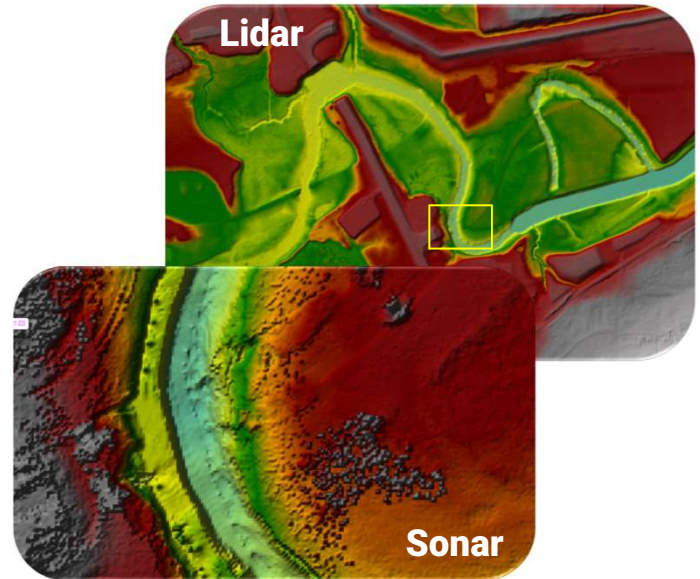
Hydraulic Model

- Topographic data limited
 - lidar + some bathymetry (sonar)
- To verify flow patterns and parameters for scour, ran a high-level 2D HEC-RAS model

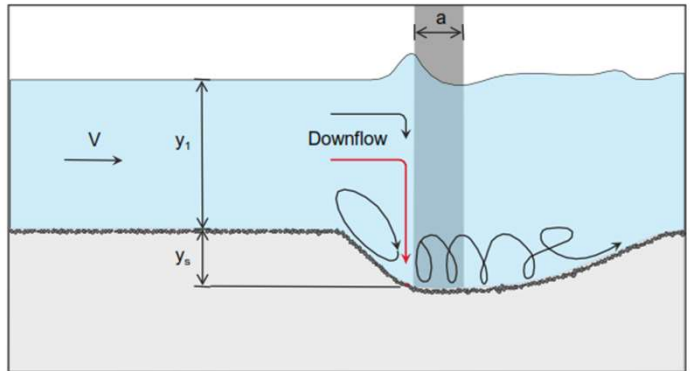
Figure 7.2. Definition sketch for pier scour.

- FHWA HEC-18 Guidance
- Used model results for input
- Ran multiple storm events – 10-year was worst case for velocities at pier (11.6 ft/s)
- Calculated 19.8 ft. of scour potential at pier from current ground line

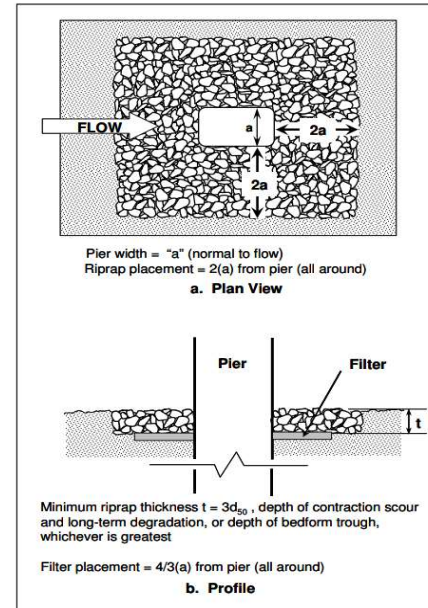
Countermeasures

- Traditional countermeasure design in FHWA HEC-23
- Model results were input into calculations
- Riprap design not feasible to construct, would cause rise in floodway

Riprap thickness =	7.7 ft	Calculated D_{50} =	2.6 ft
Riprap thickness (placed underwater) =	11.6 ft	Calculated D_{50} =	30.9 in.
Riprap extent on all sides of pier =	18.0 ft	Size =	30.0 in.
Filter extent on all sides of pier =	12.0 ft

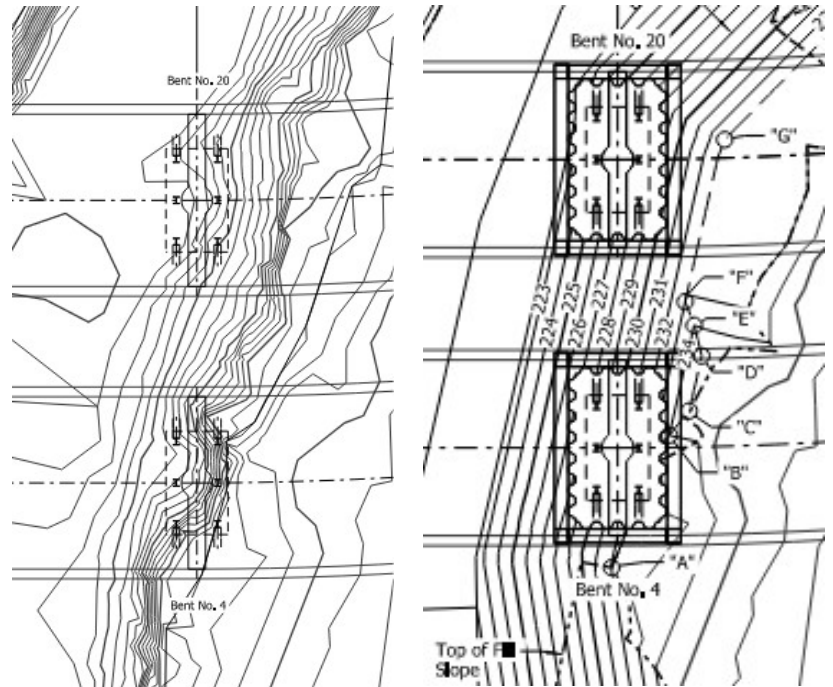
Grading

- Existing ground significantly lower than original
- Not practical to return to original condition
- Reasonable bed slope selected

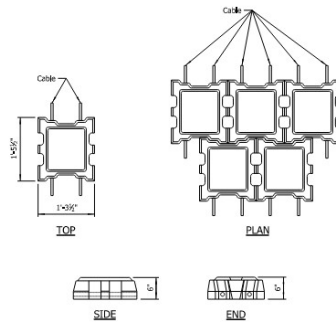
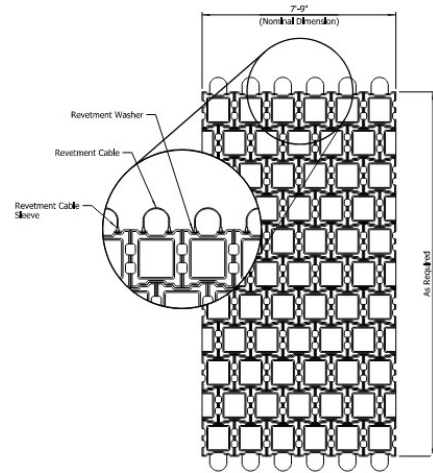
Articulating Concrete Block Mat

Wire rope vs. none

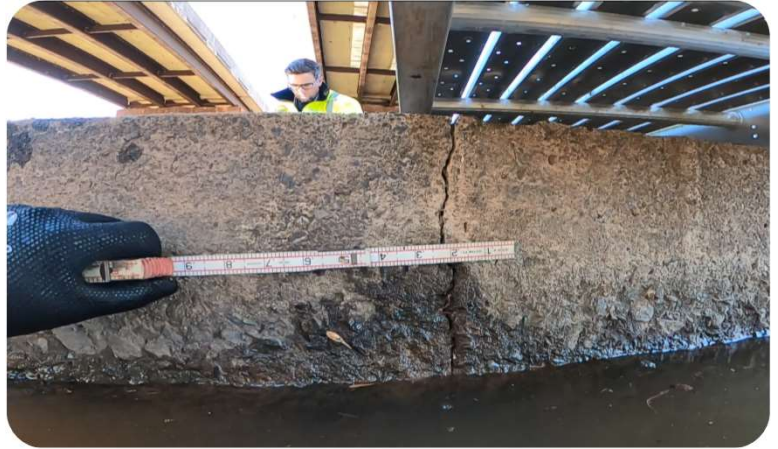
Structural Repairs

- Repair cracks in concrete footing
 - Epoxy injection
- Reduce unbraced length of piles
 - Pile capacity considerations
 - Geotechnical exploration by ARDOT

Capacities
As constructed 170 kips
Current Condition 125 kips

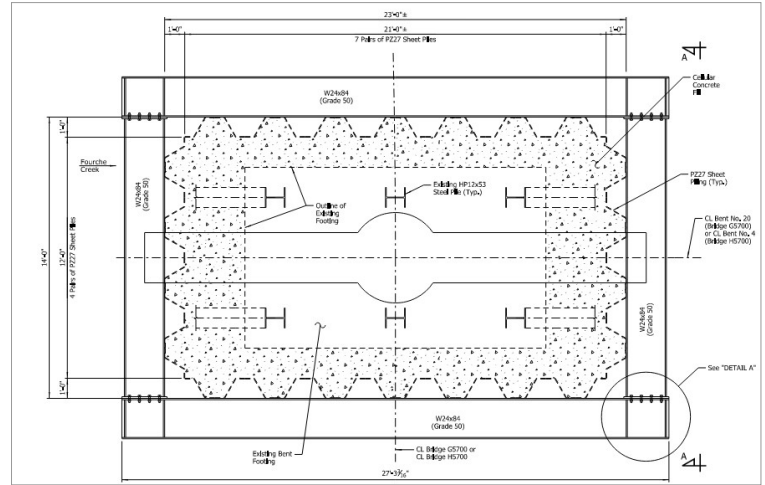
Permanent Cofferdam

- Cellular concrete
- Sheet piling with whalers

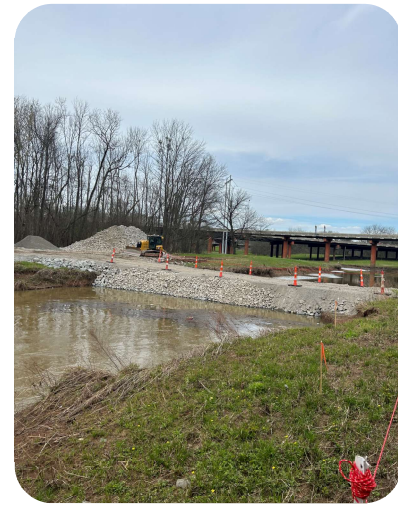
Method of Construction

- Temporary haul road
 - Allowed due to emergency nature of project and rapid timeline
- Cofferdam installed under flow conditions
