**Bridge #23132(Routine)**  
**Clinton Rd over Panther Creek**  
**Location: 0.75 MI SO SH 286**

**Team Lead: William Wood Inspection Date: August 18, 2020**

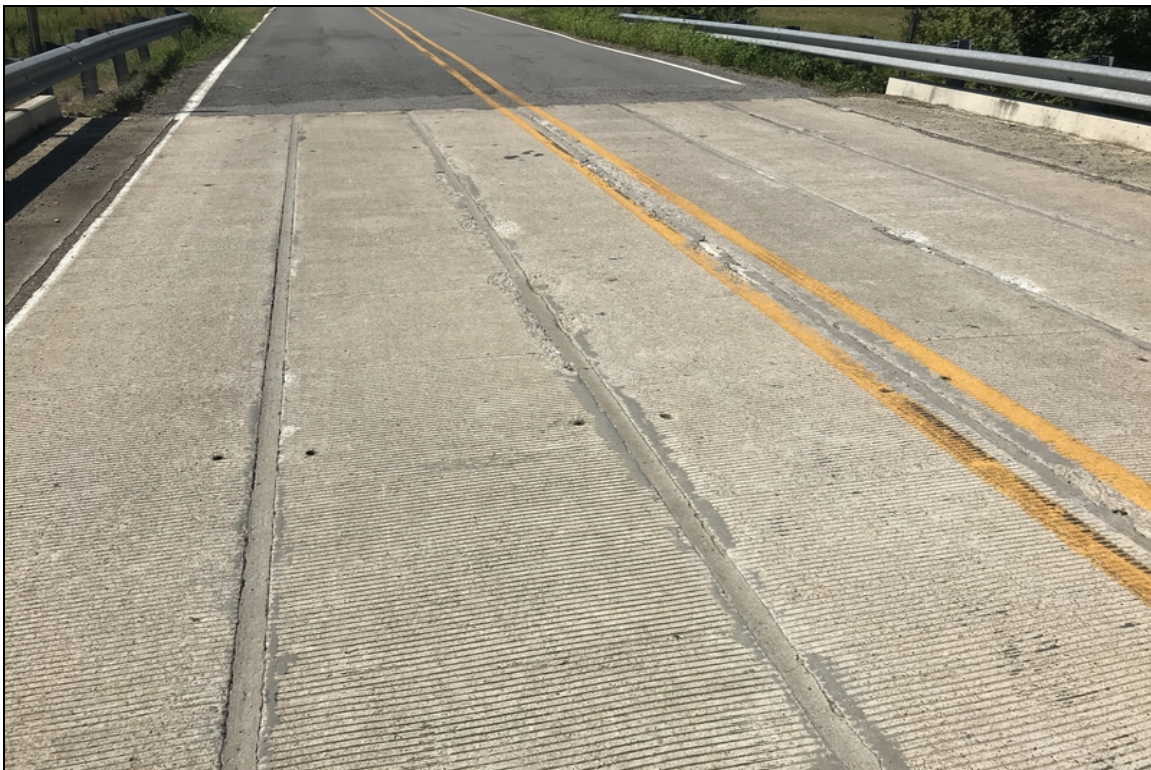
Typical deck.

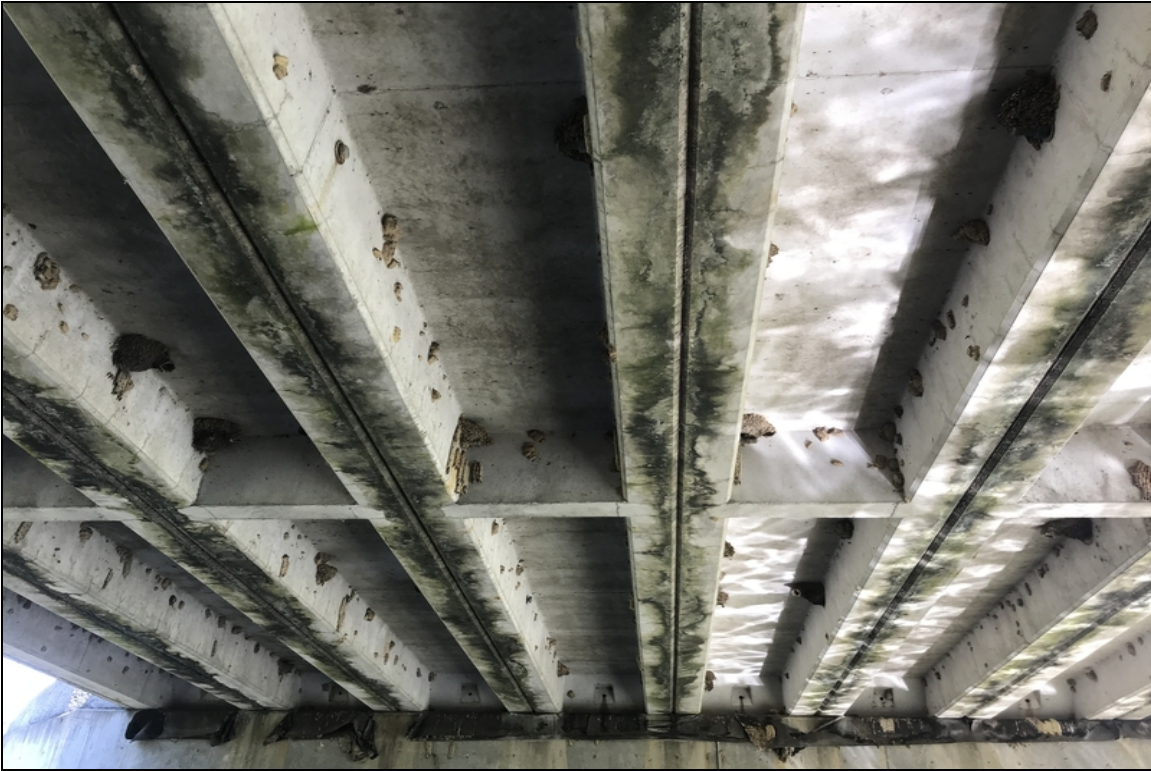
Typical undersurface.

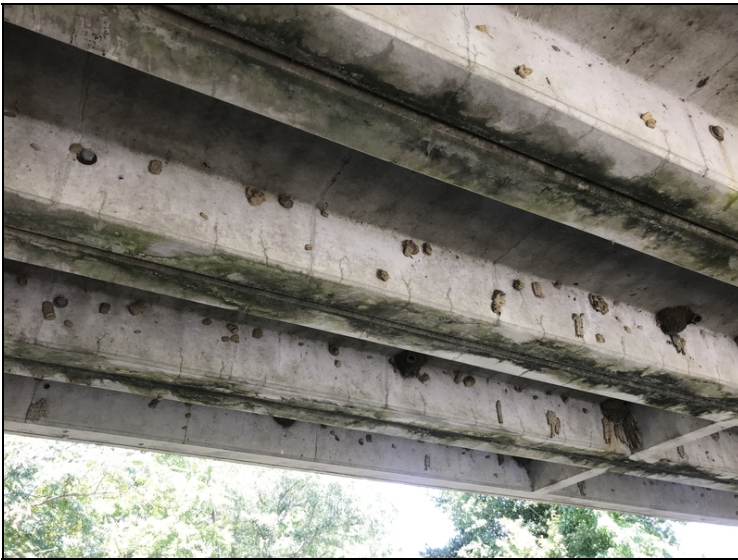
BEAMS - MINOR TO MODERATE VERTICAL CRACKING W / EFFLOR. IN LEGS OF BEAMS.

Typical cracking in legs of beams.

8 BEAM R/C CHANNEL BEAM - MINOR TO MODERATE VERTICAL CRACKING W / EFFLOR. IN LEGS OF BEAMS.  
BEAMS ARE TRANS BOLTED.

**Date Reported:** 08/19/2020  
**Priority:** D- Routine  
**Type of Work:** Repair  
**Status:** Open  
**Component:** Superstructure

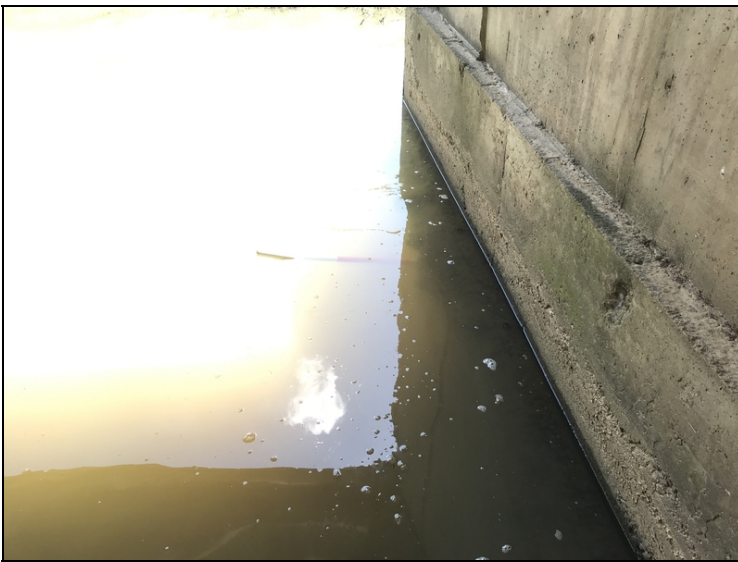
CHANNEL - MINOR TO MODERATE SCOUR AT ABUTMENTS 1 & 2.  
SCOUR APPROX. 6" BELOW & 1' UNDER ABUTMENT 1 RT. SIDE & ABUTMENT 2 LT. SIDE.

Typical scour at abutments.

ABUTMENTS - GOOD. MINOR SCOUR AT ABUTMENTS.

**Date Reported:** 08/19/2020  
**Priority:** C - Important  
**Type of Work:** Repair  
**Status:** Open  
**Component:** Channel

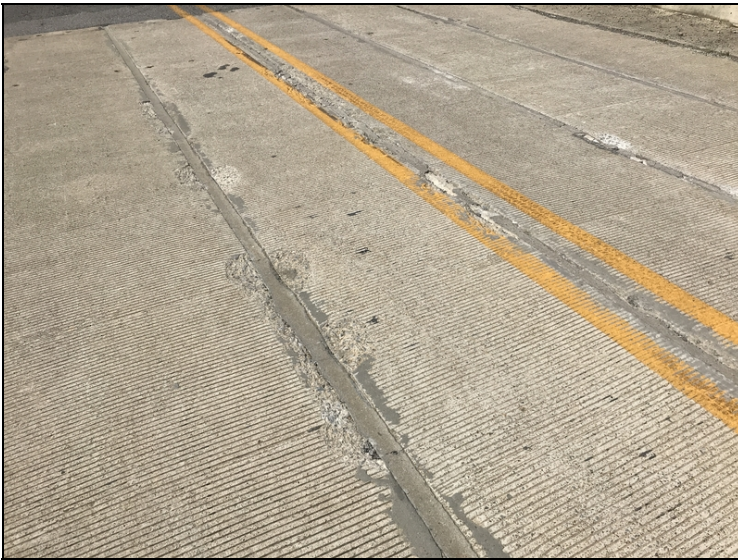
DECK - MINOR CRACKING & SPALLING IN & AROUND JOINTS ON BEAMS 3, 4, 5 & 6.

Typical spalling at beam joints.

MINOR CRACKING & SPALLING IN & AROUND JOINTS ON BEAMS 3, 4, 5 & 6.

**Date Reported:** 08/19/2020  
**Priority:** D- Routine  
**Type of Work:** Repair  
**Status:** Open  
**Component:** Deck

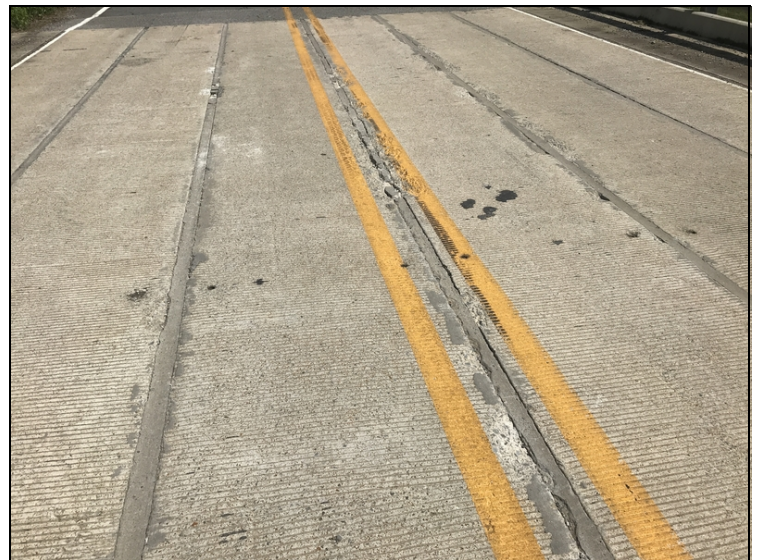
Typical grout missing at beam 3 - 5 joints.
