Bridge #21771 (Routine)  
CR70/Independ. Co. over CARTER CREEK

Location: .25 M W SH 122

Team Lead: Nathan Edwards Inspection Date: February 24, 2021

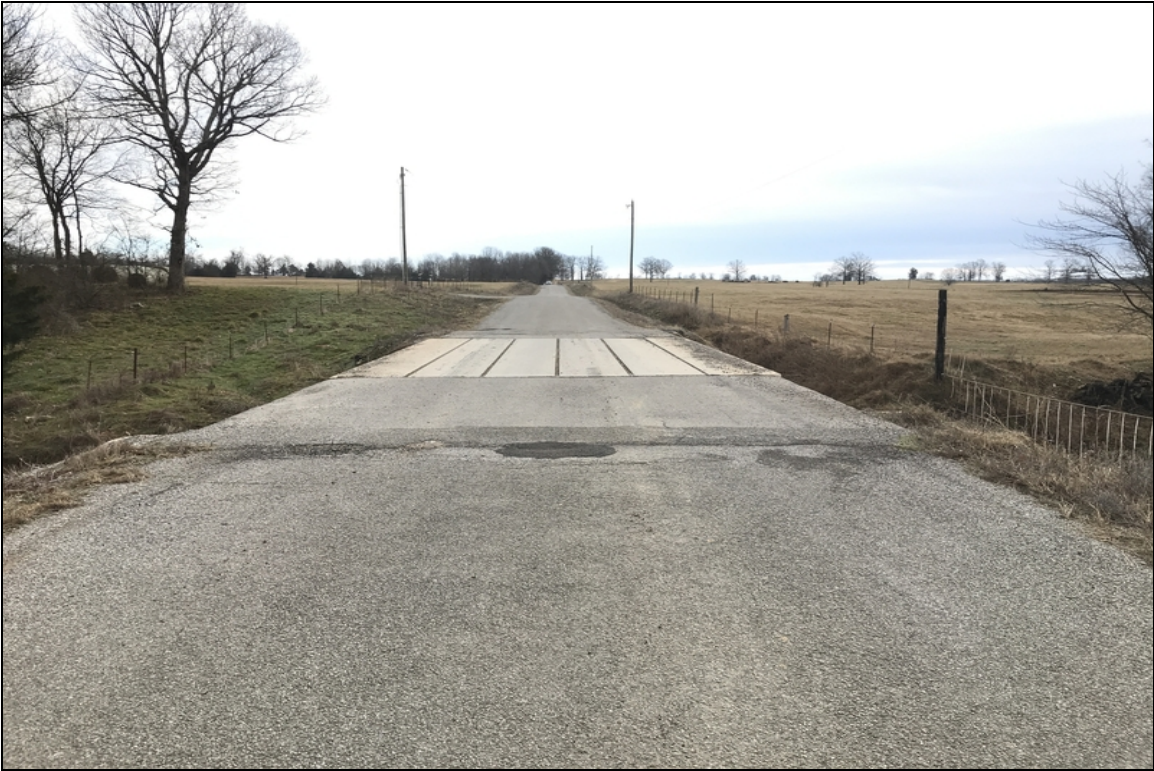
Roadway with Log Mile running West to East.

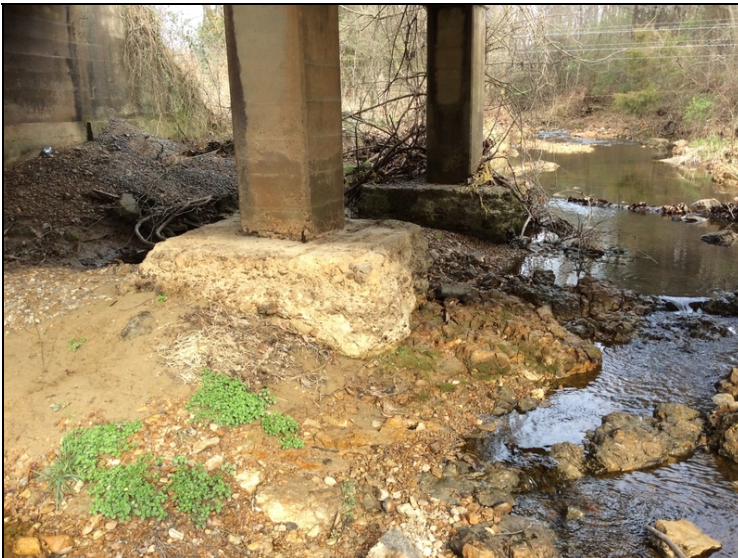
Columns and footings at Bent 1.  
Spalling & scaling to bottom.

Spalling & scaling to bottom of Columns & footings  
@ Bent 1.

Spalls /abrasion at bottom of Columns 1 & 2 at Bent 1.

Moderate scaling and spalls to footings at Bent 1.

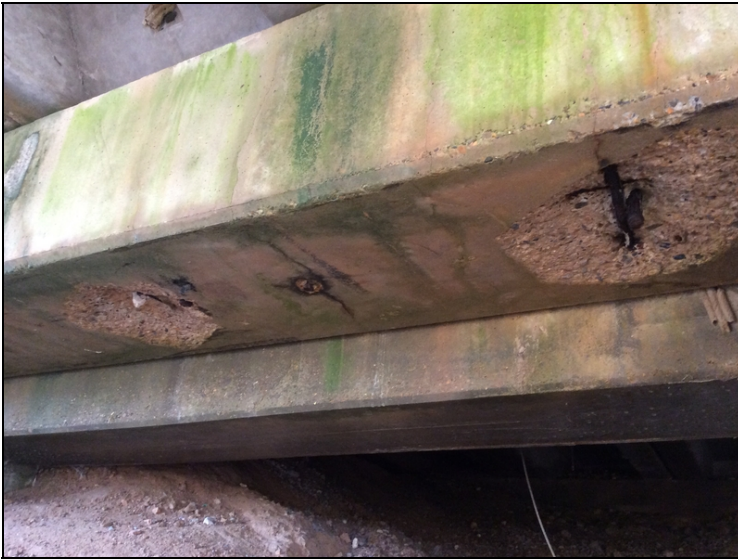
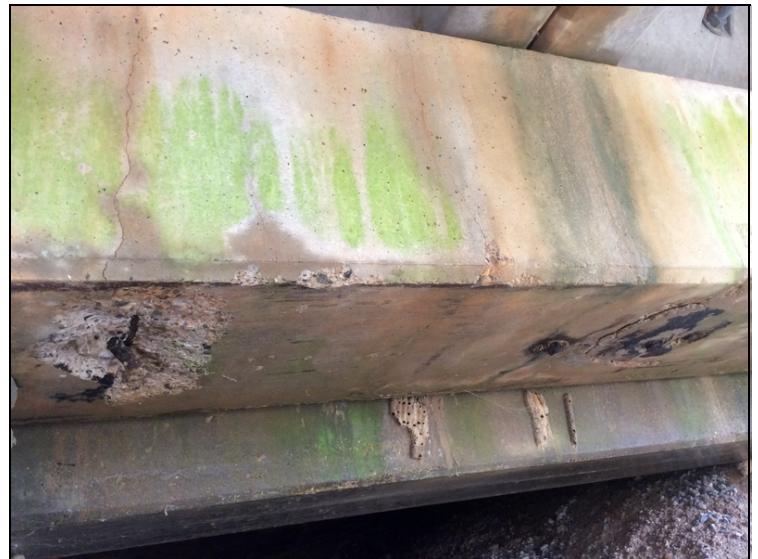
Cap @ Bent 2  
Cracks / spalls with rebar exposed.

Cracks / spalls with rebar exposed to cap @ Bent 2.

Spalls with 3' of rebar exposed to bottom of Cap at Bent 2.

Several vertical cracks to Cap at Bent 2.

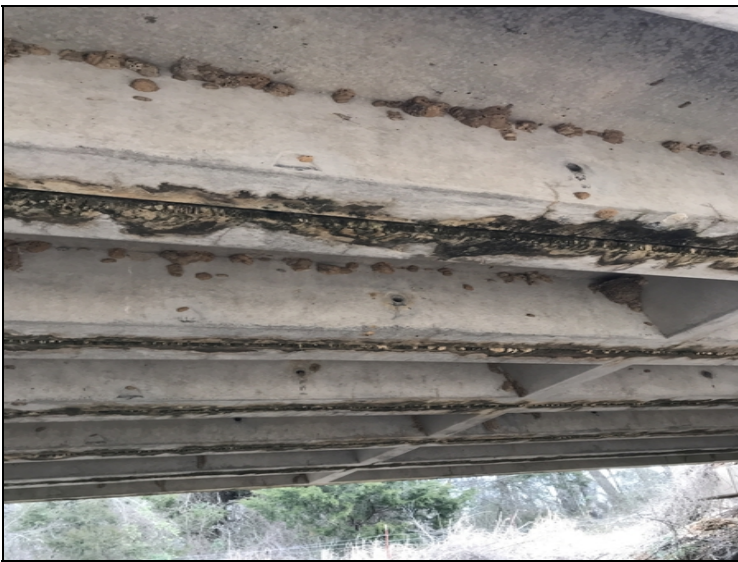
Random transverse bolts missing at Spans 1, 2, & 3.

Random transverse bolts missing at Spans 1, 2 &  
3.

Span 1 - Units 2-3, 4-5 has 1 transverse bolt missing.

Span 2 - All units have 1 transverse bolt missing.

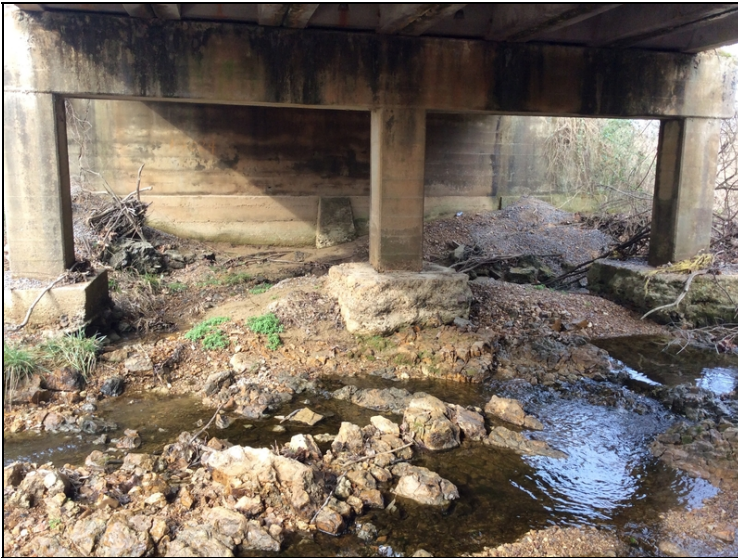
Channel  
Scour 1.5' to 2' below top of footings at Bent 1 exposing bottom of footings.  
Scour and undermining at footing at Columns 2 & 3 @ Bent 2.

Scour 1.5' to 2' below top of footings at Bent 1.

**Date Reported:** 02/07/2011  
**Priority:** A - Safety deficiency; requires prompt action  
**Type of Work:** Repair  
**Status:** Monitor  
**Component:** Substructure

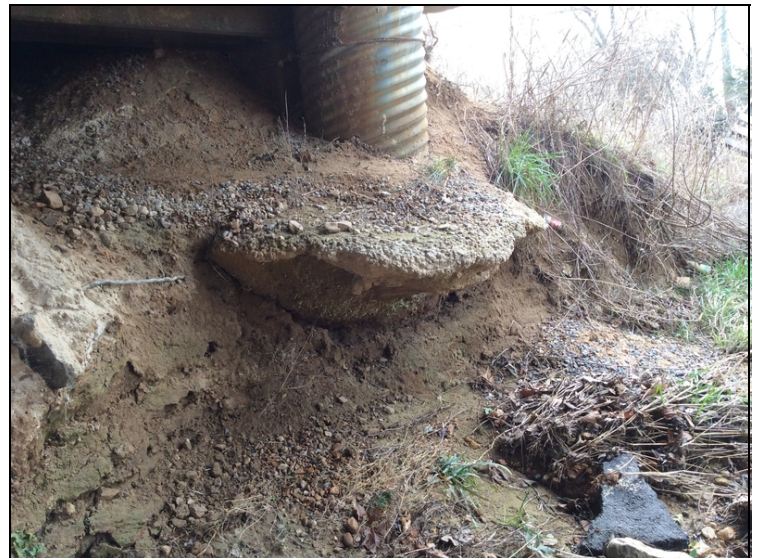
Scour and undermining at footings at Column 3 @ Bent 2.

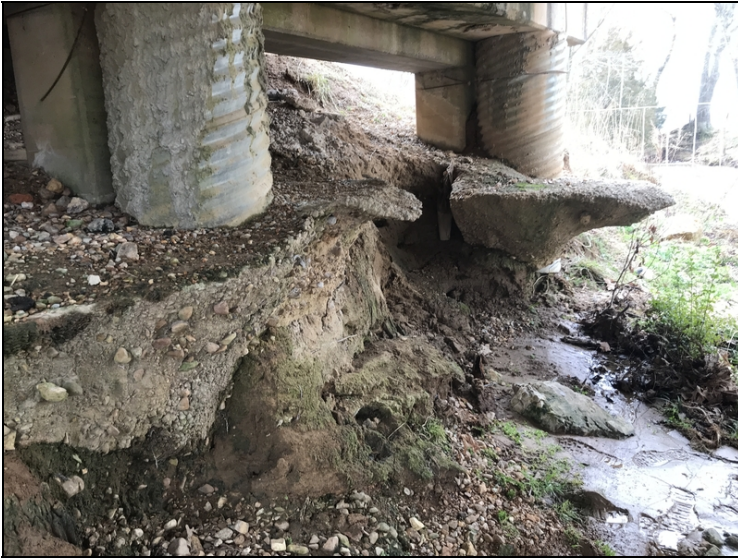
Scour at Columns 2 & 3 footing at Bent 2. Footing is undermined.
