West Fork White River Restoration at Brentwood Mountain Summary Report
Arkansas Department of Agriculture – Natural Resources Division Project 17-0900

Watershed Conservation Resource Center

July 11, 2022

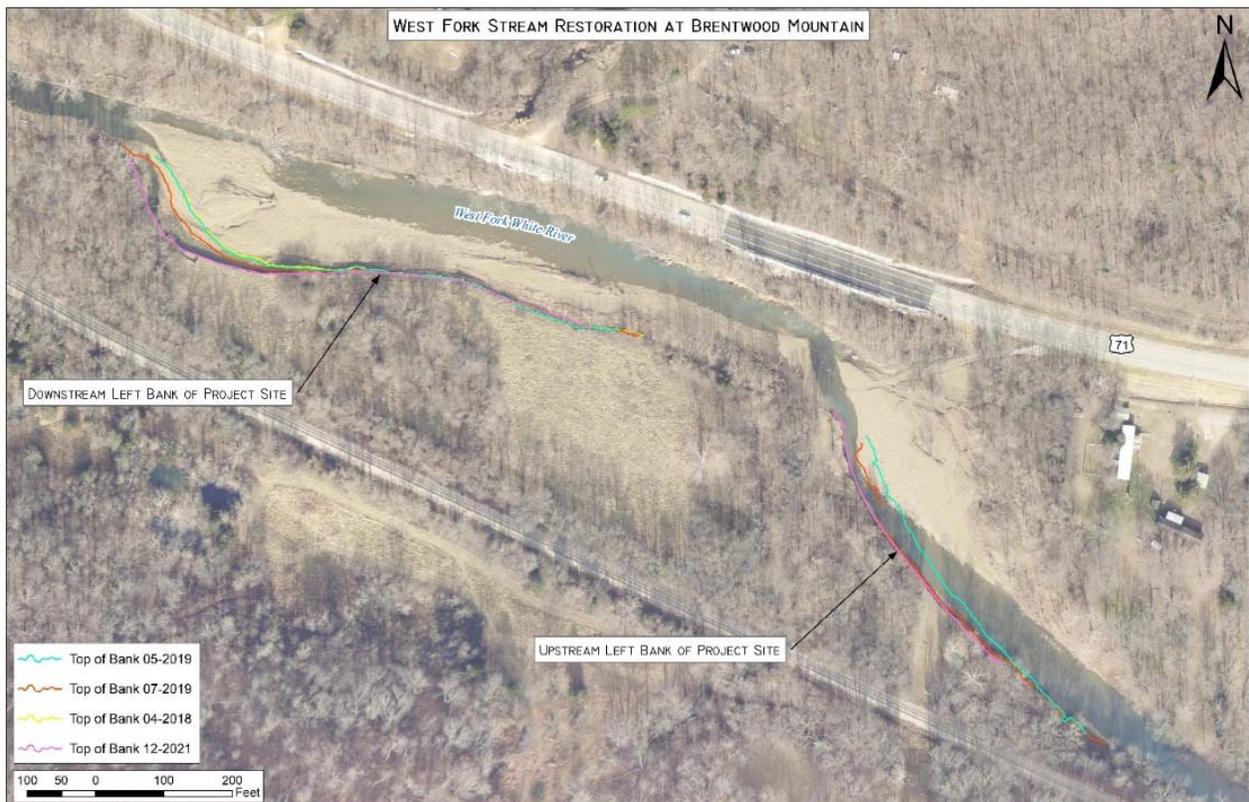
Figure 1. Brentwood Mountain site undergoing erosion and channel instability prior to restoration

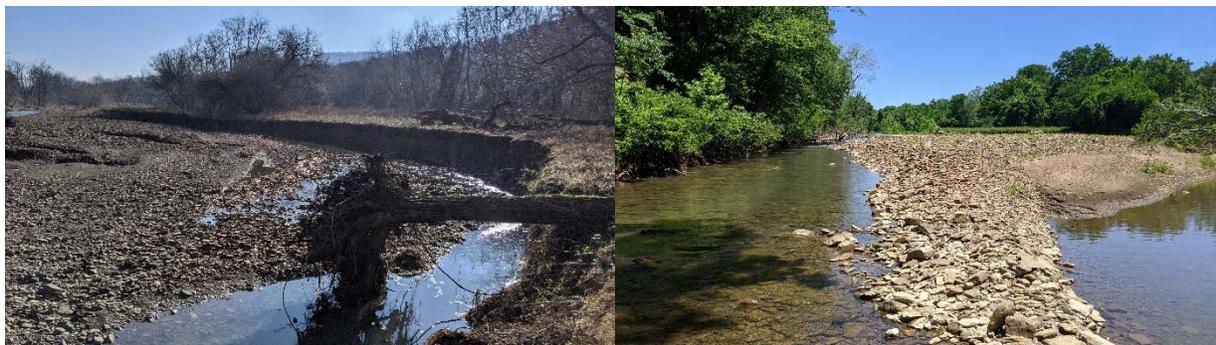
By the time of project implementation, an additional maximum of 32 feet of lateral streambank recession had occurred at the downstream bank compared to the post flood survey. Lateral channel expansion, water quality impairment, and habitat loss would have continued to occur at this location without intervention. (Figure 4).

Figure 4. Site instability, the left image shows the over-widened channel left bank downstream with a tree that recently fell from bank instability and the right image shows the aggrading mid channel point bar

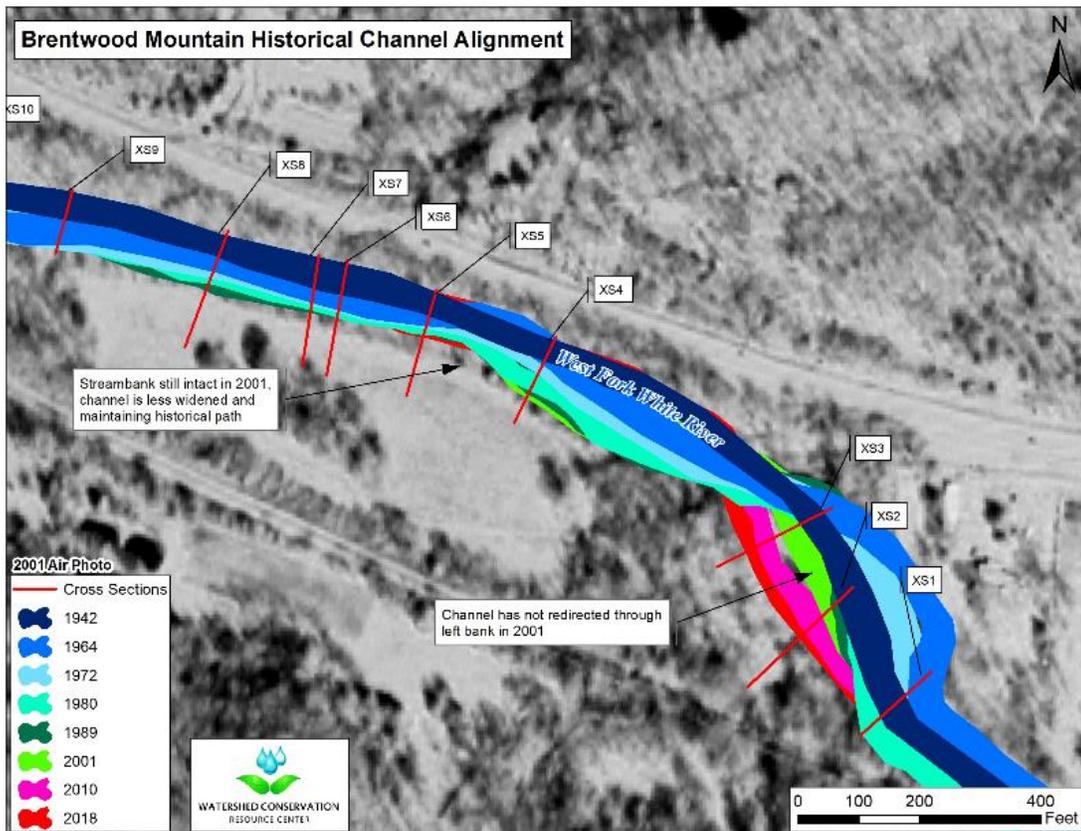
Figure 1. 2001 Air Photo Analysis, channel migration over time

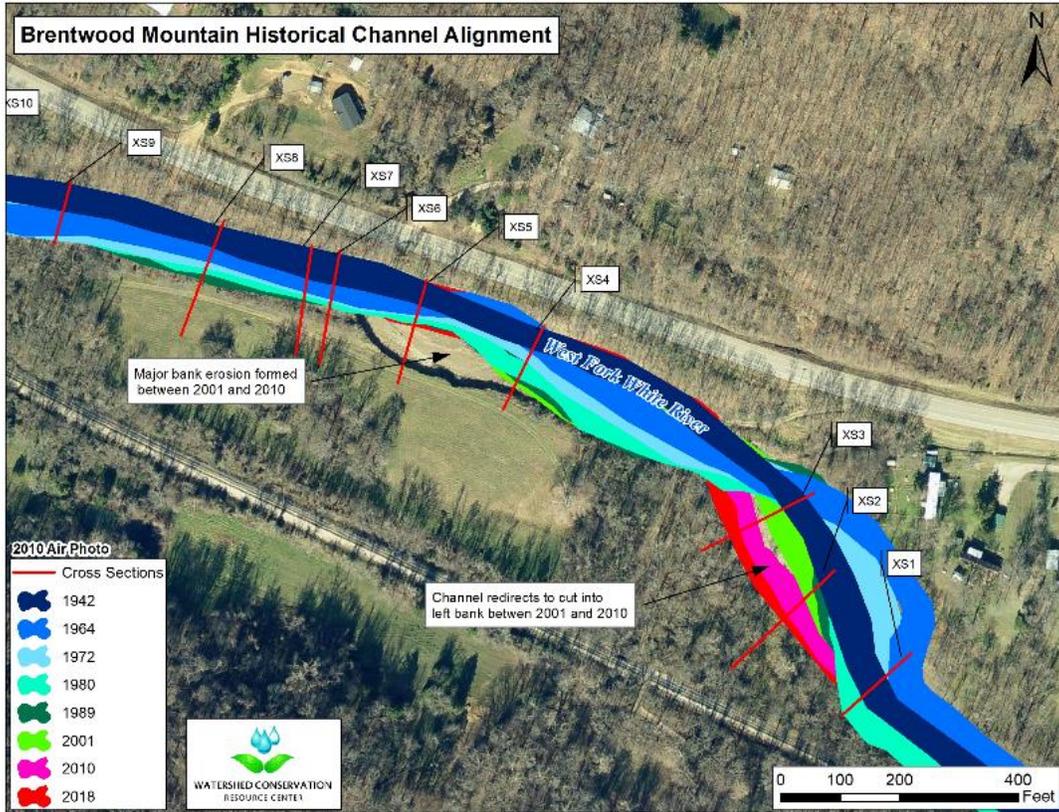
Figure 2. 2010 Air Photo Analysis, channel migration over time

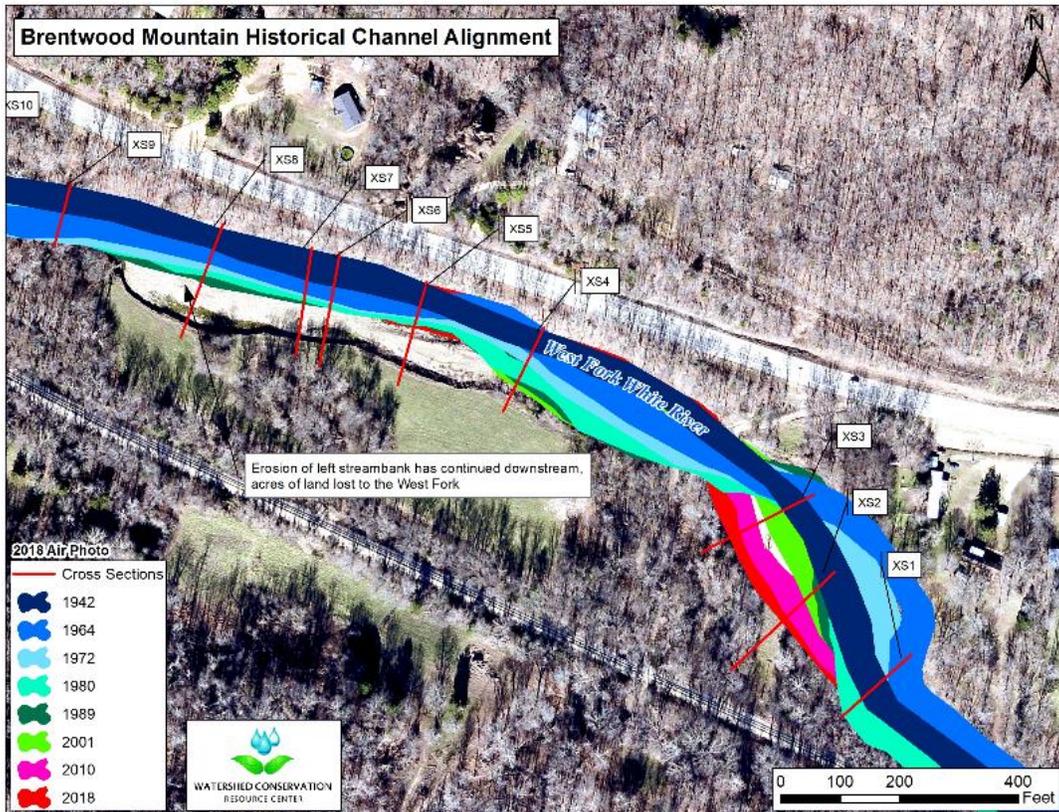
Figure 3. 2018 Air Photo Analysis, channel migration over time

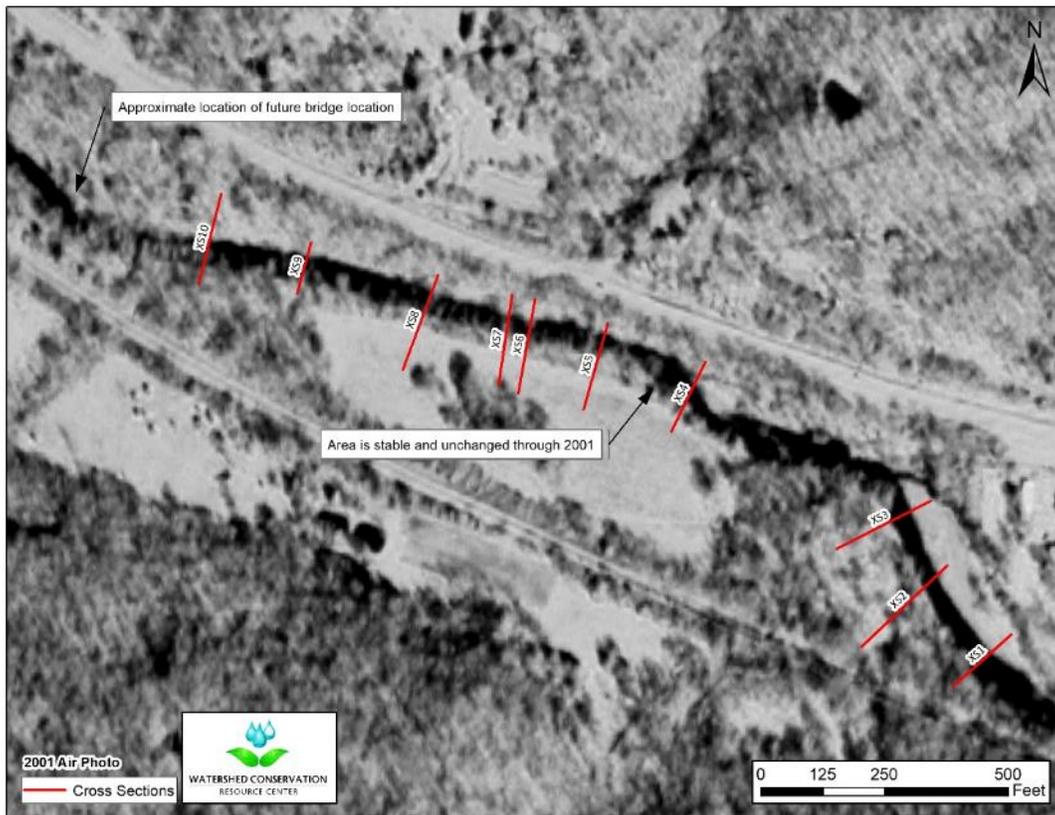
Figure 5. Aerial Imagery from 2001, left bank erosion between XS4 and XS5 is relatively stable and appears similar in shape to 1964 and 2004

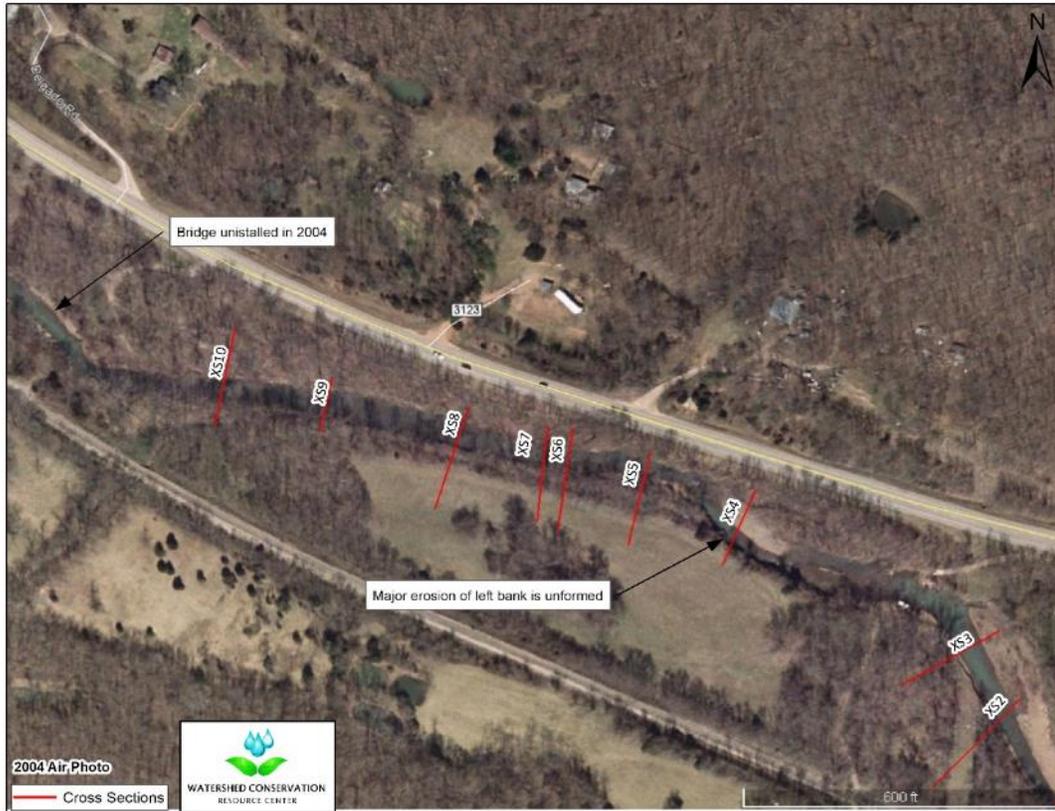
Figure 6. Aerial Imagery from 2004, the bridge downstream has yet to be installed, while the bank on XS4 is eroding, but at a more stable rate and the historical shape of the channel is as it was in years previous.

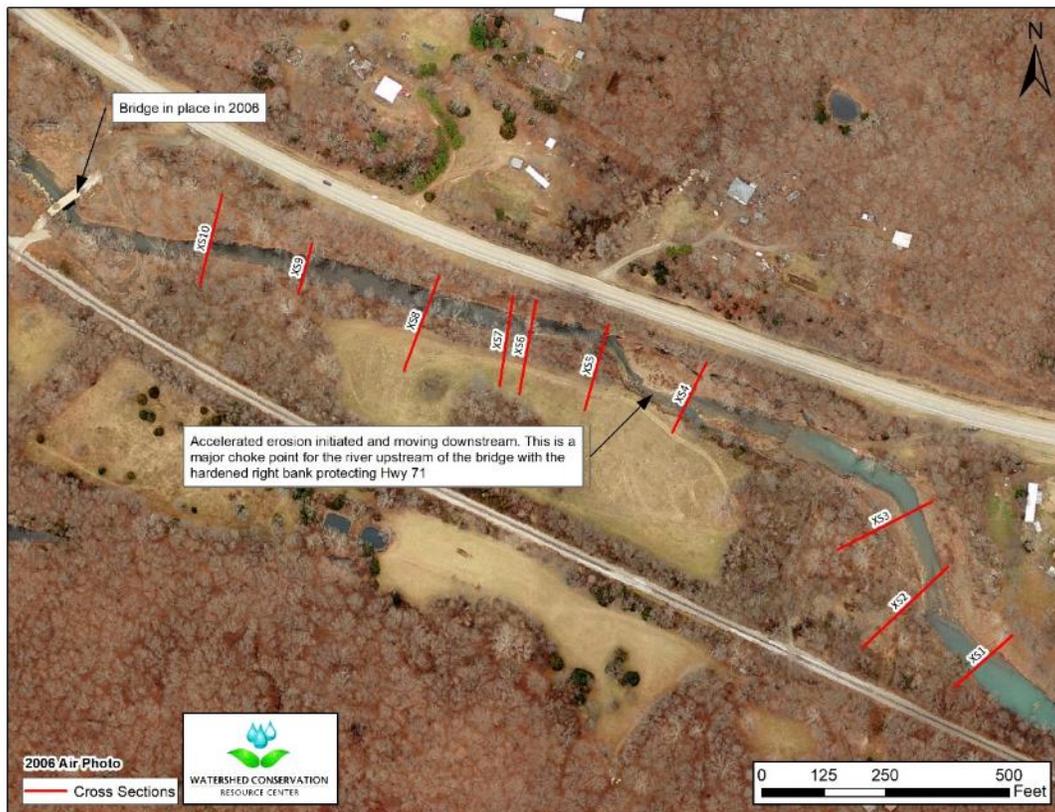
Figure 7. Aerial Imagery from 2006, the bridge downstream is installed, and left bank erosion has initiated downstream, as the erosion area between XS4 - XS5 begins to move downstream

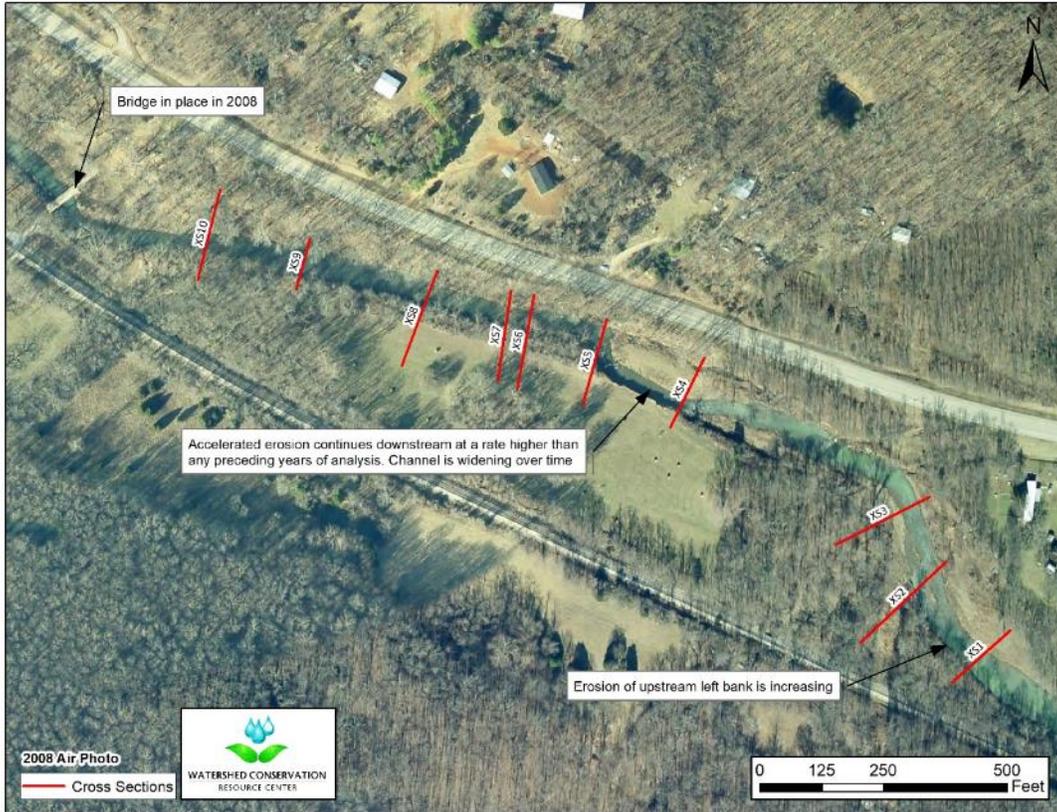
Figure 8. Aerial Imagery from 2008, the bridge downstream is still in place as the channel is eroding, widening, and rapidly changing form to adapt to bridge.

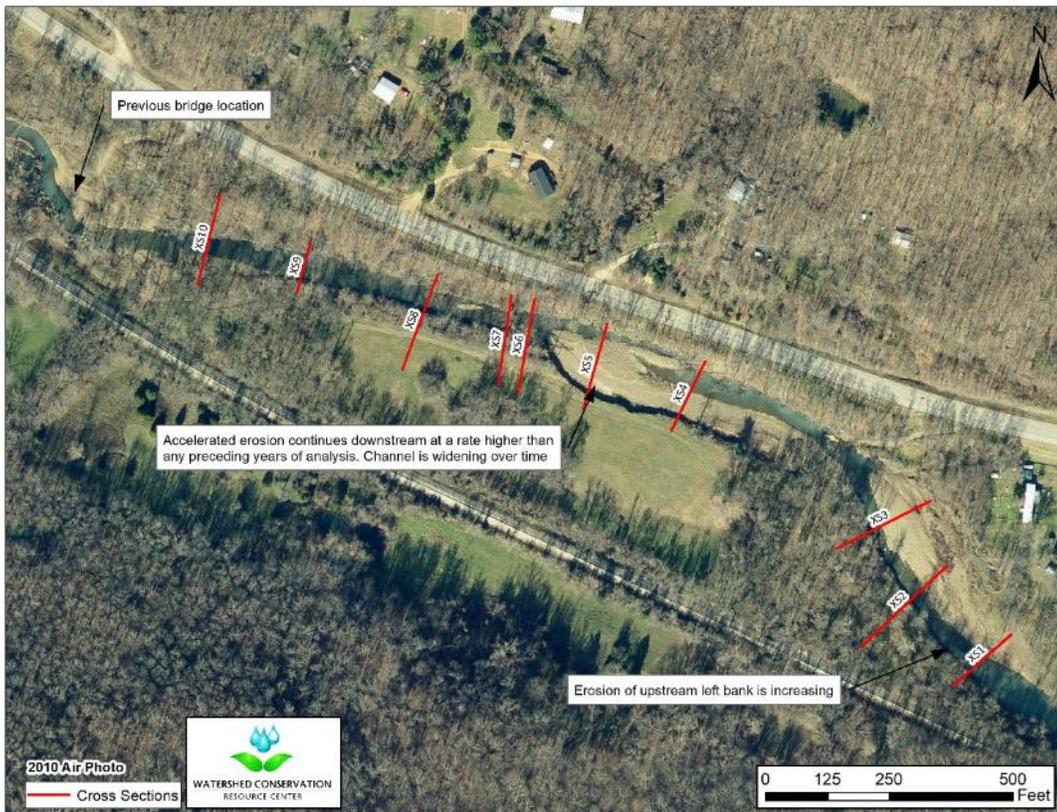
Figure 9. Aerial Imagery from 2010, the bridge downstream is removed, but the channel is over widened, destabilized and continue to washout the left streambank upstream and downstream

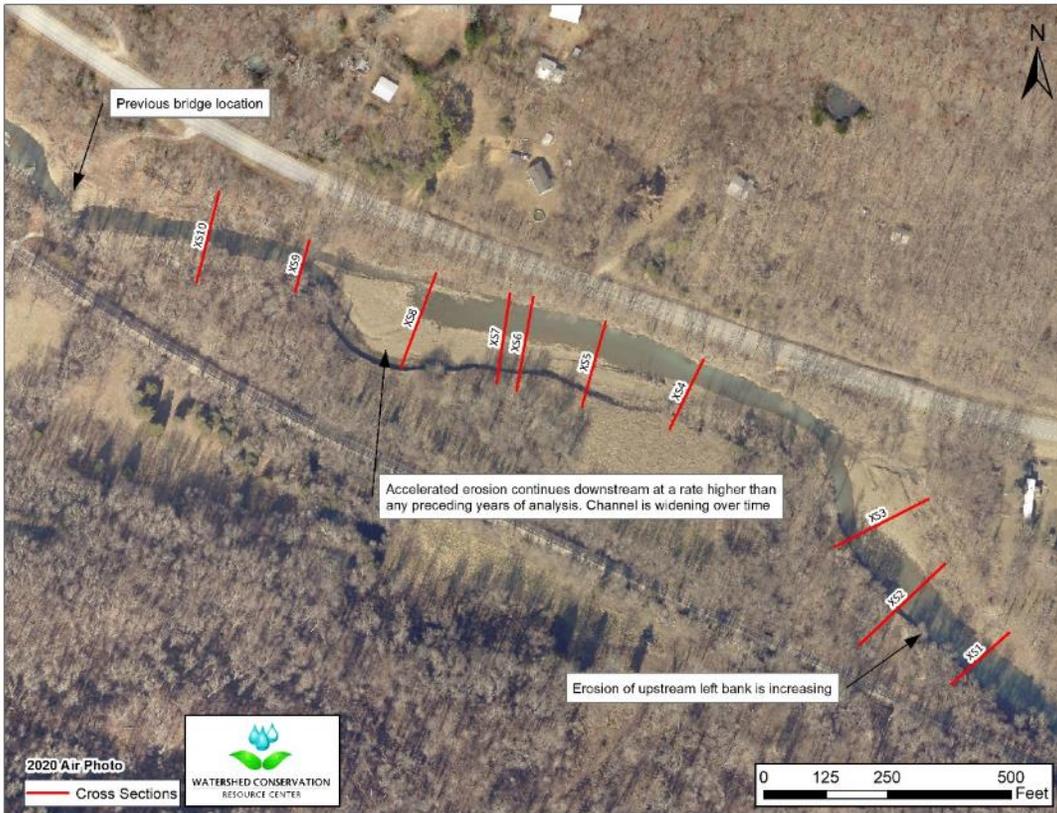
Figure 10. Aerial Imagery from 2020, the bridge is removed and erosion and channel widening has continued and increased dramatically

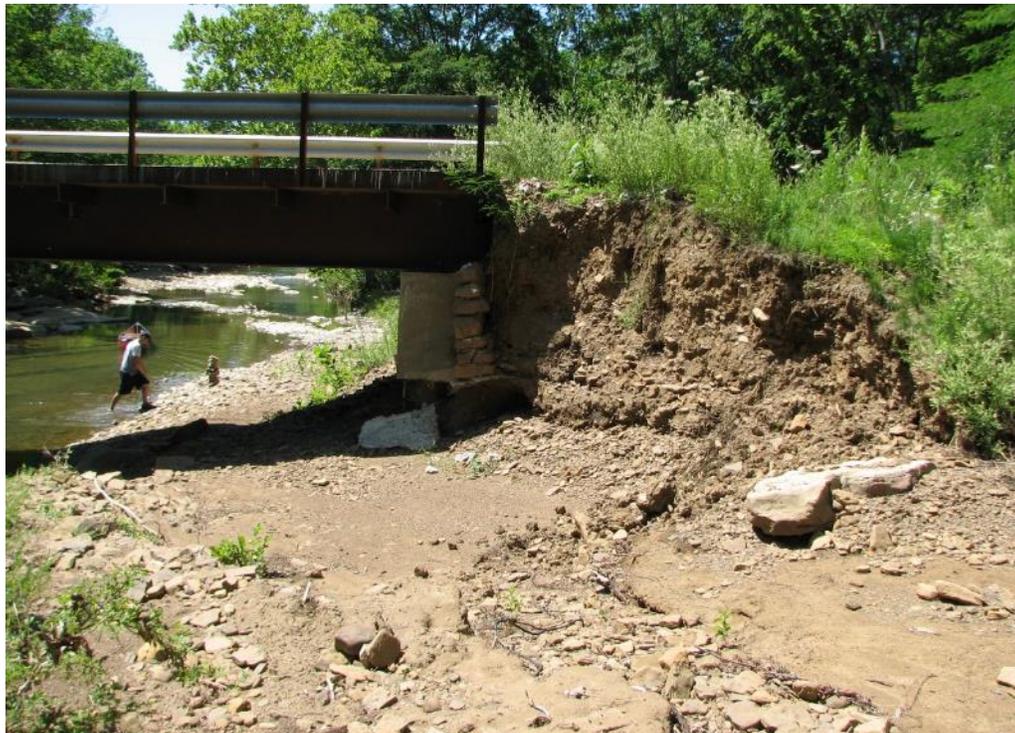
Figure 11. Photo from a 2006 inventory of bridge downstream, channel is scouring bridge abutments, indicating constriction of channel

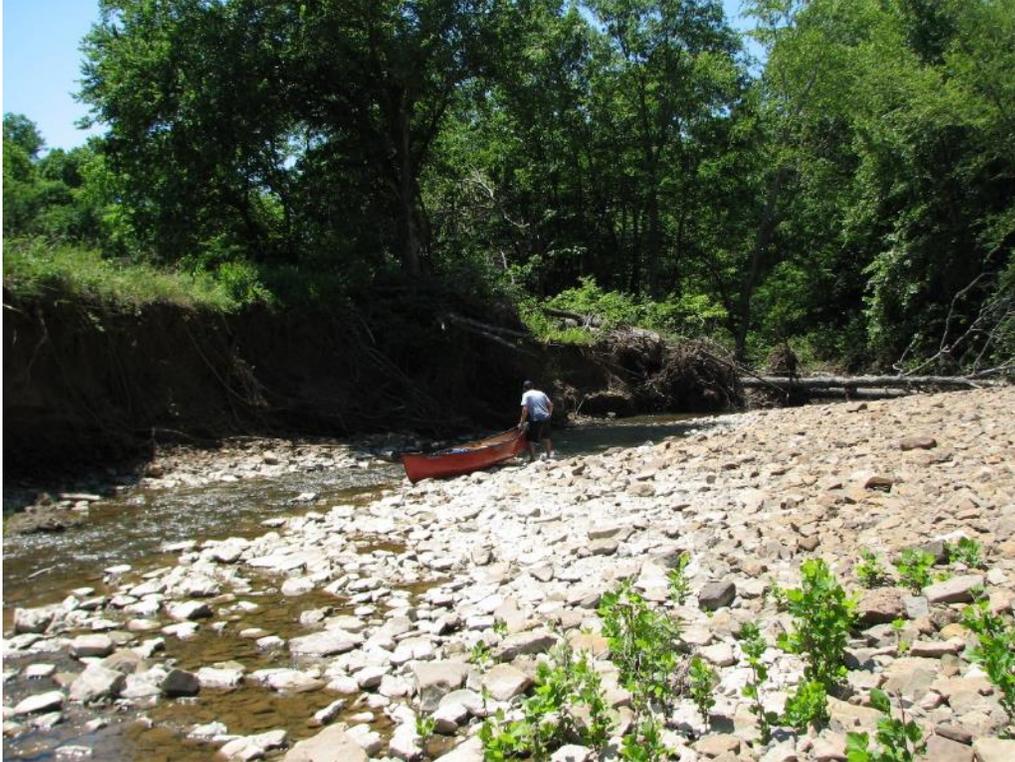
Figure 12. Bank Erosion between XS4 and XS5 is beginning to accelerate with fallen trees and shear, exposed banks

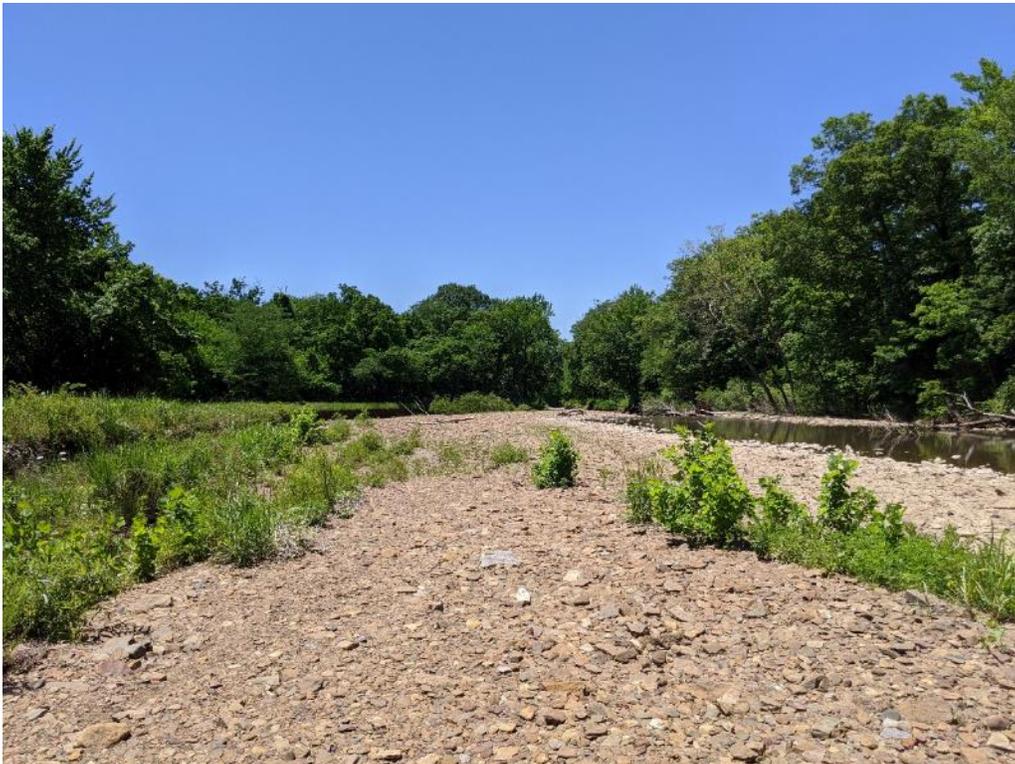
Figure 13. Approximately same area as Figure 12 in current day, major erosion of the left bank has created an over widened channel

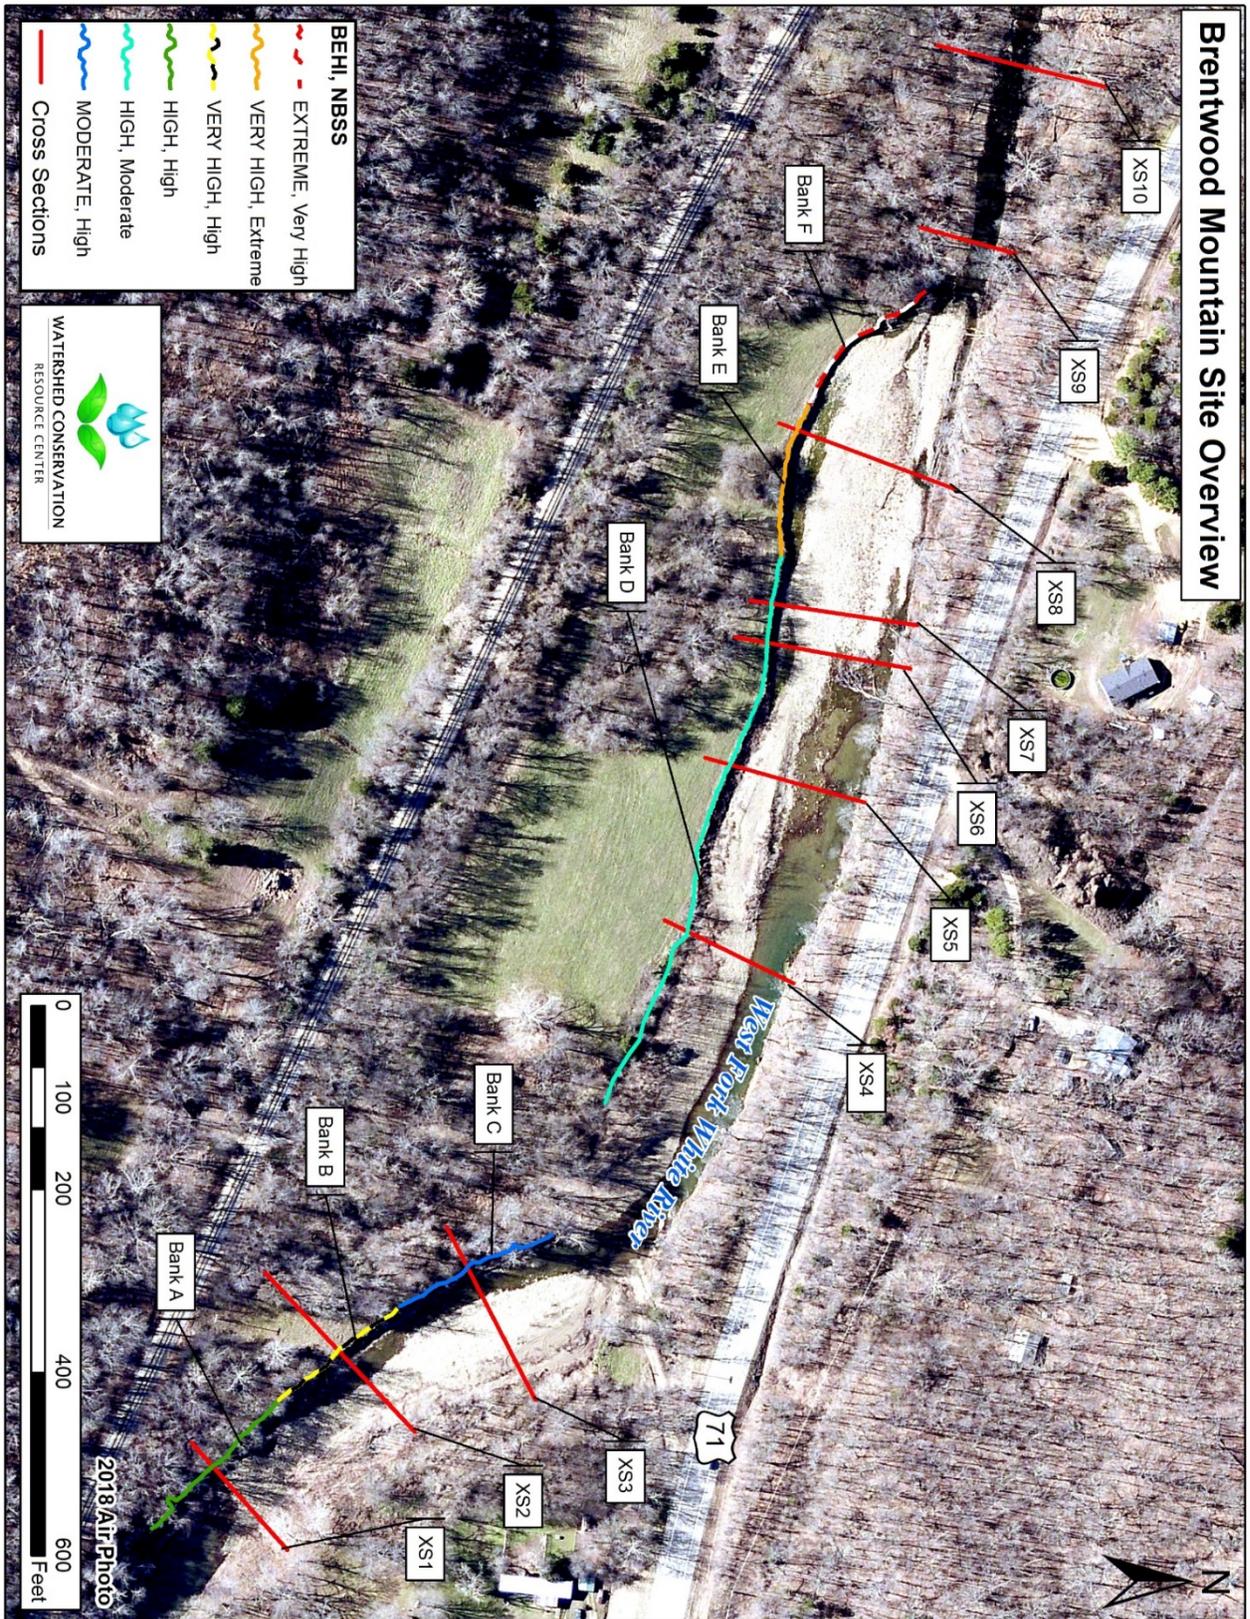
Figure 1. Cross Sections, BEHI and NBSS adjectives and Bank Names for the Stonesifer property

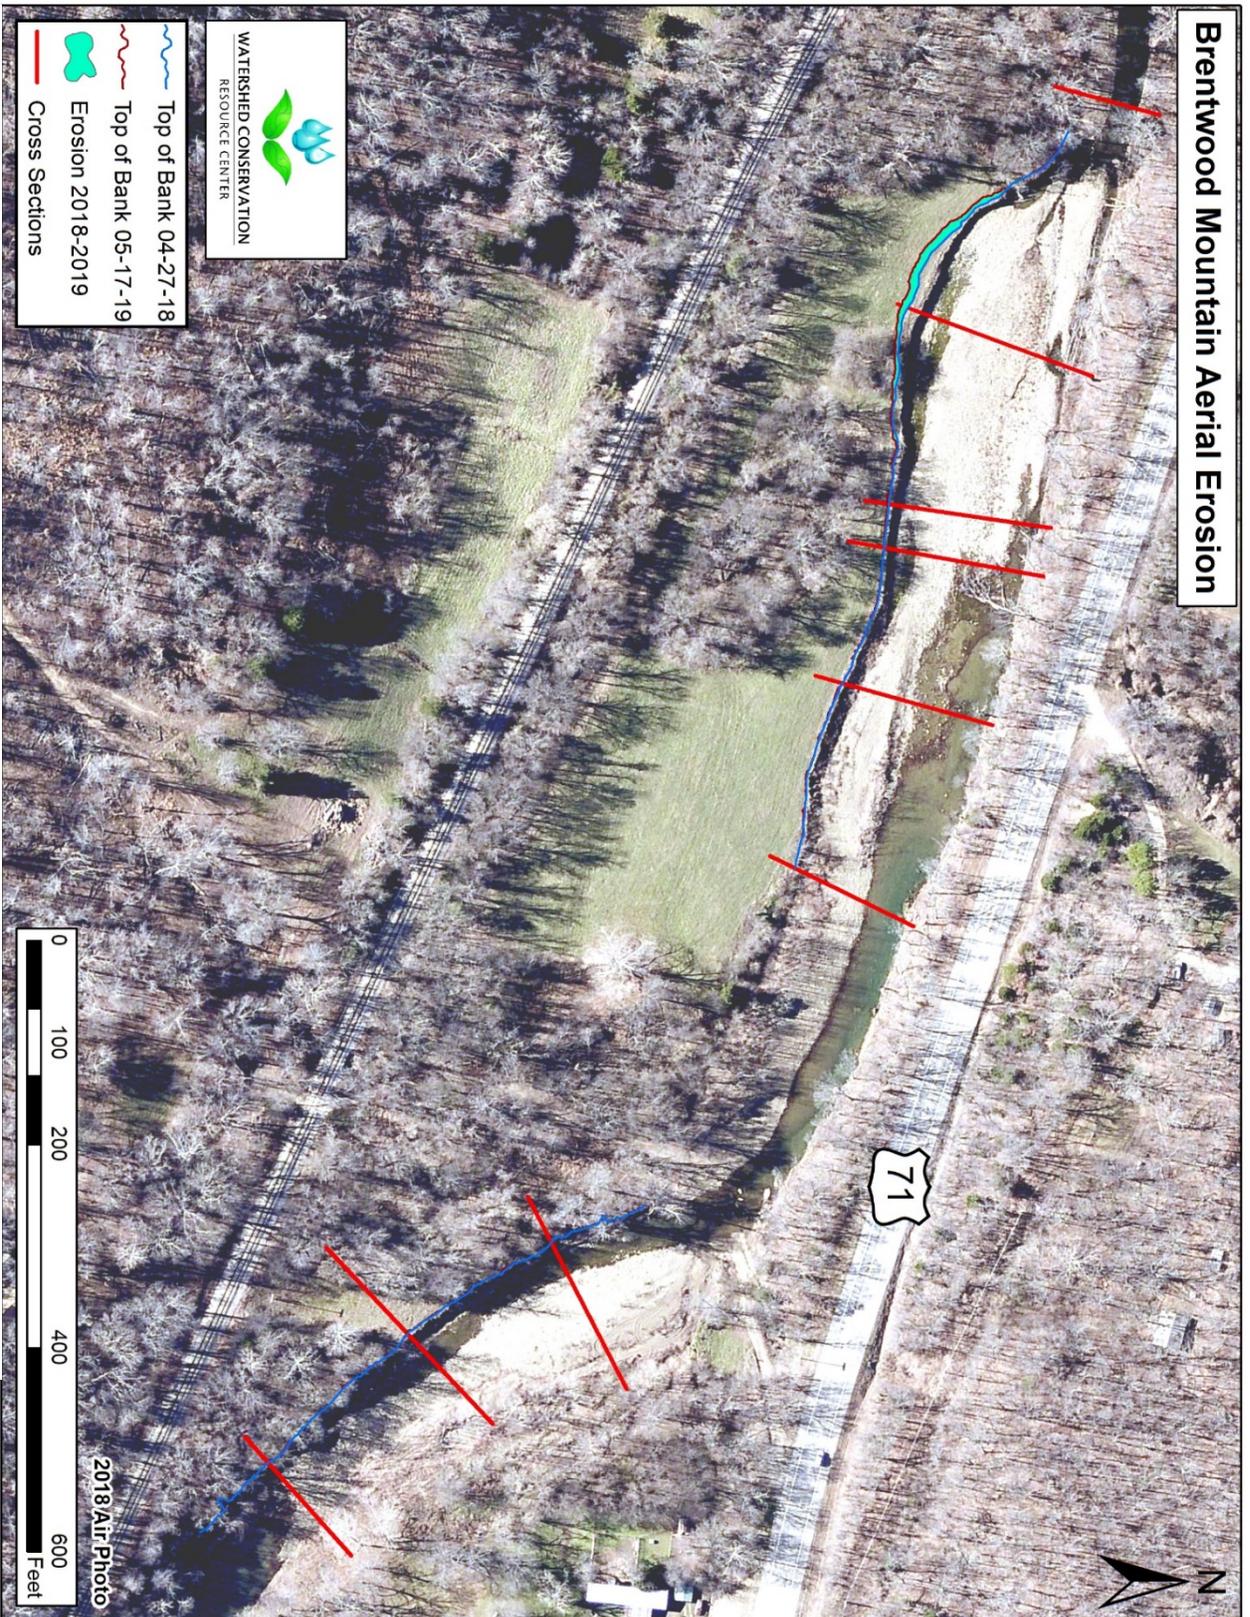
Figure 2. 2018 to 2019 Top of Bank Erosion for the Stonesifer Property

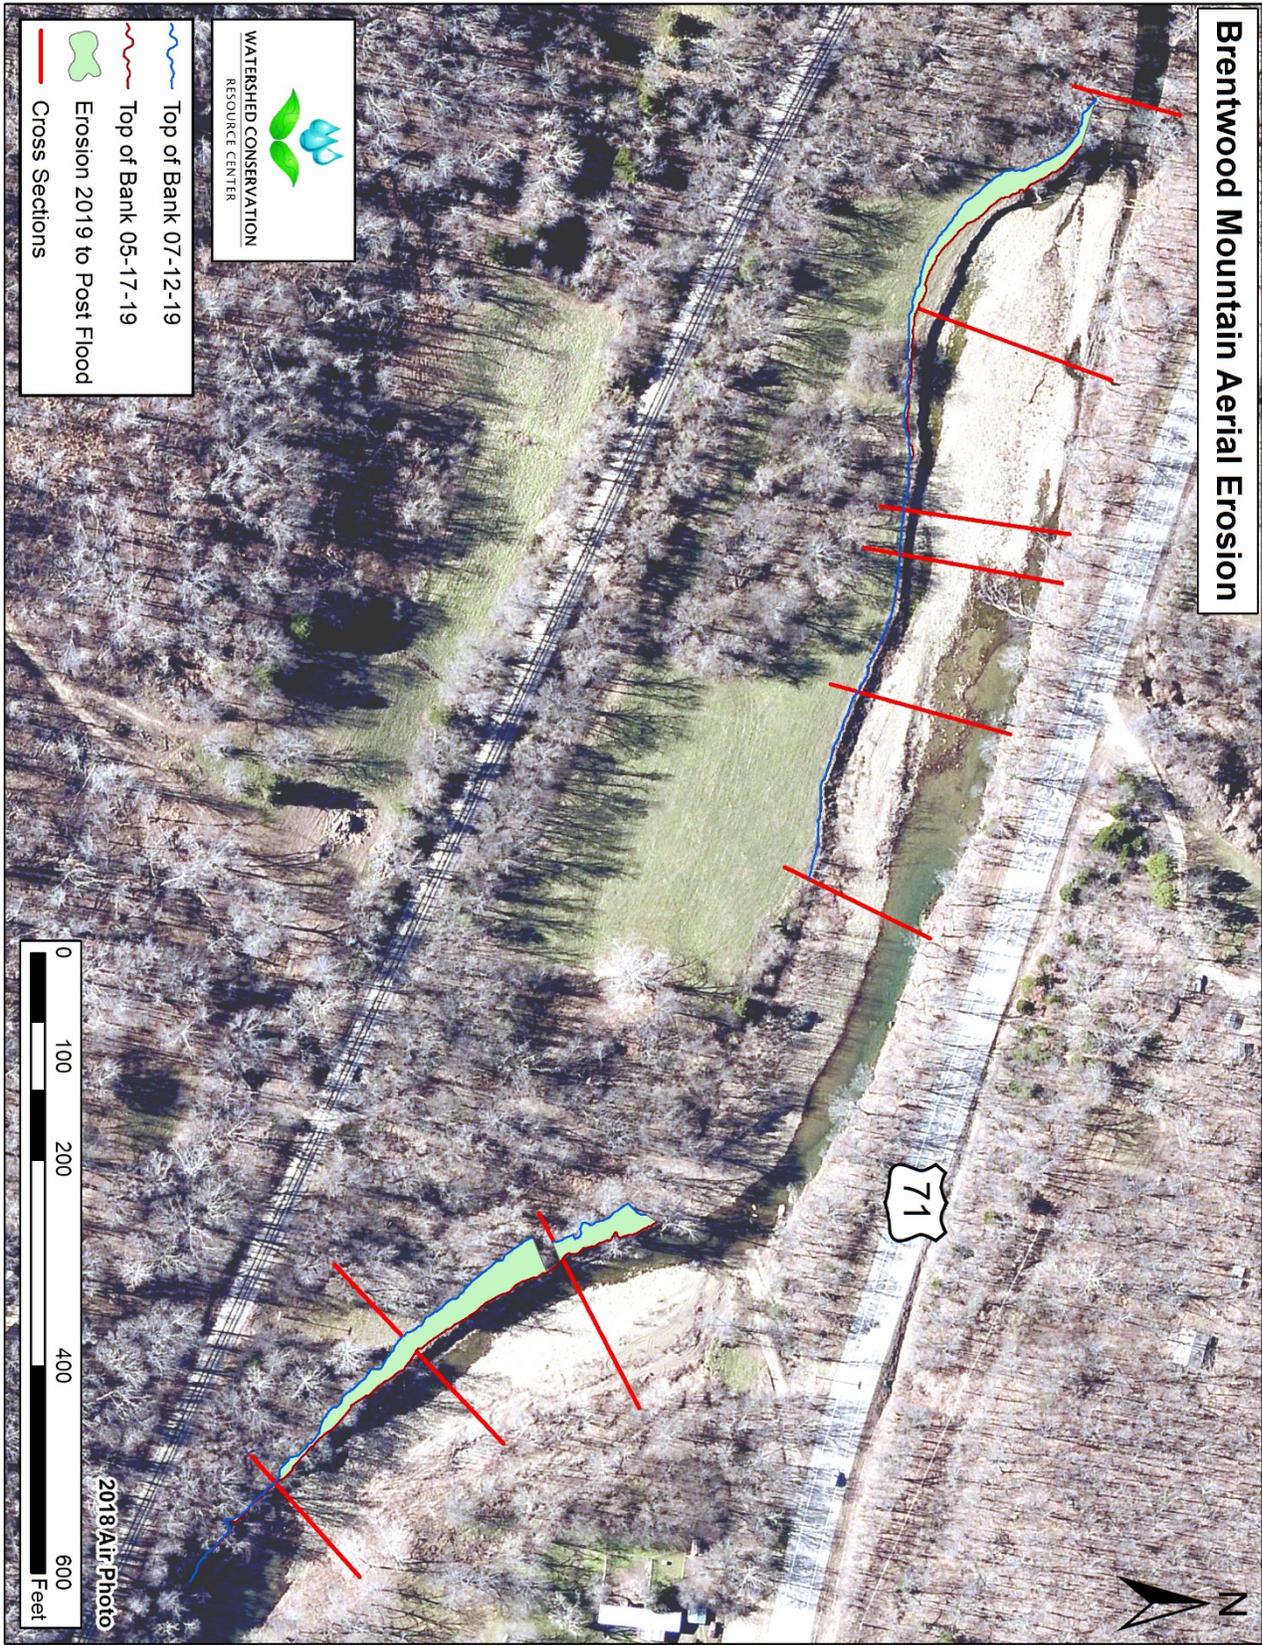
Figure 1. Top of Bank Erosion that occurred between May 17th and July 12th of 2019

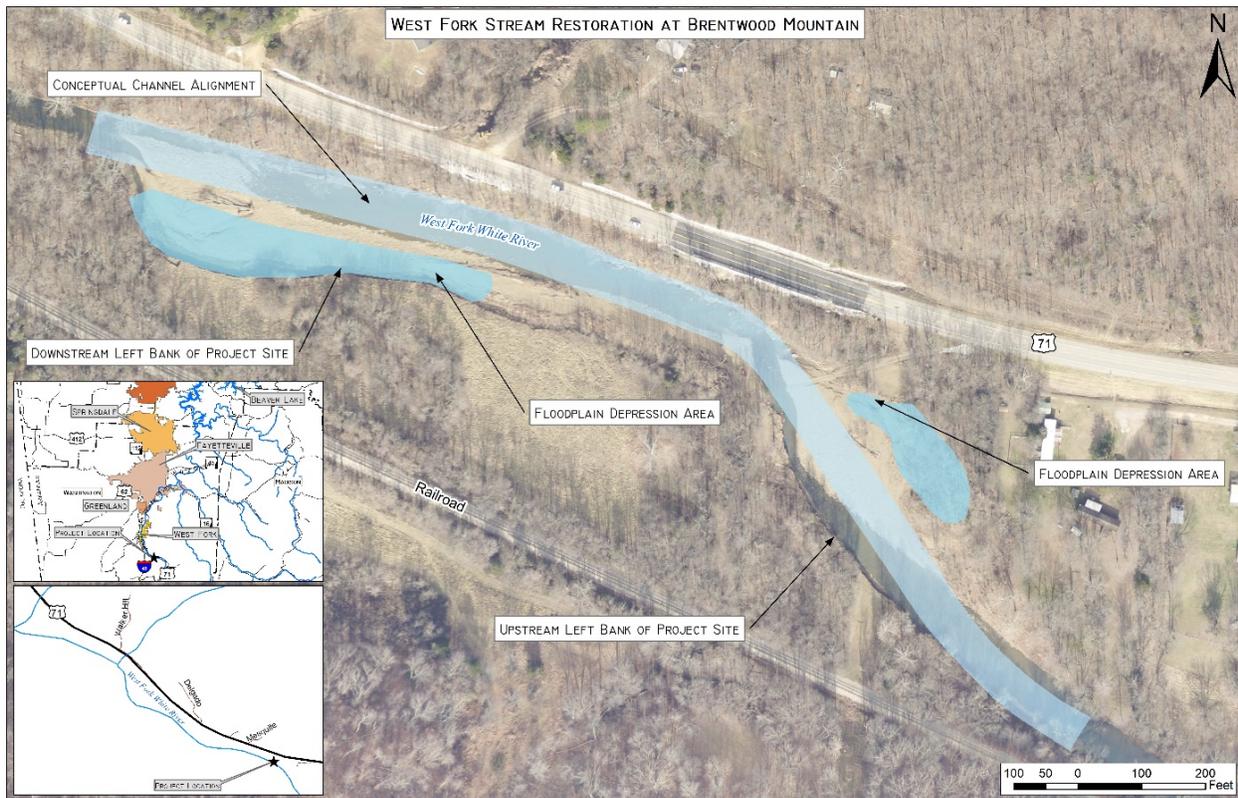
Figure 1. Brentwood Mountain site undergoing erosion and channel instability prior to restoration

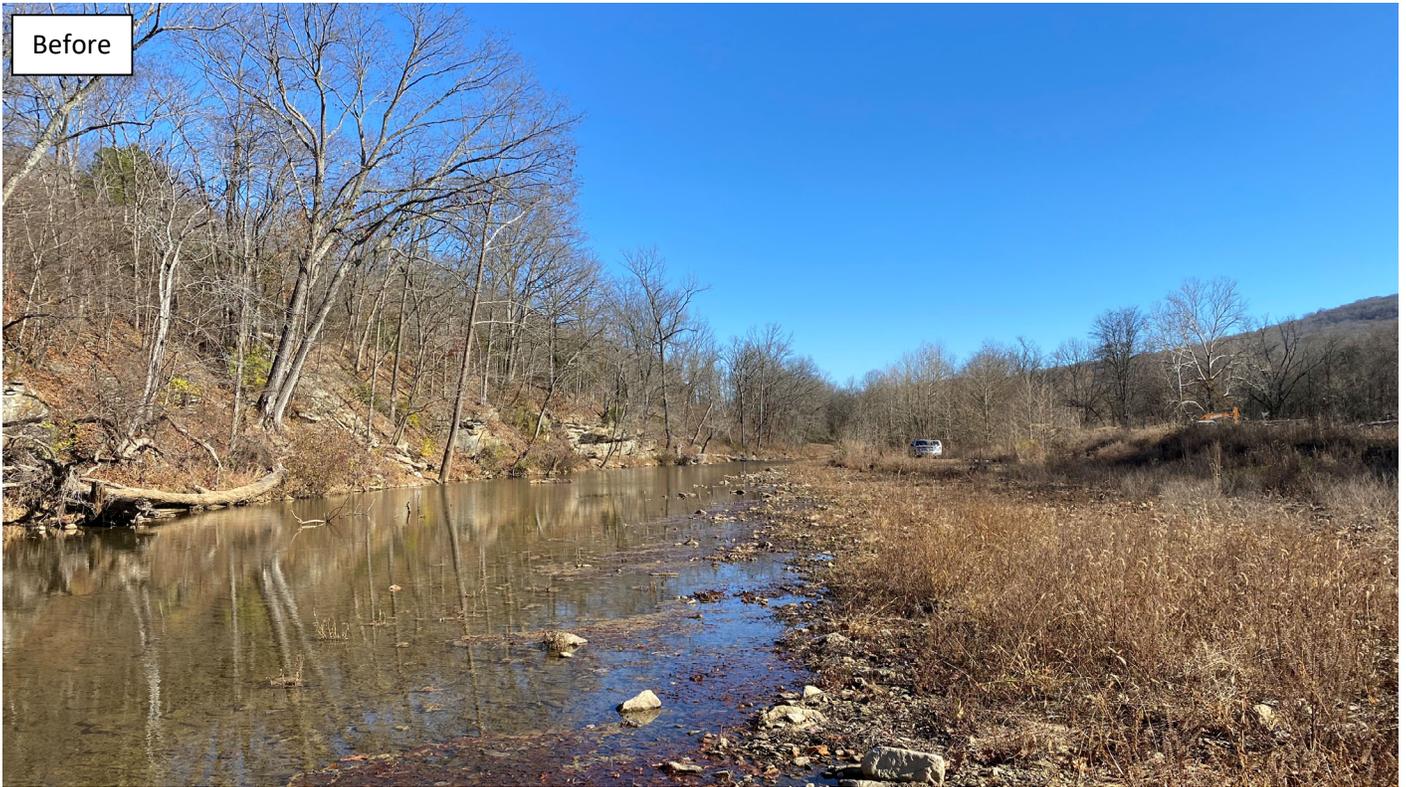
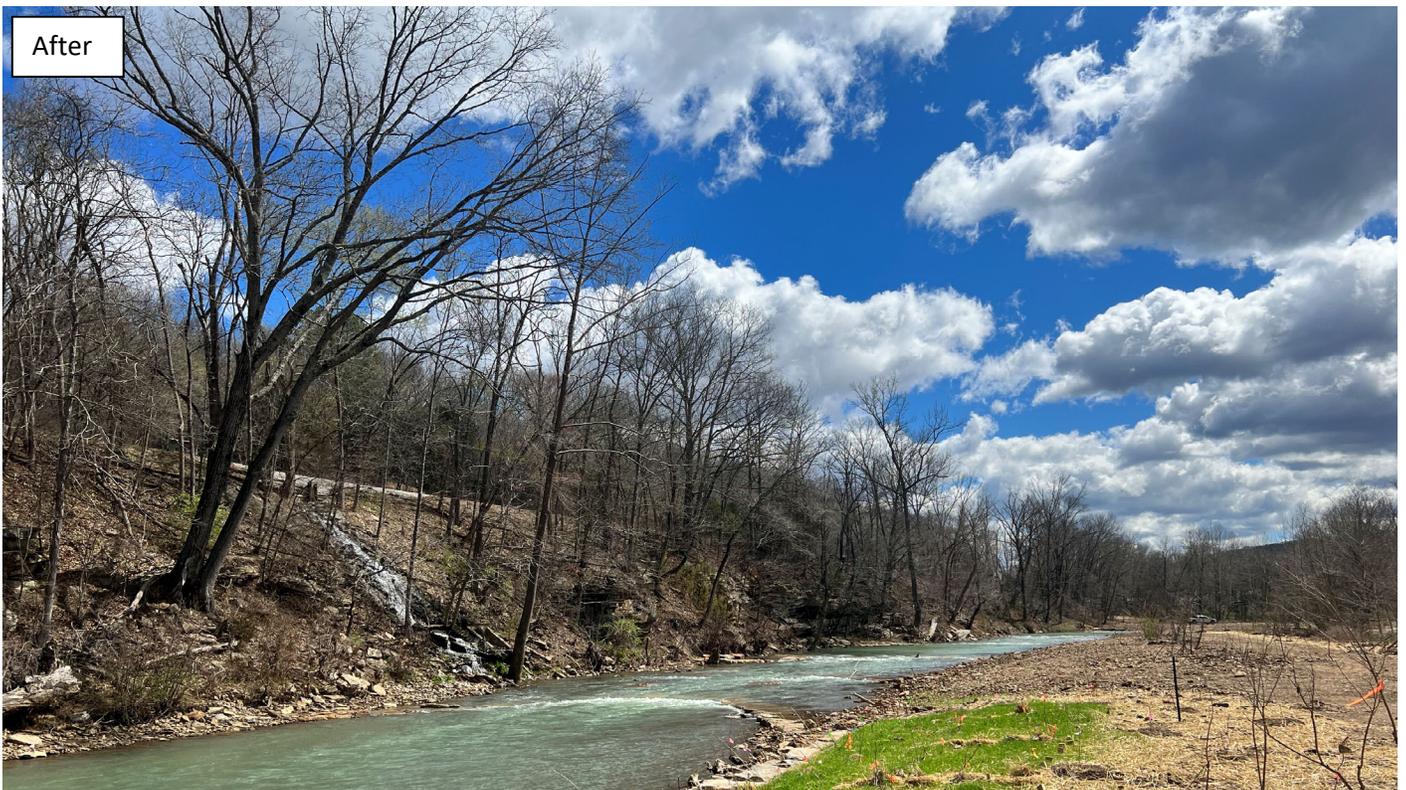
Figure 18. This photo shows the downstream area of the restoration extent looking upstream. The upper photo shows the stream with shallow pool features and poor riparian vegetation. The bottom photo shows the start of the riparian streambank, well established riffle and cross vane structure to help establish and maintain depth in the channel.

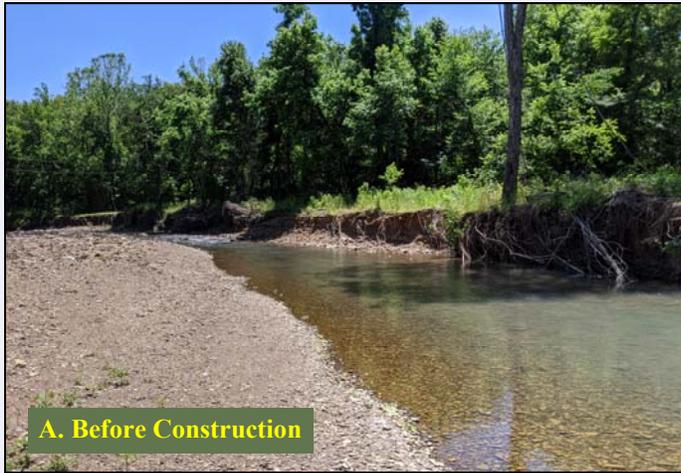
A. Before Construction

Starting from top left: A. Two streambanks along the project reach had severe erosion prior to restoration. Streambank erosion rates were observed to be 37 feet per year in some areas. B. After restoration (2022), the project reduced sediment loads by 2,200 tons/year. The channel and banks were restored using a combination of boulders, trees, and gravel to construct toe wood benches. C. Soil lifts were constructed on top of the toe wood and vegetated with native trees, shrubs, and grasses to create roughness along the channel edges and improve stream cover. D. Boulder grade controls were used to redirect flows and improve aquatic habitat. E. A low-water crossing constructed of large flat boulders helps to control channel grade and provide access. F. Cross-vanes were built to protect the streambanks and increase pool scour.
