# Bridge Inspection Report

**05715**  
**SH 35-03 LM 2.74**  
**over**  
**Camp Creek**

Structure Number: 05715

Facility Carried: SH 35-03 LM 2.74

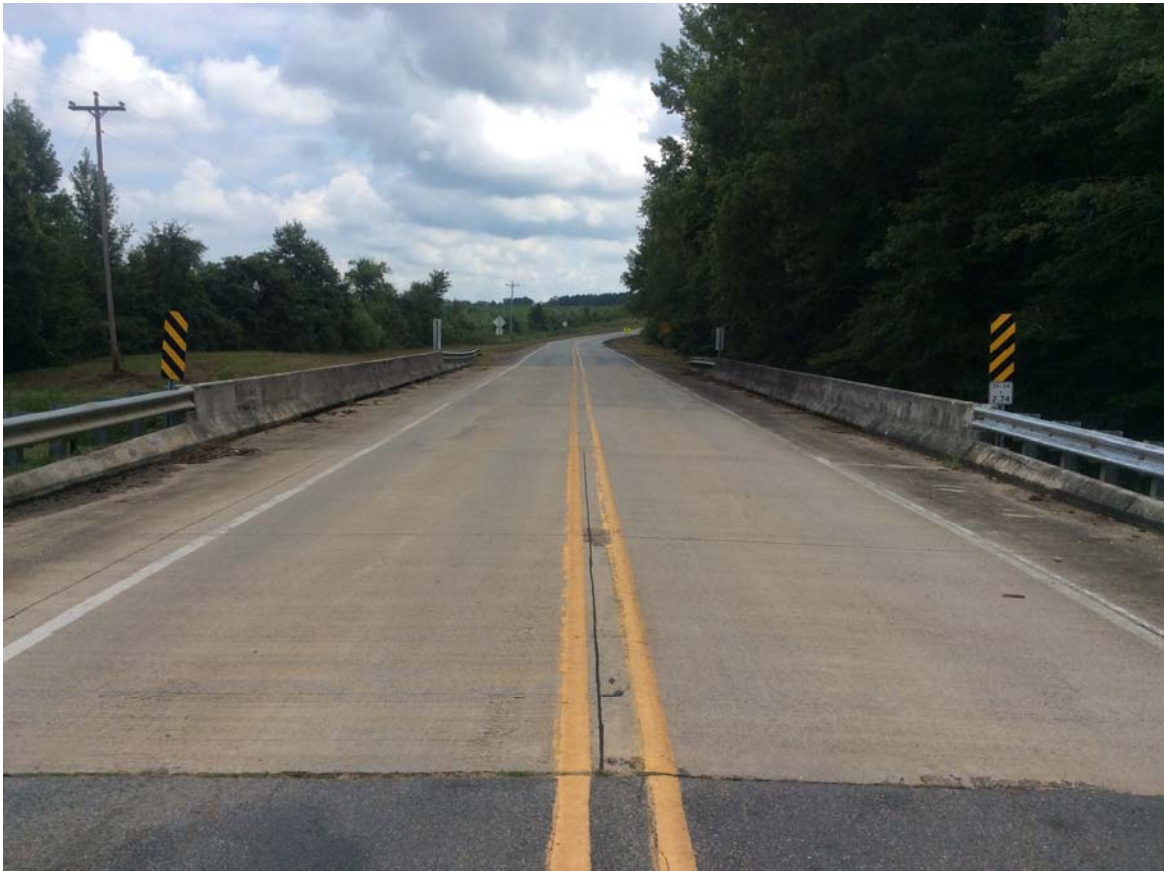
Poured joint material is mostly intact, but has lost adhesion in most places – allowing stormwater to leak through joint and onto cap.

PHOTO 1      Description      Joint - Bent 1: Loss of adhesion
