Bridge Inspection Report

M4030
SH 35-03 LM 8.97
over
Creek

Structure Number: M4030

Facility Carried: SH 35-03 LM 8.97

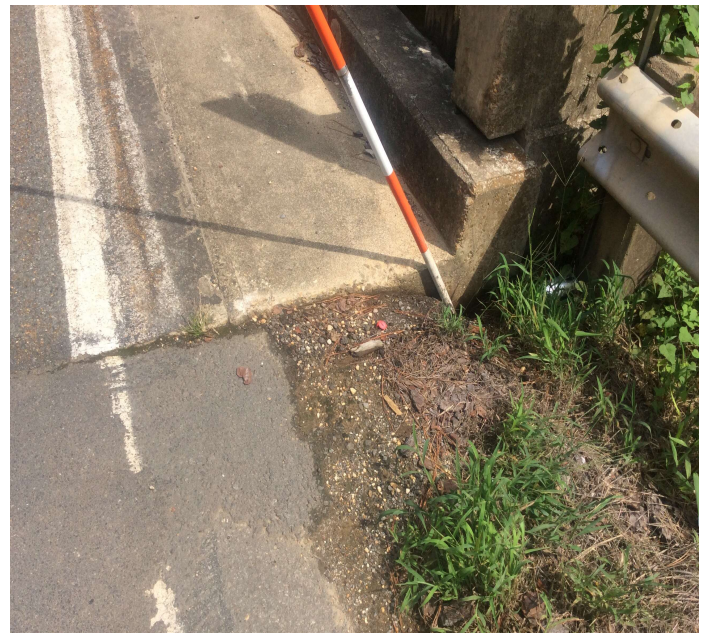
PHOTO 1 Description Bent 3 south east bridge end small area of erosion at end post.

Grant: repair., advise when complete
