# Bridge Inspection Report

**05608**

**I-555 SB-02-LM7.78**

**DEAD TIMBER LAKE**

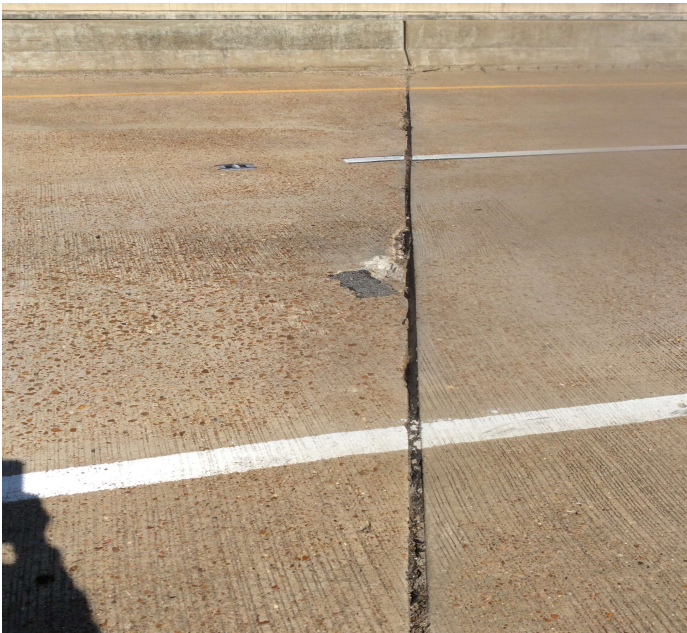
PHOTO 1 Description

Slabs have a few unsealed longitudinal and diagonal cracks.  
Span 2 has a spall along joint in Lt lane at bent 2.
