Bridge #03253(Routine)
SH 115-02-LM 16.14 over STRAWBERRY RIVER
Location: 4.0 MI S OF SMITHVILLE
Team Lead: Tim Myrick Inspection Date: July 06, 2021

Bridge #03253(Routine)

SH 115-02-LM 16.14 over STRAWBERRY RIVER

Team Lead: Tim Myrick, Inspection Date: July 06, 2021

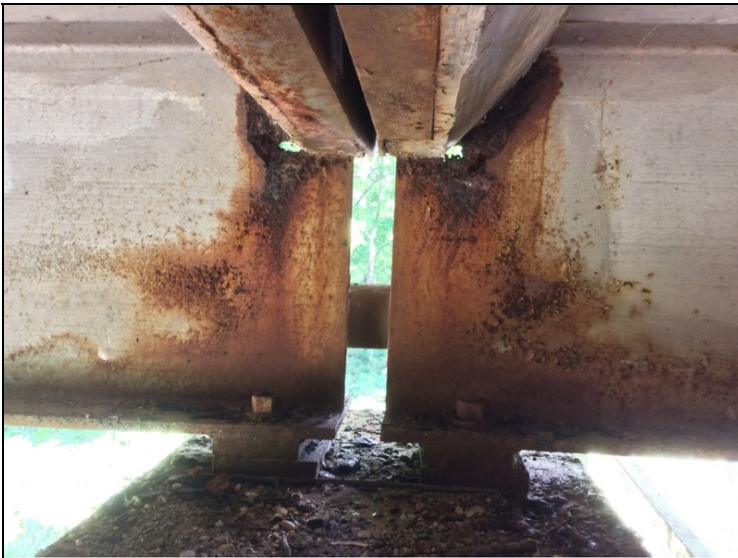
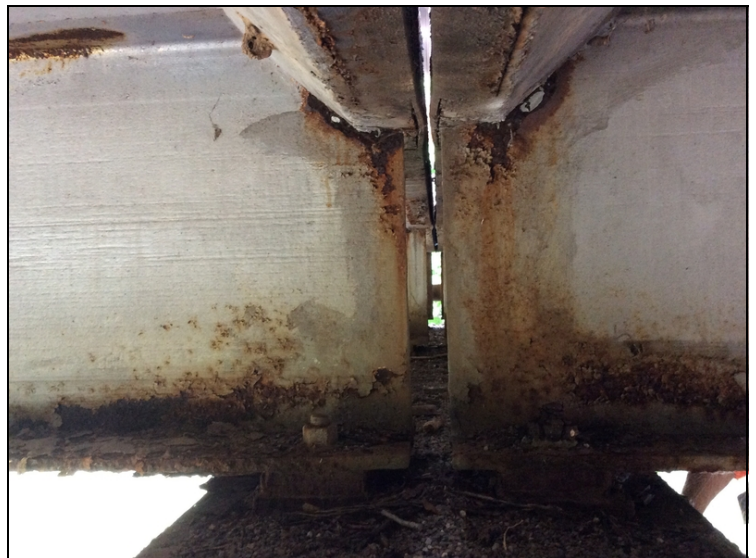
Ends of girders have rust with areas of section loss ($1/8"$ - $1/4"$ typical), especially near concrete haunch, several have holes rusted through.

Exterior girder on right side of bridge has rust and areas of section loss at utility connections.

- *Girders have been repaired this report, observed at inspection, JFA/CWS 06-11-2020
- **Girders have been repaired this report, observed at inspection, TJM/CCP 07/01/2021

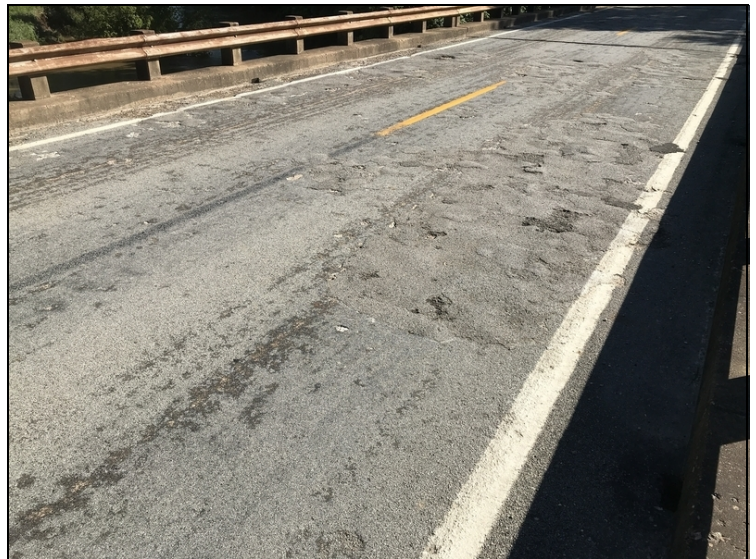
Span 14

Deck at Spans 12 – 14 have several spalled areas with some exposed rebar. Wearing surface has several spalls and asphalt patches.

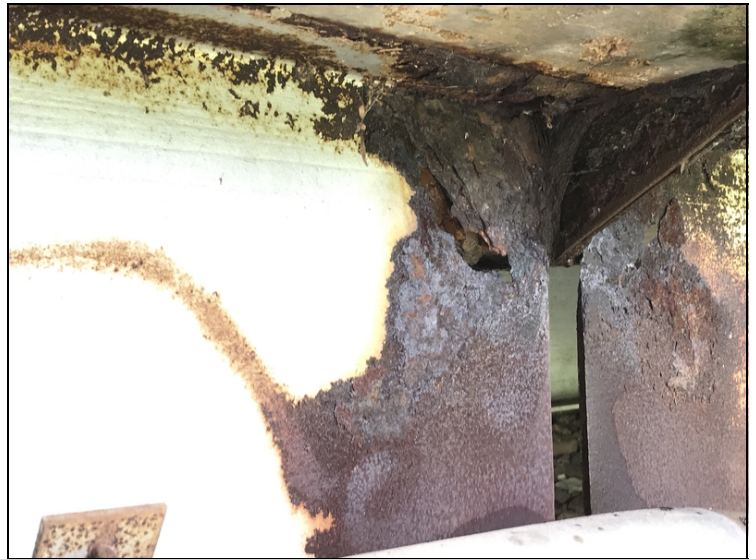
Span 16 bent 17 girder 5 2019

- **Span 16 girder 5 bent 17 has a 9" x 2" hole in web below haunch, web is beginning to buckle.
- **Span 17 girder 4 bent 17 has a 6" x 1" hole in web below haunch and a 19" x 2" hole in bottom of web 12" from end of girder. Bearing has 1 anchor bolt missing.
