# Bridge Inspection Report

**07031**  
**SH 1-01 LM 3.99**  
**over**  
**Canal # 19**

Structure Number: 07031

Facility Carried: SH 1-01 LM 3.99

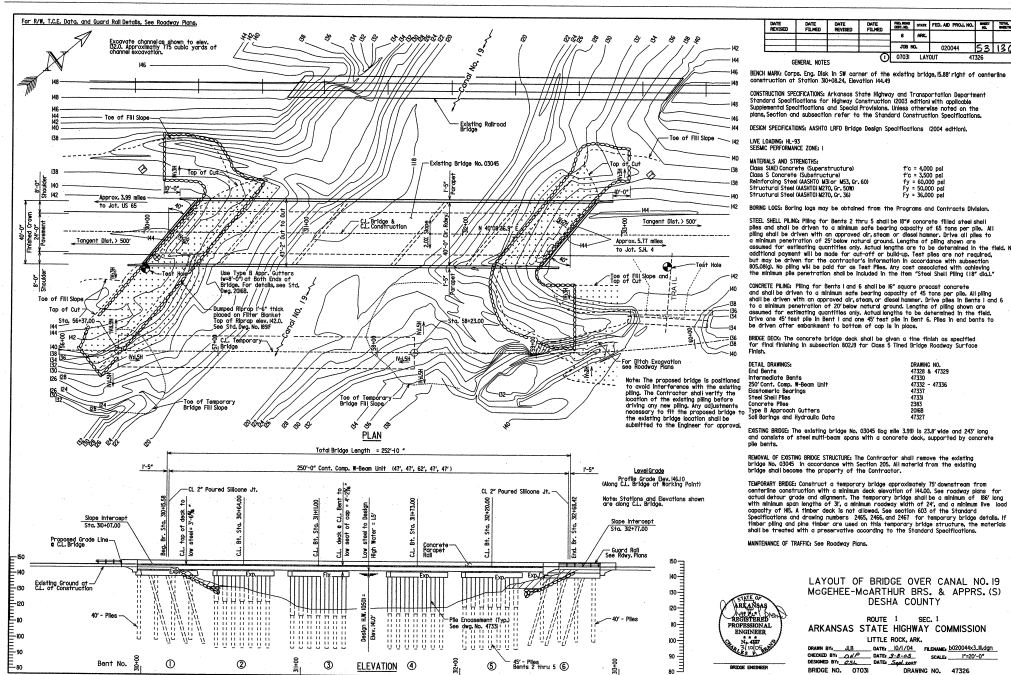
Bearings - Bent 6: Anchor nuts missing off various bearings - 5 total.

PHOTO 1      Description      Bent 6 Bearing 5 right (nut missing)
