# Bridge Inspection Report

**06446**  
**US 65-19 LM 6.45**  
**over**  
**SH 1 and UPRR**

Structure Number: 06446

Facility Carried: US 65-19 LM 6.45

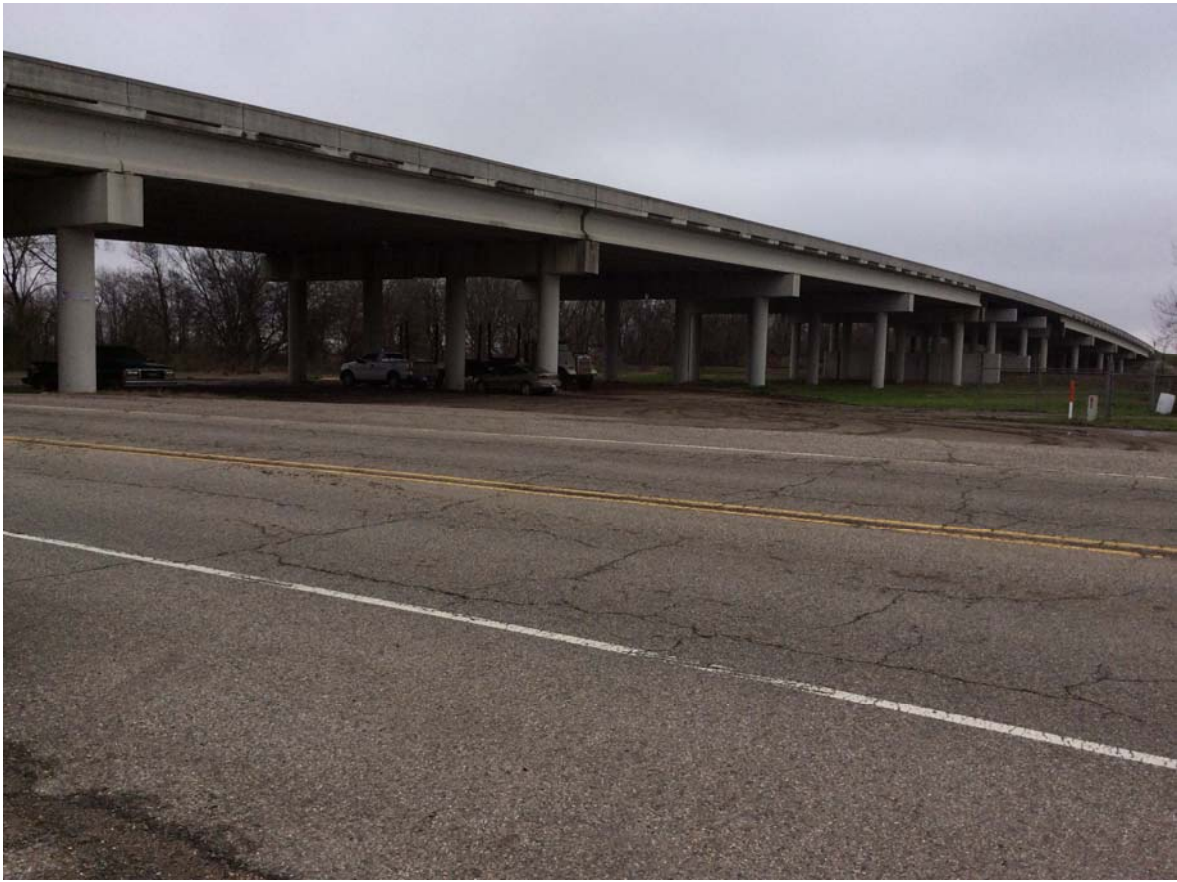
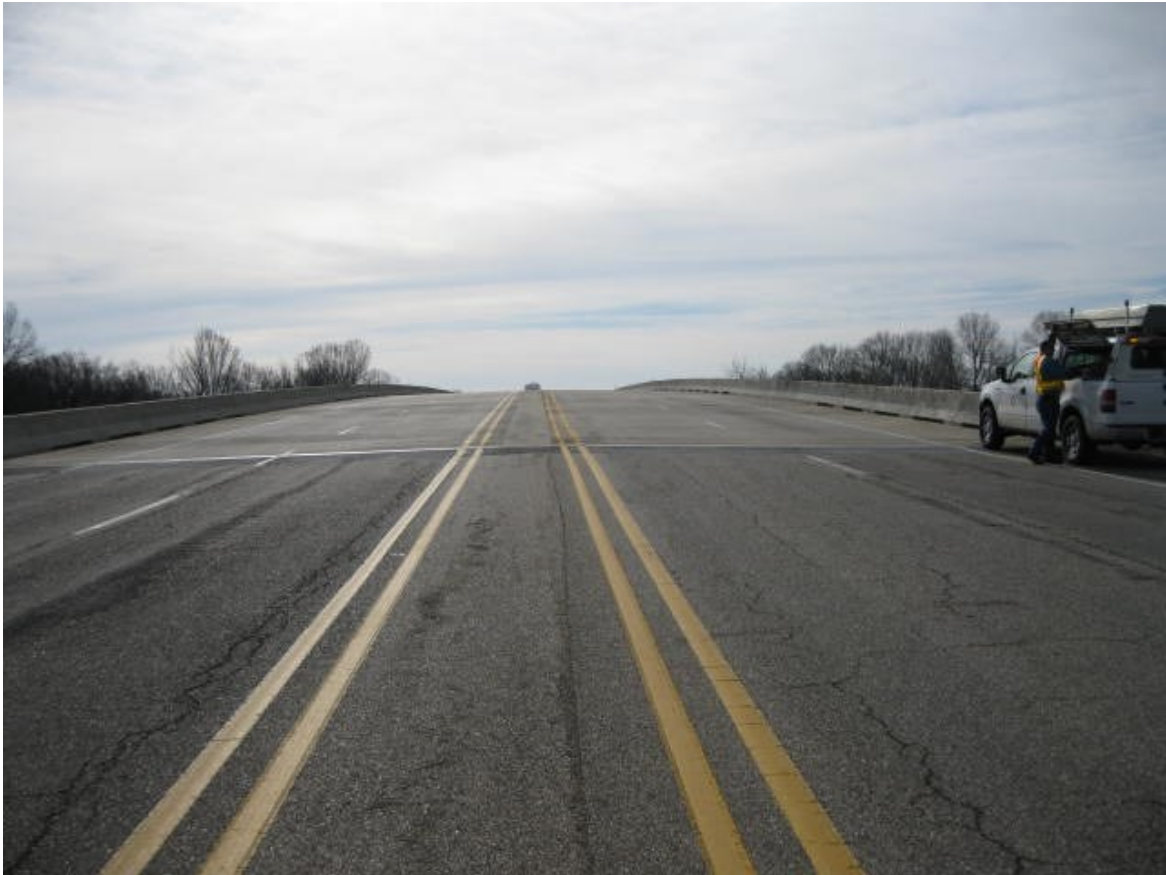
Deck - all spans: Unsealed, hairline- to minor-sized transverse cracks - with reflective efflorescence on soffit between Girders 5 & 6 - and some hairline- to minor-sized longitudinal cracks beginning to form in the outside lanes along the edges of girders.
