Structure Number: 03840

Facility Carried: SH 208-03 LM 2.54

## Bridge Inspection Report

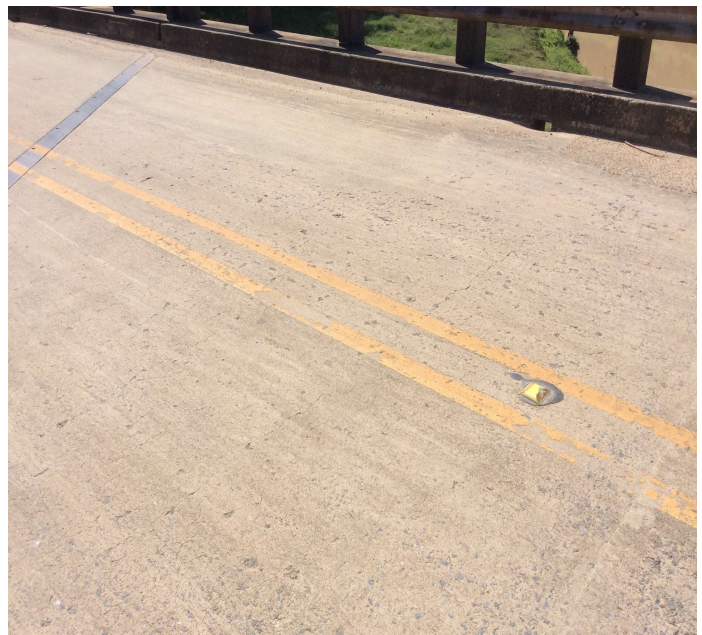
PHOTO 2 Description

Numerous areas of delaminations, spalling, and patches - especially on Spans 3, 4, 6, & 7.

Several spalls are deeper than 1" or greater than 6" in diameter (CS3) and some have been patched with asphalt mix.

Other areas of the deck have scattered wear/scaling where the mortar/fine aggregates have come loose leaving the coarse aggregates exposed.

Several unsealed minor- to moderate-sized transverse cracks.

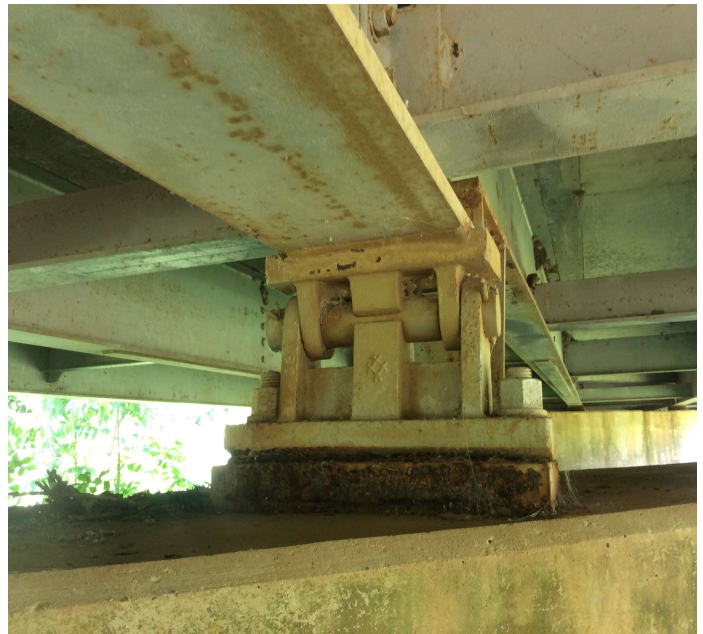
PHOTO 2      Description

Girders - all spans: Some scattered surface rust with areas of heavier surface corrosion, some light pitting, and minor flaking at ends.

Bearings - all bents: All bearings have surface rust with a couple having some flaking and minor pack rust.
