Asset #B5501 (Routine)

I-530 NB LM 31.85 over SH 256

Location: 1.4 Mi W SH 365-WhiteHall

Team Lead: Sharon Hooks, Inspection Date: 09/14/2022

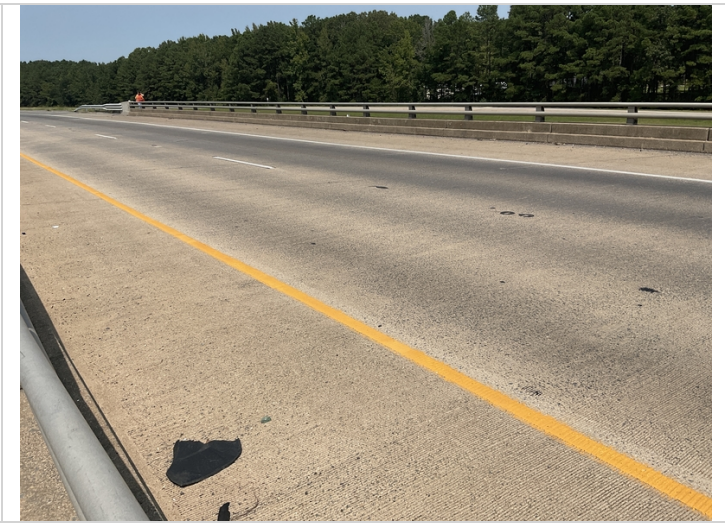
Deck over view.

(12) Deck: 42' wide x 168' long = 7056 sqft. Moderate sized longitudinal cracks in left (outer) lane. One or two minor, unsealed, transverse cracks with some light, reflective efflorescence on soffit. Some unsealed map-cracking (curing cracks?) scattered throughout deck. Span 1-2 left: A couple small shallow spalls in left (outer) lane in outer wheel rut. Soffit – all spans: Some scattered cracking with efflorescence on overhangs (72 sqft CS2).							
107	Steel Open Girder/Beam	LF	1008	1000	8	0	0
1000	Corrosion	LF	8	0	8	0	0
515	Steel Protective Coating	SF	8215	6573	1386	190	66
3410	Chalking (Steel Protective Coatings)	LF	1386	0	1386	0	0
3440	Effectiveness (Steel Protective Coatings)	LF	256	0	0	190	66
