# BRIDGE INSPECTION REPORT NBIS FORM III

Inspected by RLW / TCT  
 Date 04-08-2003

Dist- 02; Co- 01 -- ARKANSAS; Rte- 00299; Sect/Zone- 00/A; Log- 003.650; Str #- 20859

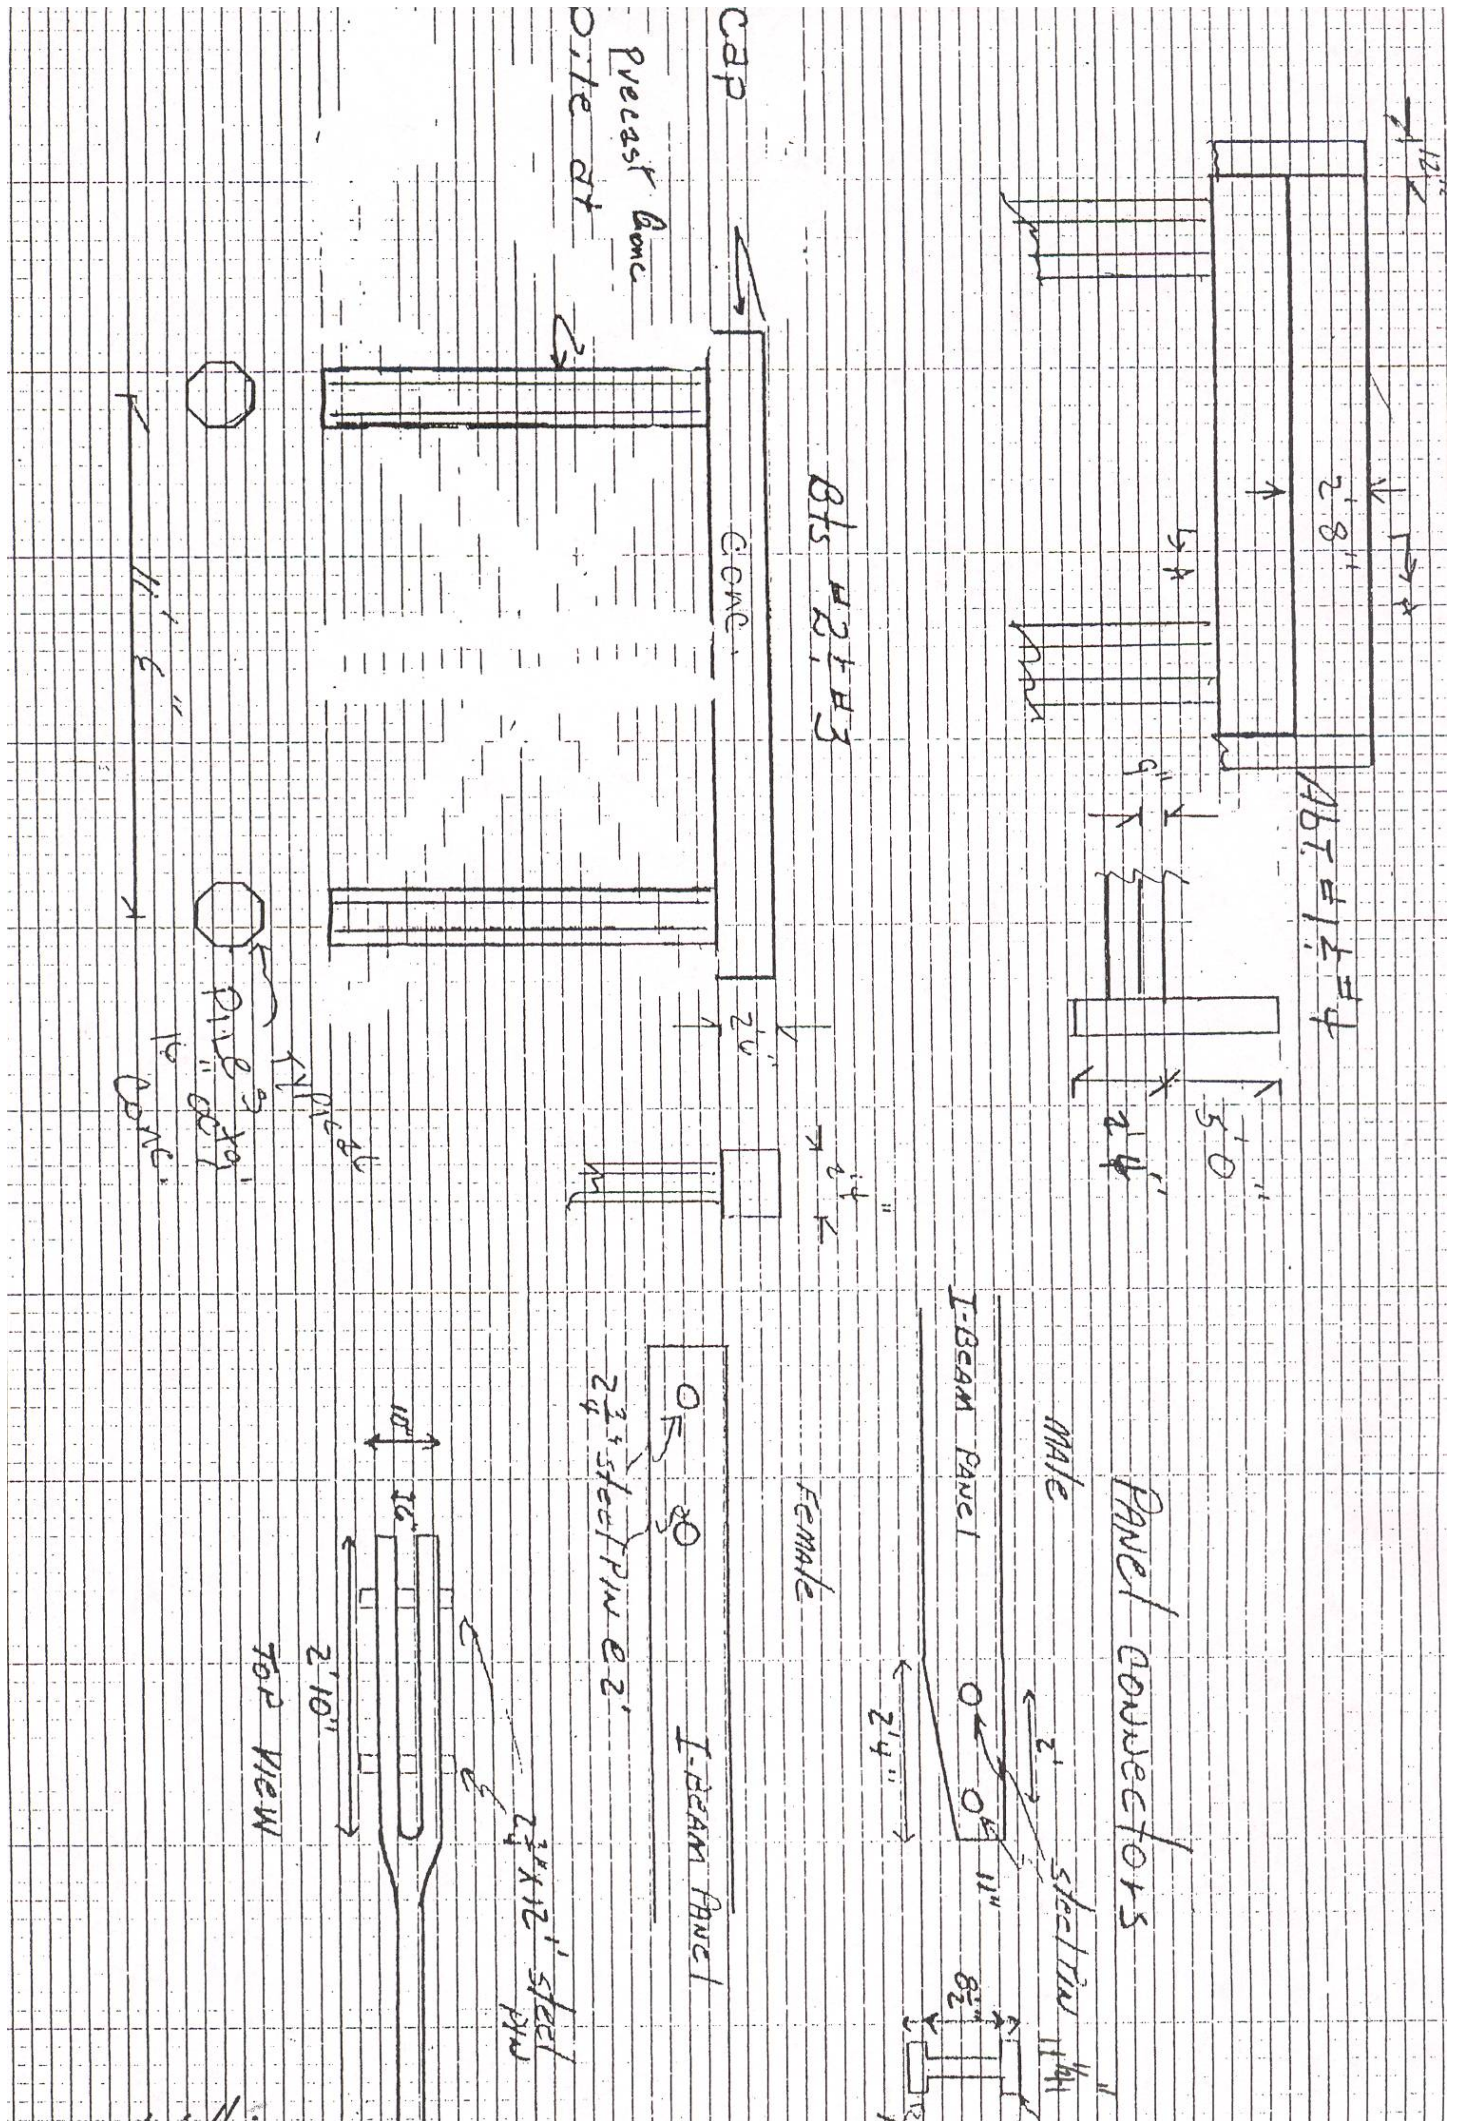
Location of Pin/Connection Plats.

# 4 P/C Plt Deflects most Free Play  
 @ Pins. ( $\frac{1}{8}$ "  $\pm$   $\frac{1}{16}$ " )

# 2 & 6 P/C Plts. Deflect Little. Less Than  $\frac{1}{8}$ " Free play.

Note Cover Plate Between Girders 2 & 3 Weld Broken. These are located @ P/C Plts 3 & 5.
