Bridge #02122(Routine)

US 82-02-10.60 over BODCAW CREEK

Location: 1 MI WEST OF STAMPS

Team Lead: Dale Bittle Inspection Date: January 24, 2020

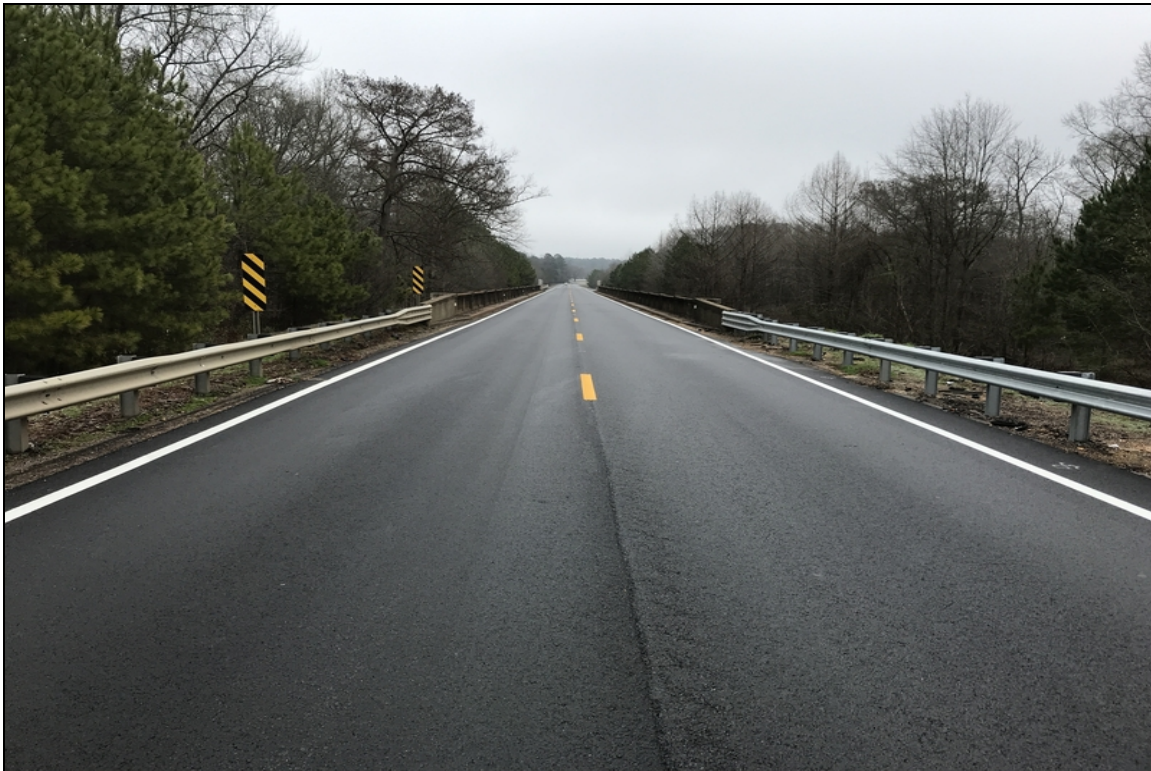
ELEM	DESCRIPTION	UNITS	TOTAL	CS1	CS2	CS3	CS4
1000 (311)	Corrosion	EA	40	0	0	40	0
1000- rust and section loss to all bearings							
313	Fixed Bearing	EA	40	0	0	40	0
1000 (313)	Corrosion	EA	40	0	0	40	0
1000- rust and section loss to all bearings							
331	Reinforced Concrete Bridge Railing	LF	724	562	0	162	0
7000 (331)	Damage	LF	162	0	0	162	0
7000- collision damage to bridge railing. rebar exposed.
