Bridge #02549(Routine)

US 82 SEC.01 -7.37 over MILL CREEK

Team Lead: Charlie Rogers Inspection Date: August 21, 2019

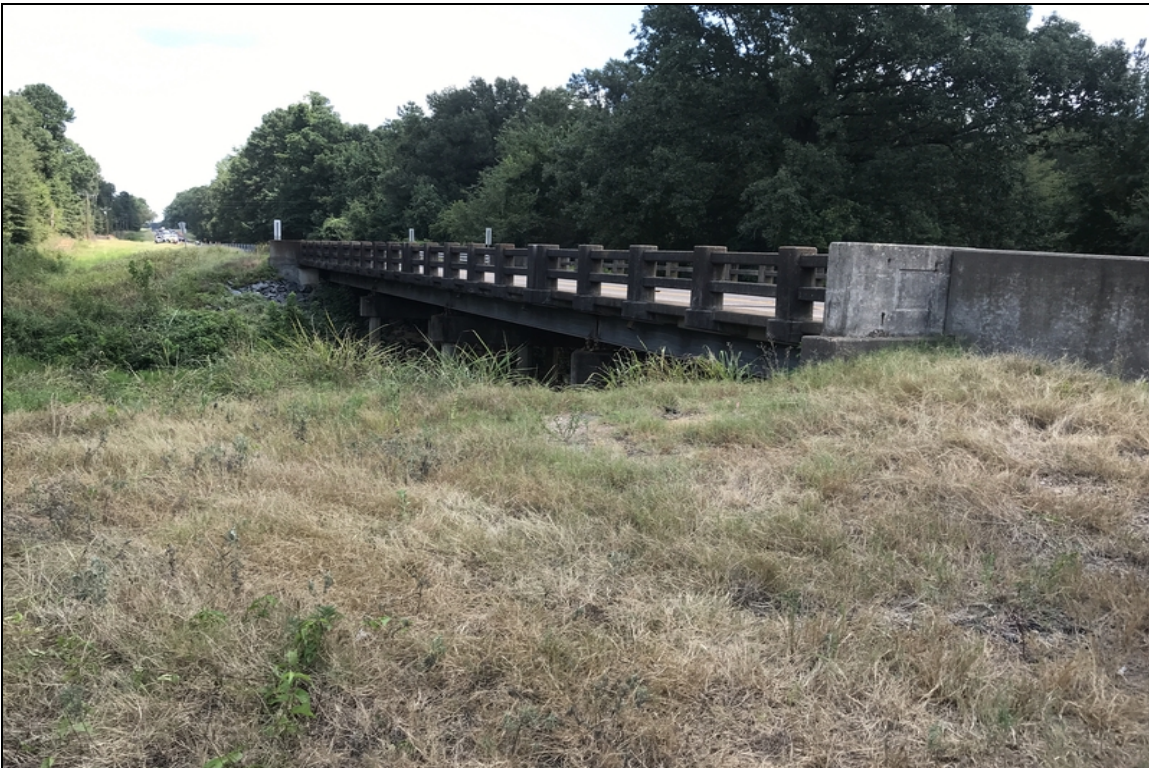
(311)	Span 1 beam 2 bearing shows some vertical movement 1/8" under heavy truck traffic. Sole plate are showing signs of wearing on rocker bearings typical all.. some bearing have heavy pack rust and anchor bolt are rusted in two.....						
313	Fixed Bearing	EA	20	0	0	20	0
1000	Corrosion	EA	20	0	0	20	0

(313)	Span 1 beam 2 bearing shows some vertical movement 1/8" under heavy truck traffic. Sole plate are showing signs of wearing on rocker bearings typical all.. some bearing have heavy pack rust and anchor bolt are rusted into.....						
331	Reinforced Concrete Bridge Railing	LF	245	245	0	0	0

Typical of all bearings

8/21/2019...Beam ends have some section loss in various locations....Dropped superstructure to a 4 due to beam ends showing some rusting and section loss in various locations, advanced section loss to fixed and movable bearings...
