Bridge Inspection Report

06044

**SH 282-Crawford Co
over
FROG BAYOU**

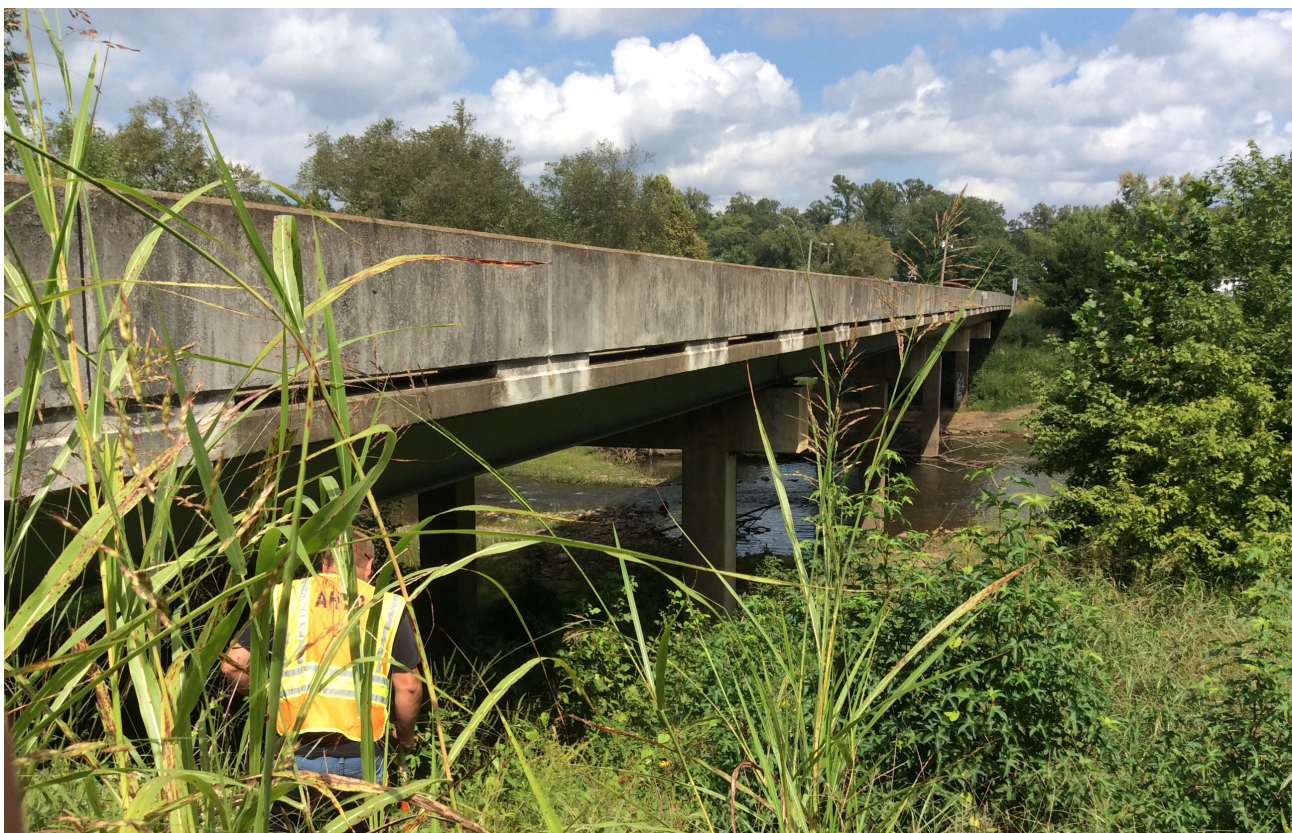
Compression joint seal at Bent # 4 has fallen out of the expansion joint assembly and is resting on the cap. Compression joint seals at Bents # 1, # 2, # 3, and # 5 have pulled away from the assemblies and are leaking dirt and debris on the caps.

PHOTO 2 Description Bent 4 deck joint seal missing

Work Code: Replace
