# Bridge Inspection Report

**02649**

**State Highway 28  
over  
Negro Creek-Scott Co.**

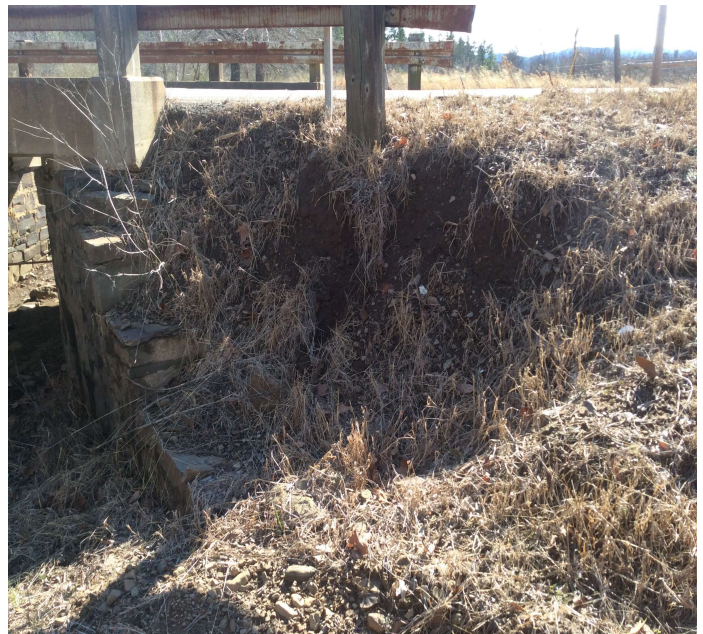
The North slope at the West Bridge end has an area of erosion that has caused loss of embankment material and is nearing the approach roadway.

PHOTO 1      Description      Erosion to the North slope at the West bridge end.

Work Code: Repair
