Asset #B6242(Routine)

I 49 NB LANES over W. Wilson Street - Wash.

Location: JCT I 49 & CO RD 26

Team Lead: Eric West, Inspection Date: 07/19/2022

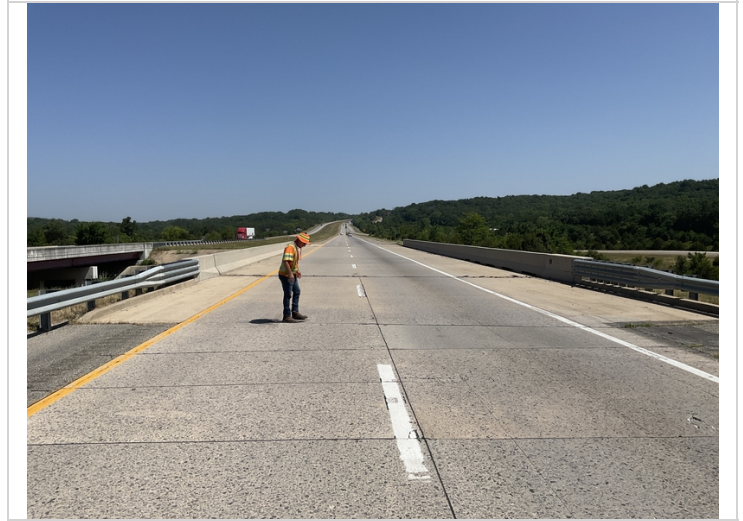
Roadway

(12) -There is sealable longitudinal, transverse, and map cracking on the driving surface of the deck. -Map cracking appears to be most excessive in the outside lane. -The transverse saw joints in the deck have deteriorated sealant.							
107	Steel Open Girder/Beam	LF	948	627	320	1	0
1000	Corrosion	LF	321	0	320	1	0
515	Steel Protective Coating	SF	9795	8995	400	400	0
3410	Chalking (Steel Protective Coatings)	LF	400	0	400	0	0
3440	Effectiveness (Steel Protective Coatings)	LF	400	0	0	400	0
