Asset #A6243(Routine)

I-49 SB LNS over State Highway 265

Team Lead: Eric West, Inspection Date: 07/18/2022

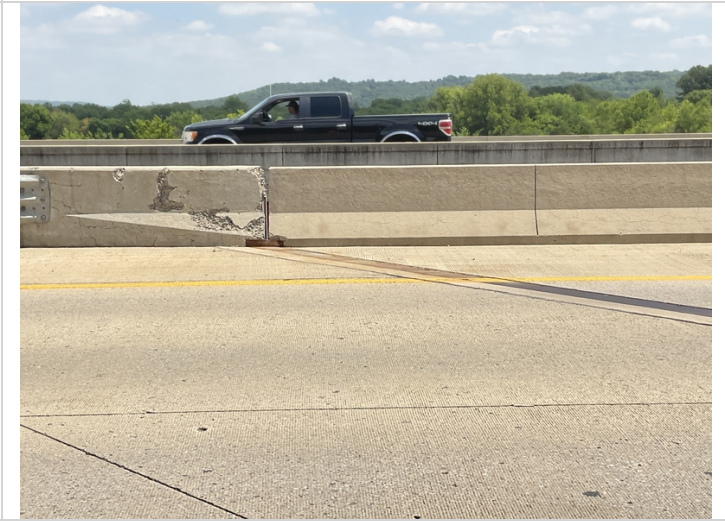
(321) -Sealable map cracking typical in both approach slabs. -Approach slabs have areas of wide transverse cracks.							
331	Reinforced Concrete Bridge Railing	LF	480	1	62	417	0
1130	Cracking (RC and Other)	LF	479	0	62	417	0
1234	ASR	LF	1	1	0	0	0

Typical bridge rail map cracking.
