Bridge Inspection Report

05537
SH 385 WHITE CO.
over
US 67-SEC 13

Structure Number: 05537

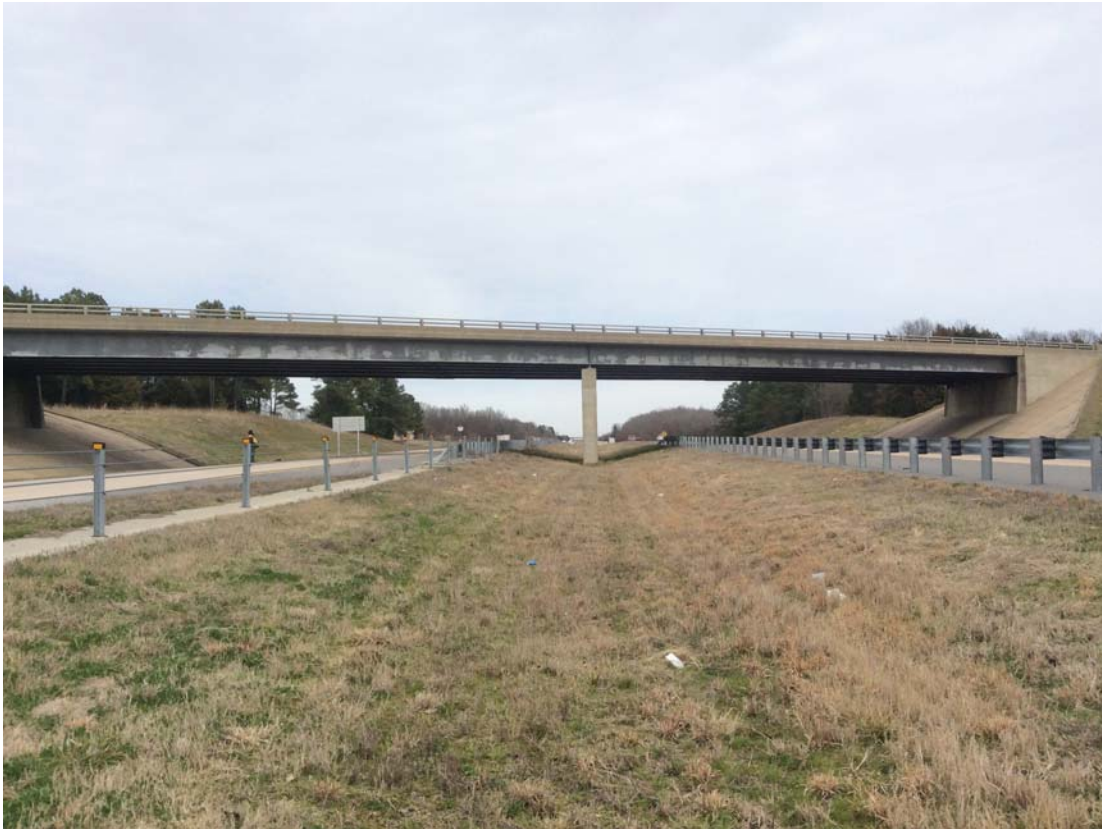
Unsealed cracks to approach slabs @ Abutment 1 & 2.

PHOTO 1 Description Unsealed cracks to approach slabs @
Abutment 1 & 2.

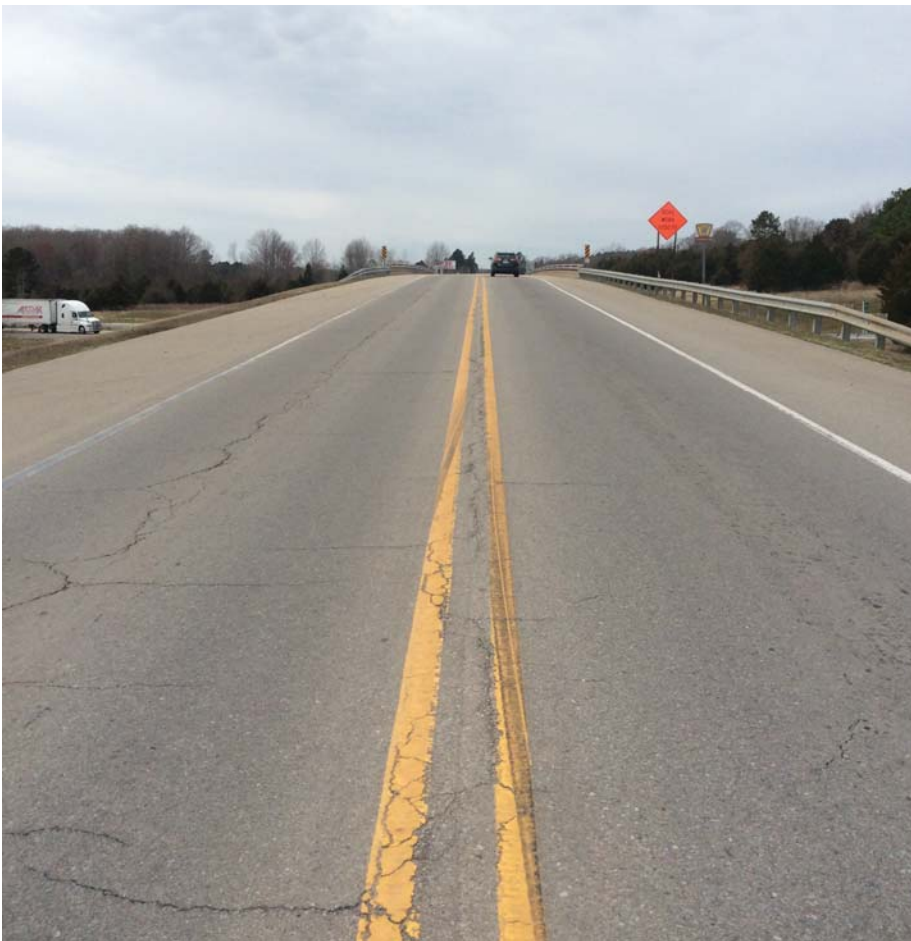
Unsealed cracks to deck @ all Spans.

PHOTO 1 Description Unsealed cracks to deck @ all Spans.
