Bridge Inspection Report

01443

SH 367 Log 1.05

BAYOU TWO PRAIRIE

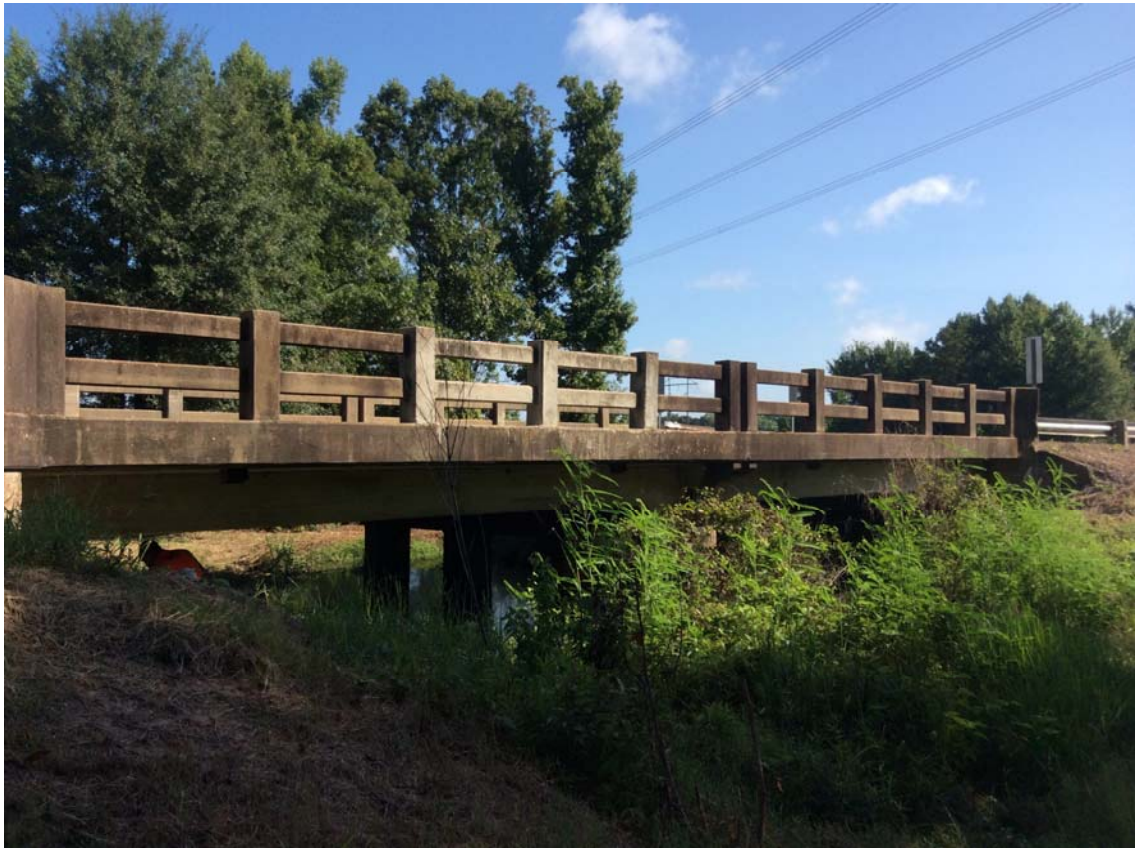
The girder has a spall with exposed rebar on the bottom.

PHOTO 1 Description Span 1, girder 1 at bent 1
Spall with exposed rebar.
