Bridge Inspection Report

01453

SH 367 Log 9.36

CYPRESS RELIEF

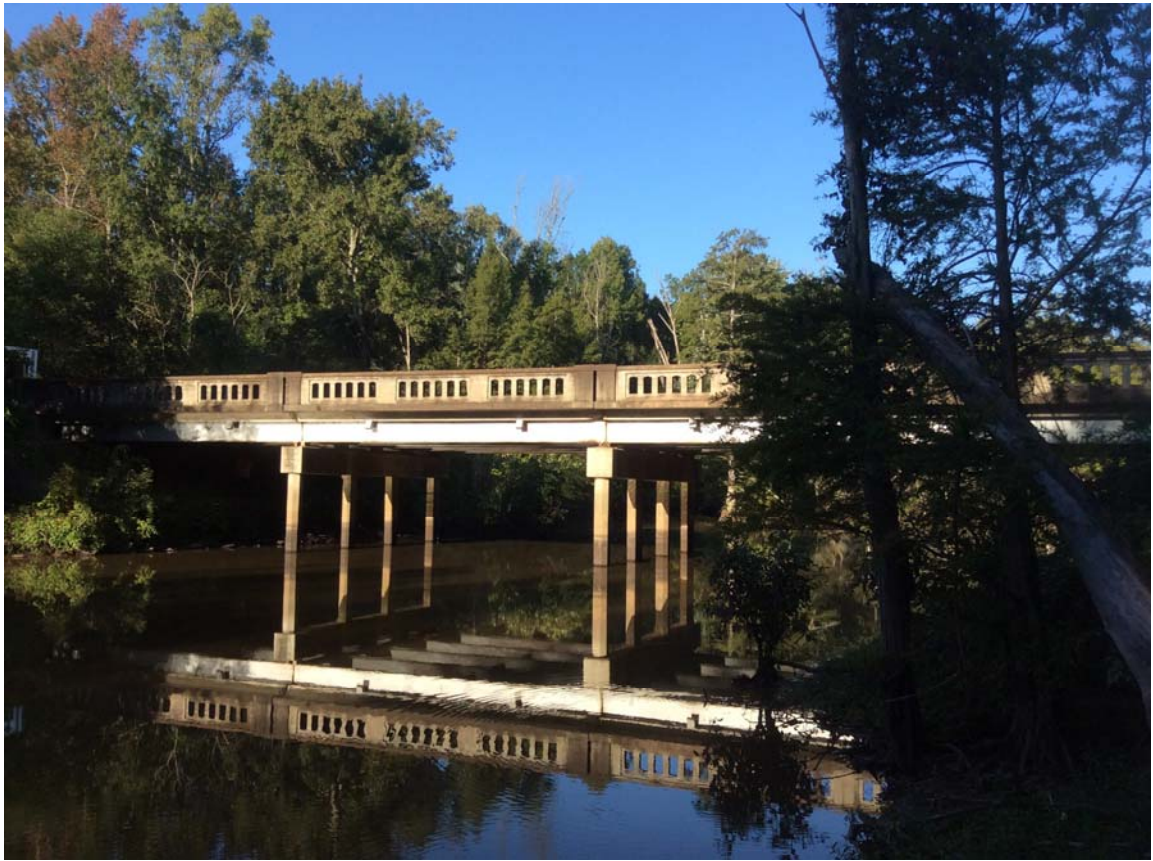
PHOTO 23 Description Span 2 at bent 3 beam 3 holes in the upper and lower webs and pitting to bottom flange up to 3/8 deep.
