Asset #03228(Routine)

SH 31 Overpass over I-40 LOG 174.58

Location: 1.64 MI N US 70

Team Lead: Bryan Saunders, Inspection Date: 03/23/2023

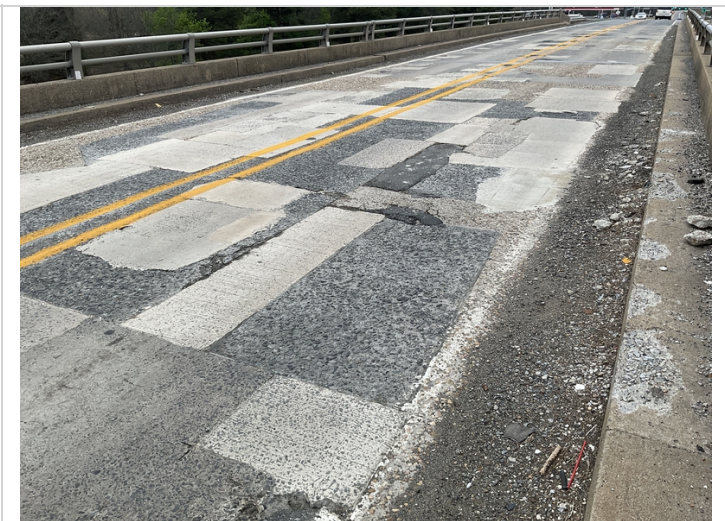
Deck view span 3

(12) Exposed rebar in the deck in various locations due to patches failing deck has large patches spalls with asphalt and exposed rebar in all spans The deck surface has numerous patched areas, span 3 is the worst with approx 1580 sf of patched areas. Some of the patched areas have exposed rebar and the overhangs have Spalls with exposed rebar at the deck drains and deck haunches. All spans have cracking with efflorescence and rust stains on the soffit. The deck surface has transverse cracks on approx. three foot centers, 0.030 to 0.040 width and these cracks have been sealed.							
107	Steel Open Girder/Beam	LF	1100	735	150	215	0
1000	Corrosion	LF	365	0	150	215	0
515	Steel Protective Coating	SF	8513	0	4500	1813	2200
3440	Effectiveness (Steel Protective Coatings)	LF	8513	0	4500	1813	2200

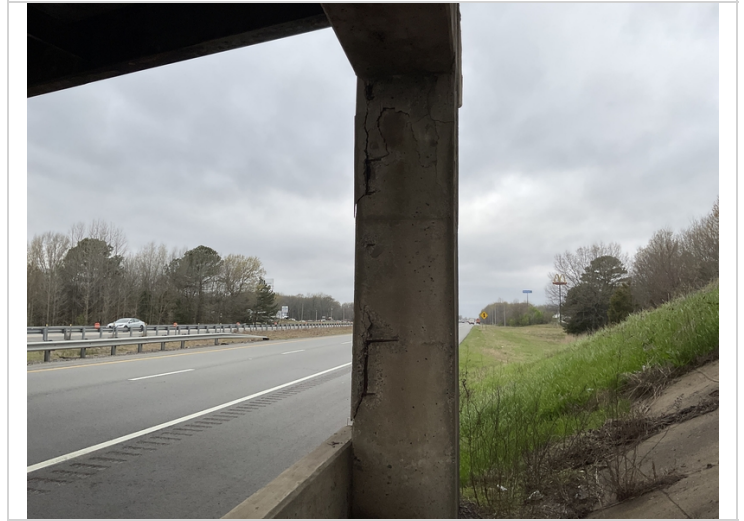
Column 1 at bent 4

(205) Bent 2 column 1 and 2 large crack and delams at tops Bent 3 column 1 large vertical crack and spall with rebar Bent 3 column 2 large vertical cracks rebar exposed bottom right delam top left Bent 4 column 1 large delam at the top and exposed rebar Bent 4 column 2 vertical cracks							
215	Reinforced Concrete Abutment	LF	58	50	8	0	0
1080	Delamination/Spall/Patched Area	LF	2	0	2	0	0
1130	Cracking (RC and Other)	LF	6	0	6	0	0

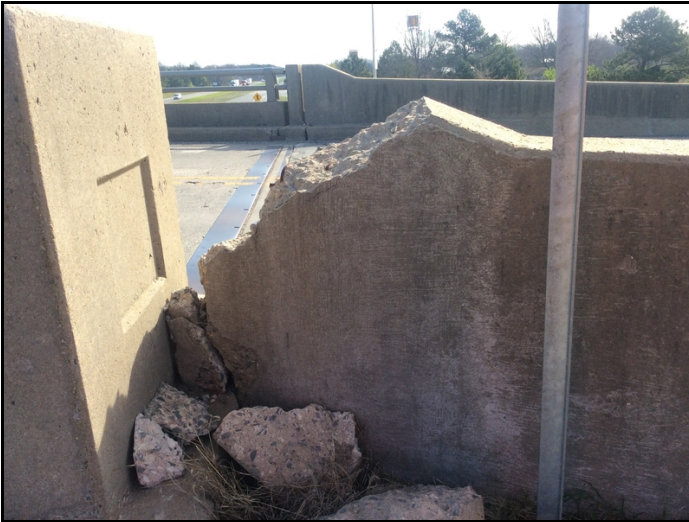
Left end post at bent 1.

Left approach rail at bent 1 has a large spall.
