**Asset #M1582(Routine)**  
**SH 86 Log 3.92 over WATTENSAW BAYOU REL**

**Location: 3.9 MI S JCT SH 38**

**Team Lead: Bryan Saunders, Inspection Date: 10/23/2023**

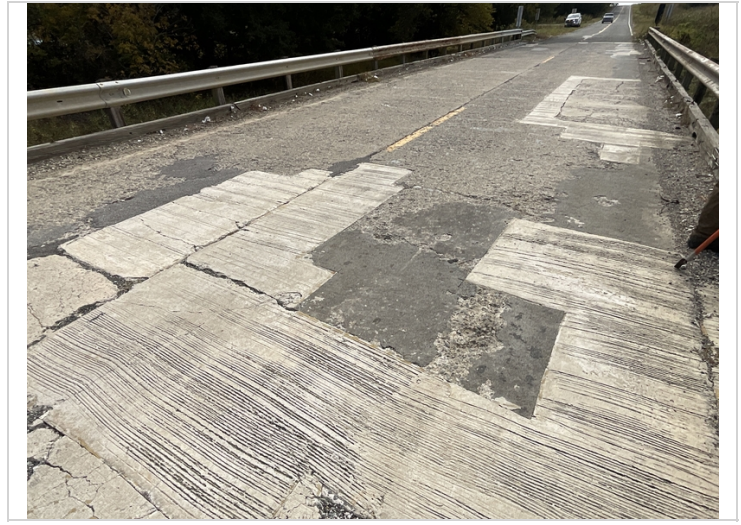
Deck view

concrete deck has large cracks, large spalls and heavy scaling

concrete patches have failed.

failed concrete patches have been repaired with asphalt
