Asset #01858(Routine)

US 63 Log 10.07 over WOLF BAYOU

Location: 2.5 M N OF SH 86 WEST

Team Lead: Bryan Saunders, Inspection Date: 06/07/2023

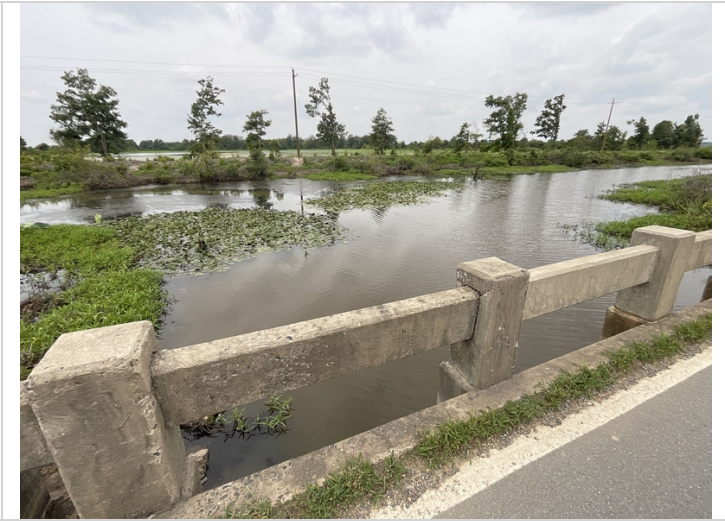
Deck view

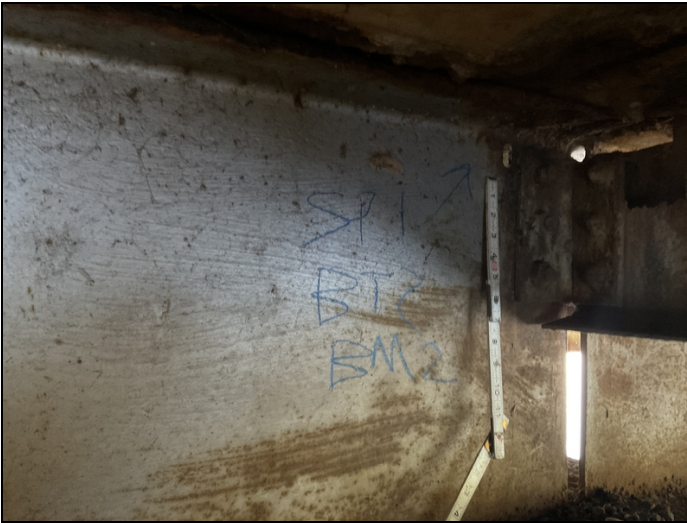
Bent 2 span 1 beam 2 hole in the upper web.

Span 1, bent 2, beam 2: upper web with deep pitting and diaphragm with large hole due to corrosion action.

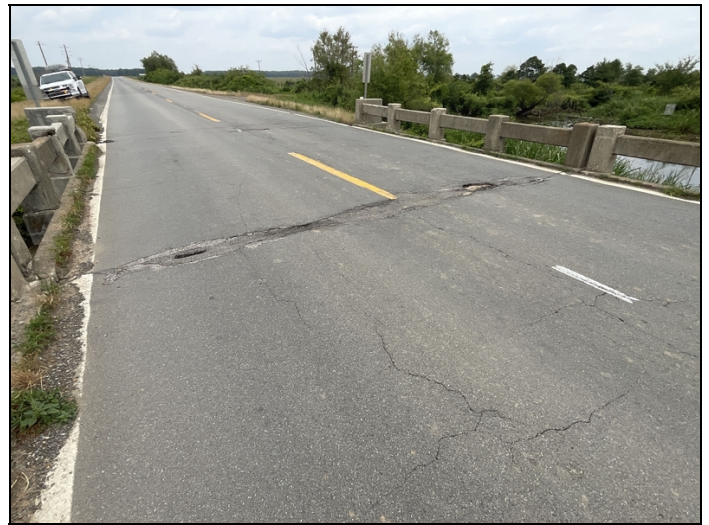
(12) The bottom of the deck has numerous Spalls with exposed rebar, transverse cracks and rust stains in all spans. (510-12) Potholes over joints							
107	Steel Open Girder/Beam	LF	383	0	127	249	7
1000	Corrosion	LF	383	0	127	249	7
515	Steel Protective Coating	SF	2033	0	600	978	455
3440	Effectiveness (Steel Protective Coatings)	LF	2033	0	600	978	455

Potholes at joints
