Asset #01859(Routine)

## US 63 Log 8.69 over LAGRUE CREEK RELIEF

Location: 1.9 M S OF SH 86 EAST

Team Lead: Bryan Saunders, Inspection Date: 05/23/2023

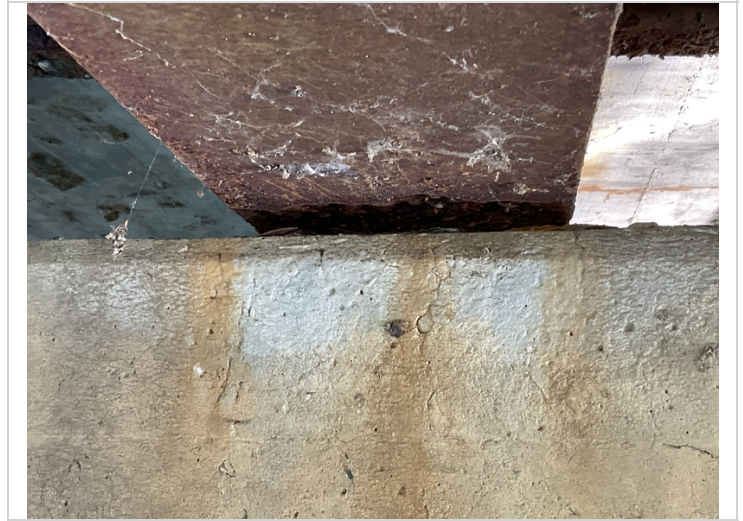
Bent 2 span 2 beam 4

Bent 2 beam 4 1" hole at upper web laminated rust at lower web and flange

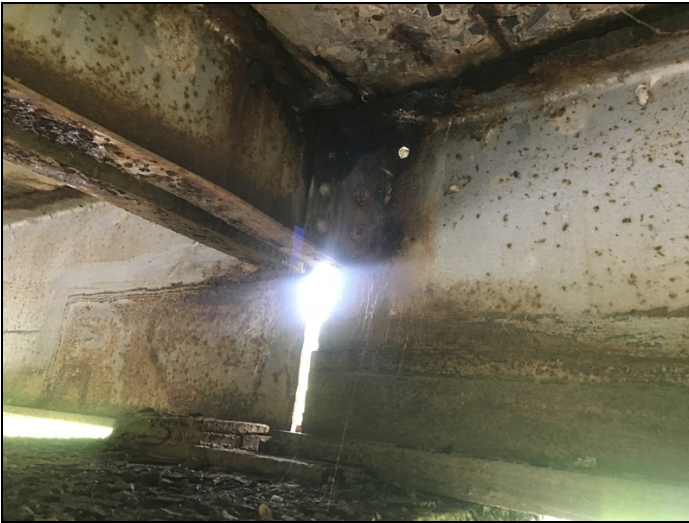
Span 4, bent 4 girder 1

Bent 4, span 4, girder 1: upper web has a 1 inch hole and the upper flange has lost section to a knives edge
