Asset #M0756(Routine, Underwater type 2)

SH 33 Log 3.15 over HONEY CREEK

Team Lead: Bryan Saunders, Inspection Date: 03/20/2023

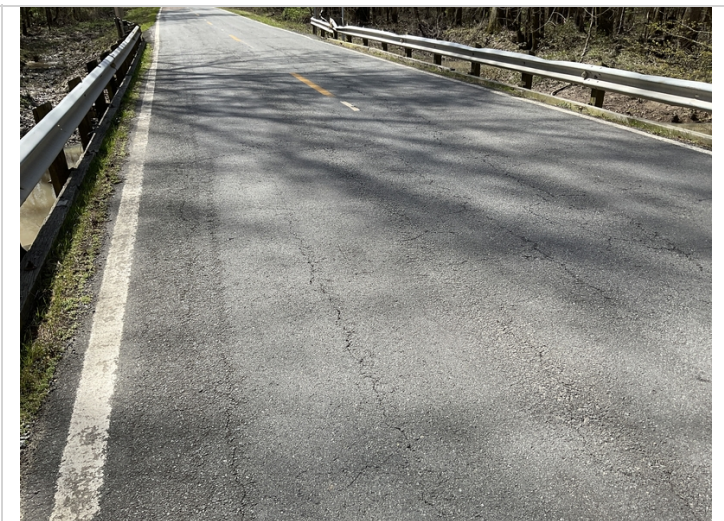
Deck view

(12) Right & Left side of deck has concrete deterioration at gutter line. (510-12) longitudinal cracks							
111	Timber Open Girder/Beam	LF	969	837	105	27	0
1140	Decay/Section Loss	LF	27	0	0	27	0
1160	Crack (Timber)	LF	105	0	105	0	0

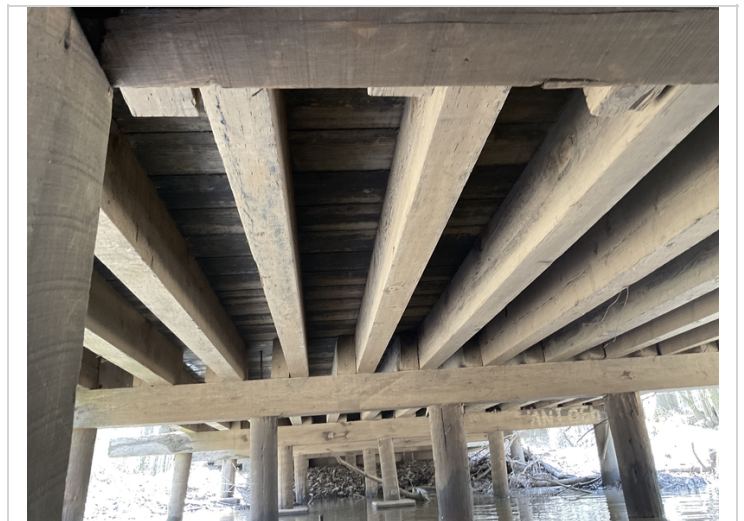
Soffit view

(111) Span 5 girders 2, is cracked. State forces have replaced girder 1, 12, and 13 at span 5. And have used plywood shim at girder to cap  Span 4 girders 1 is decayed Span 3 girders 7,8, 11 and 13 have cracks and are decayed. Span 2 girders 1,3 and 7, 11 have splits and decayed. Span 1 girders 13 and 11 are cracked entire length , girder 8 is cracked, state forces have replaced girder 13 at span 1. See photo							
216	Timber Abutment	LF	57	0	10	47	0
1140	Decay/Section Loss	LF	42	0	10	32	0
6000	Scour	LF	15	0	0	15	0
