Bridge #A6920(Routine)
I-30 EB Log 132.19 over US 70, U.P.R.R.,Fr.Rd.

Location: 2 M NE Jct SH338

Team Lead: Bryan Saunders Inspection Date: April 19, 2021

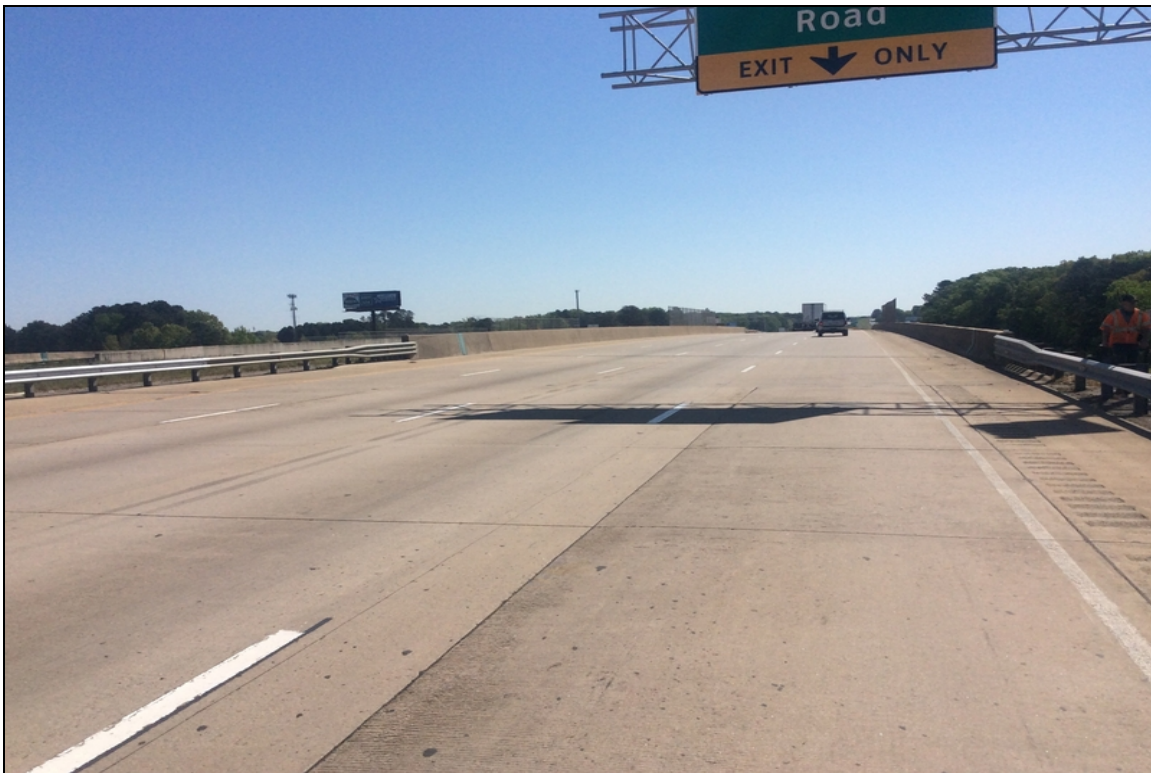
Approach

ELEM	DESCRIPTION	UNITS	TOTAL	CS1	CS2	CS3	CS4
Cracks in both approach slabs. Patches where plowable markers have been removed.							
331	Reinforced Concrete Bridge Railing	LF	822	575	247	0	0
1120	Efflorescence/Rust Staining	LF	97	0	97	0	0
1130	Cracking (RC and Other)	LF	150	0	150	0	0
(331)							
Cracks with efflorescence staining in both rails.

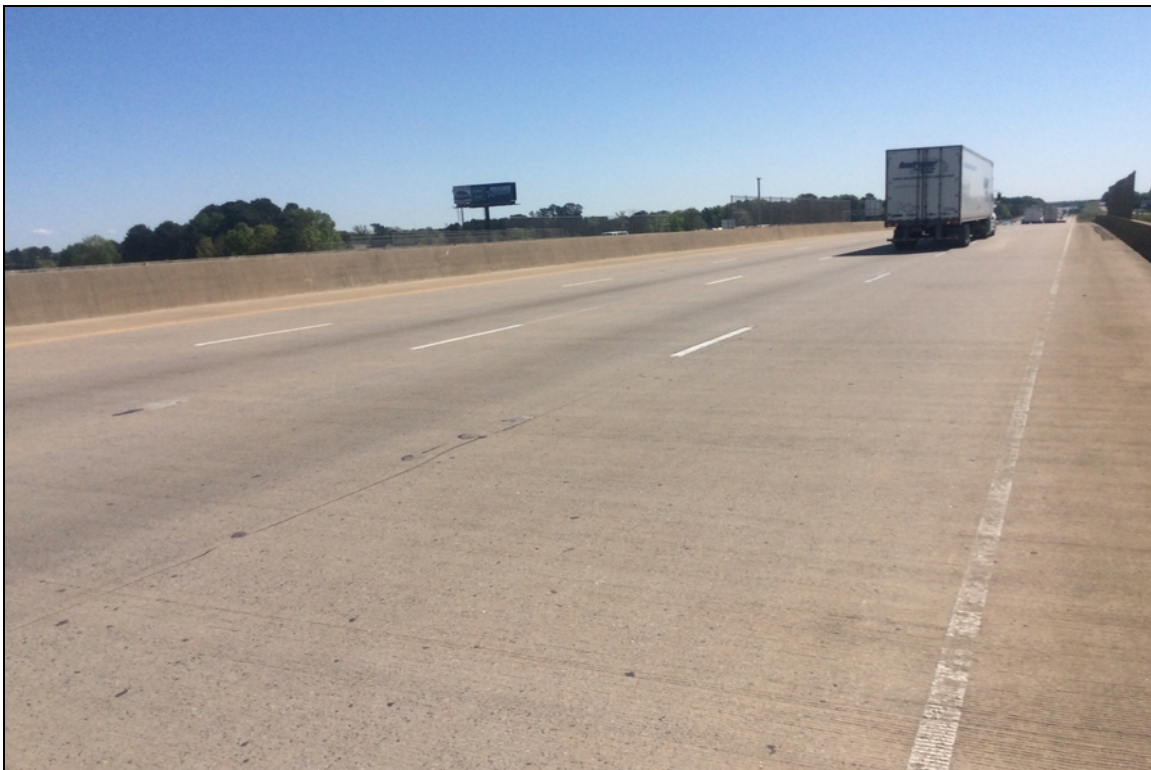
Typical deck

(12)							
Deck has unsealed transverse and longitudinal cracks up to 0.050". Patches in all spans where plowable markers have been removed.							
107	Steel Open Girder/Beam	LF	2877	2877	0	0	0
515	Steel Protective Coating	SF	42825	37723	5102	0	0
3420	Peeling/Bubbling/Cracking	SF	2	0	2	0	0
3410	Chalking (Steel Protective Coatings)	SF	5100	0	5100	0	0
(107-515)							
Outside Girders are chalking							
205	Reinforced Concrete Column	EA	6	6	0	0	0
215	Reinforced Concrete Abutment	LF	226	218	8	0	0
1120	Efflorescence/Rust Staining	LF	4	0	4	0	0
1130	Cracking (RC and Other)	LF	4	0	4	0	0
