Bridge #06675(Routine)

US 70-District 6 over White River-Prairie Co.

Team Lead: Monty Frazier Inspection Date: January 14, 2020

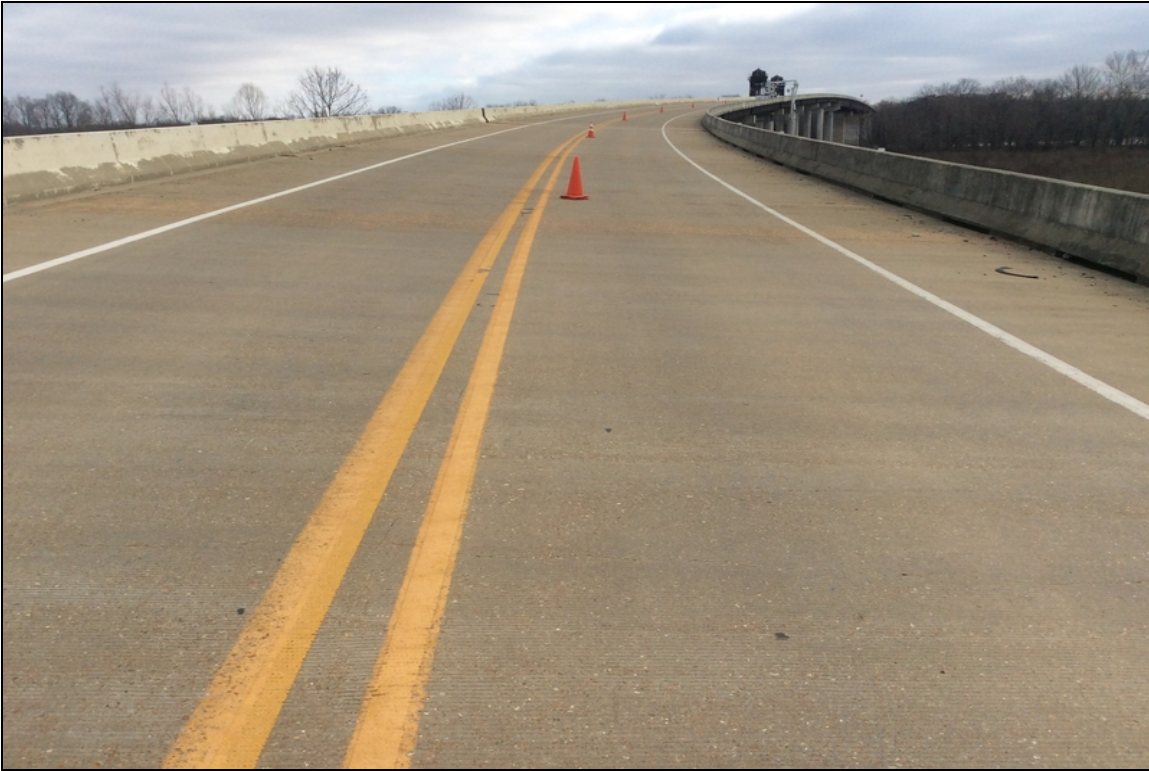
Typical driving surface

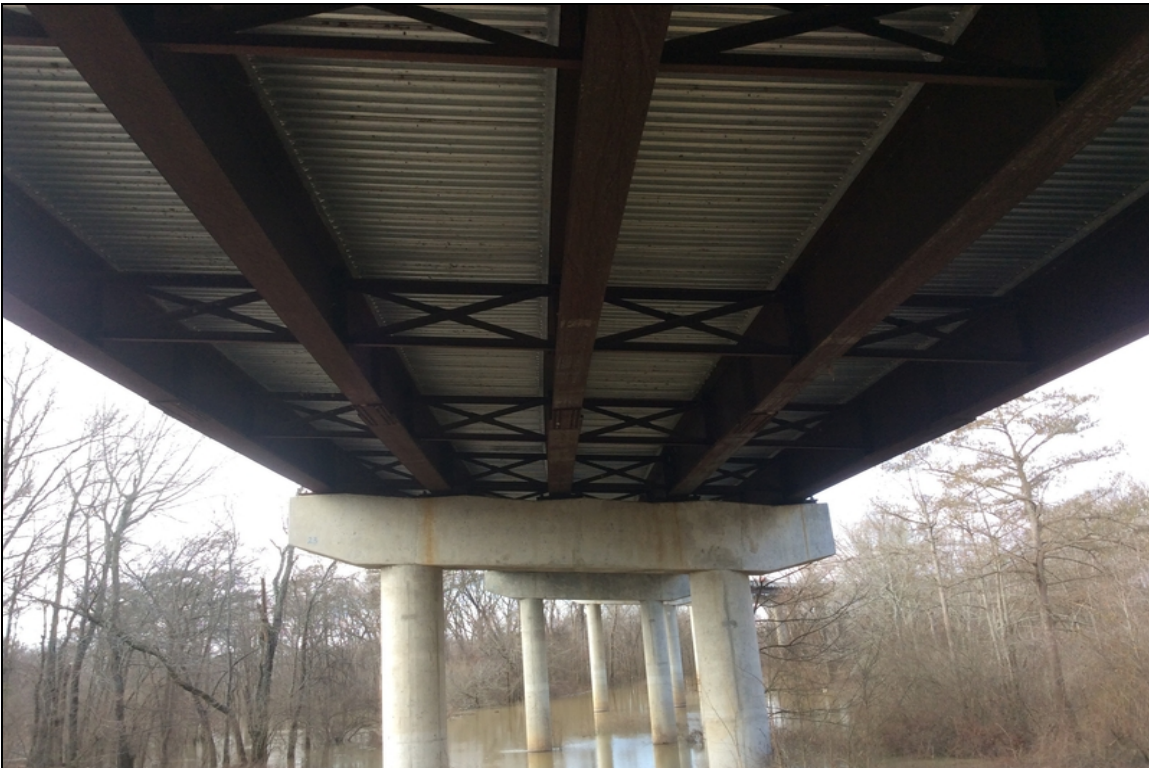
Typical under surface

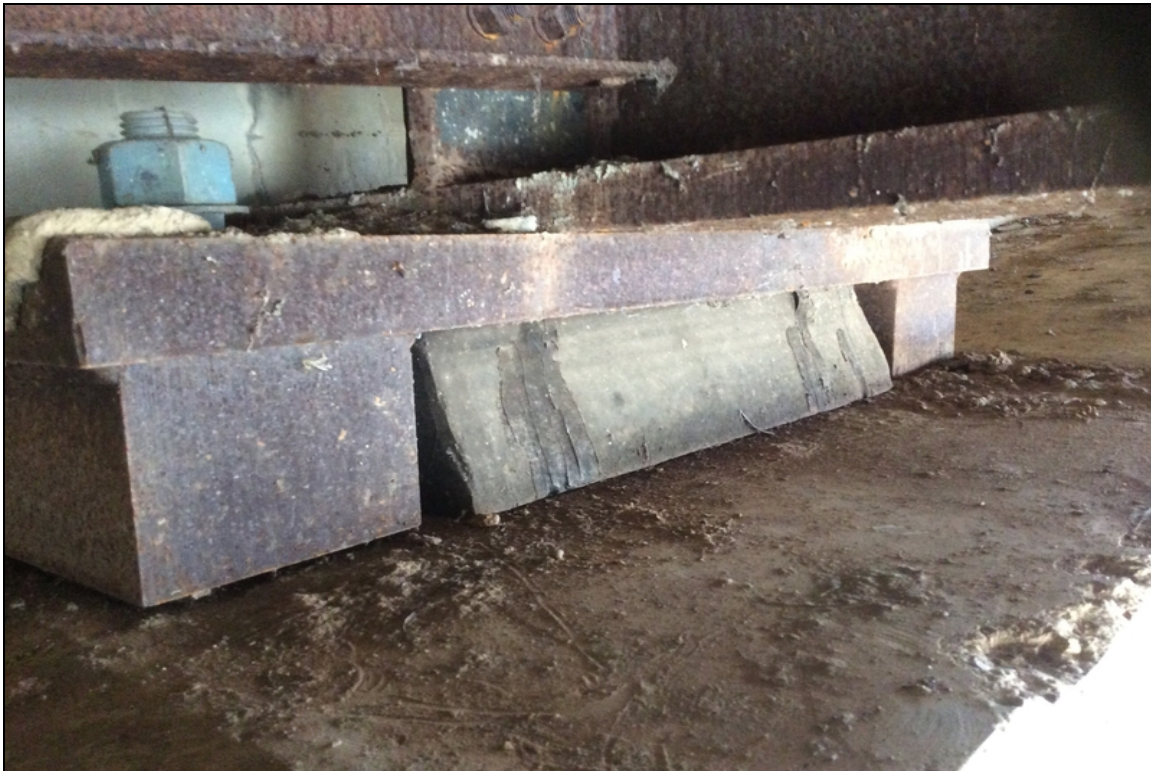
Typical condition of the bearings at the West Abutment

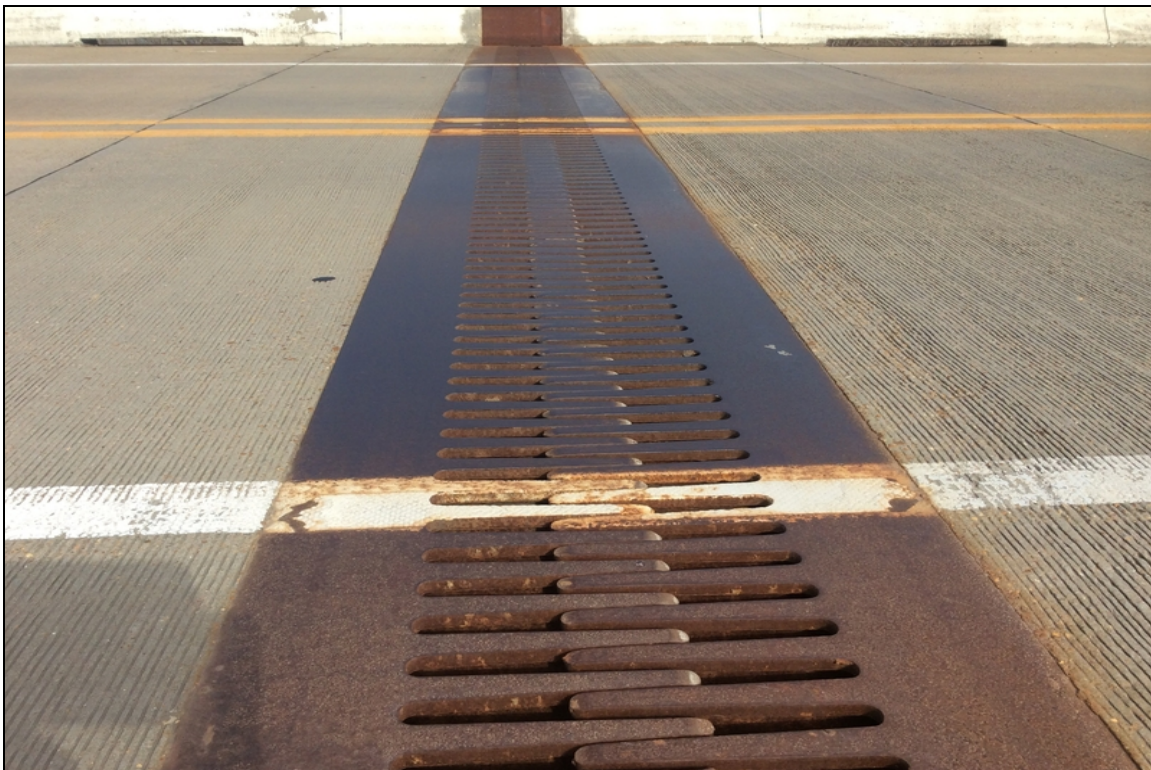
(303)							
01/22/2020 - MFF & JRT (No apparent noteworthy deficiencies at this inspection)							
1/23/2017 - RWF & KRM - Minor areas of debris impaction in the sliding plates and dirt and debris accumulation in the joint troughs.							
Some debris in the finger joints.

Typical condition of the assembly joints

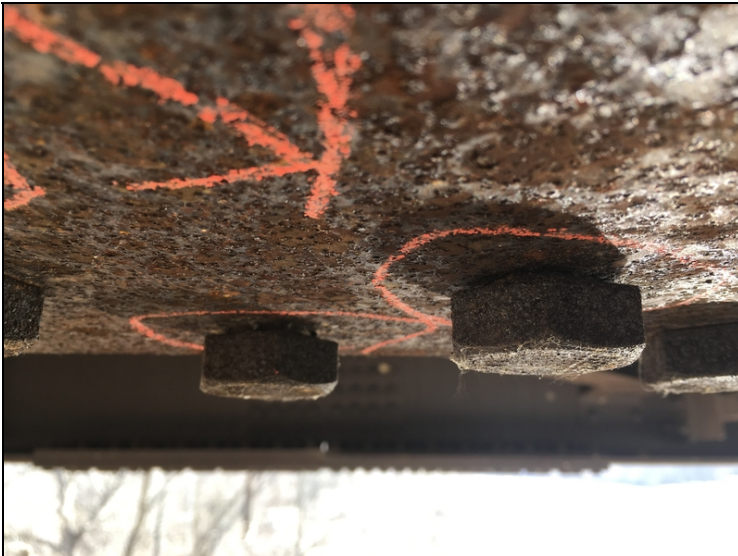
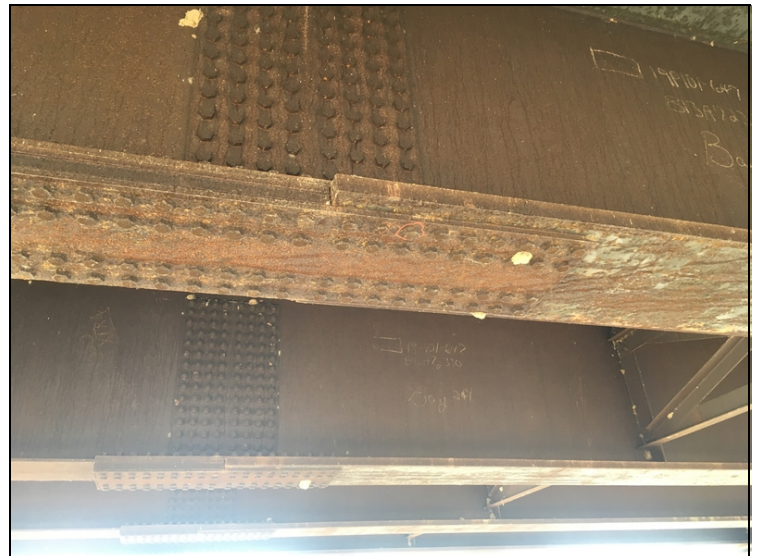
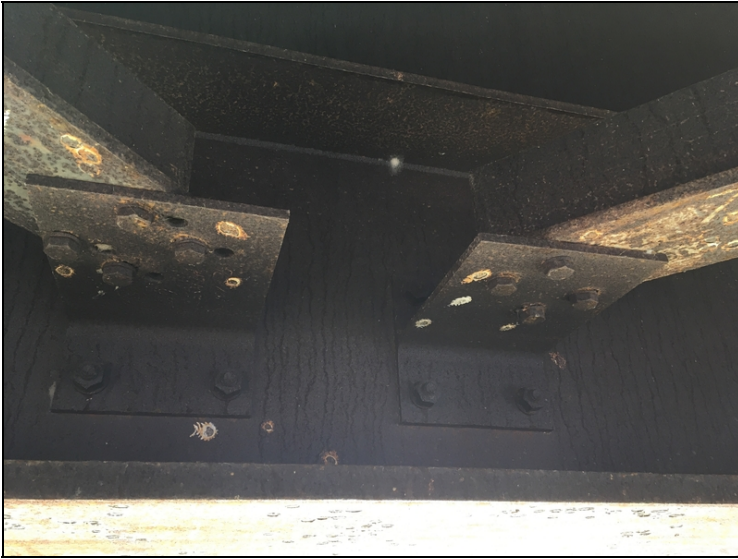
(107)	01/21/2020 - MFF & JRT						
	The bottom flanges have active corrosion with minor flaking rust typically along the exterior girders.						
	1/23/2017 - RWF & KRM - Isolated areas of loose bolted connections in the splice plates. Minor areas of small flaking rust visible in the bottom flanges and splice plate.						
205	Reinforced Concrete Column	EA	40	29	11	0	0
1120	Efflorescence/Rust Staining	EA	3	0	3	0	0
1130	Cracking (RC and Other)	EA	8	0	8	0	0

Span 12 Girder 2 Loose bolt at first splice plate connection.
Span 12 Girder 5 Loose bolt at second splice plate connection.
Span 13 Girder 2 Loose bolt at lateral bracing between the third and fourth splice plate.
Span 14 Girder 4 Loose bolt at second splice plate connection.
Span 16 Girder 2 Loose bolt at first splice plate connection.

Span 12 first splice plate ahead bent 12 girder 5
loose bolt.

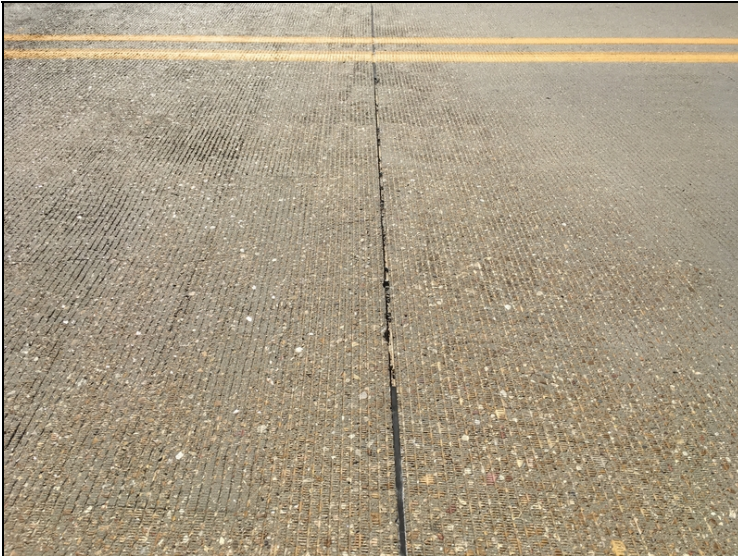
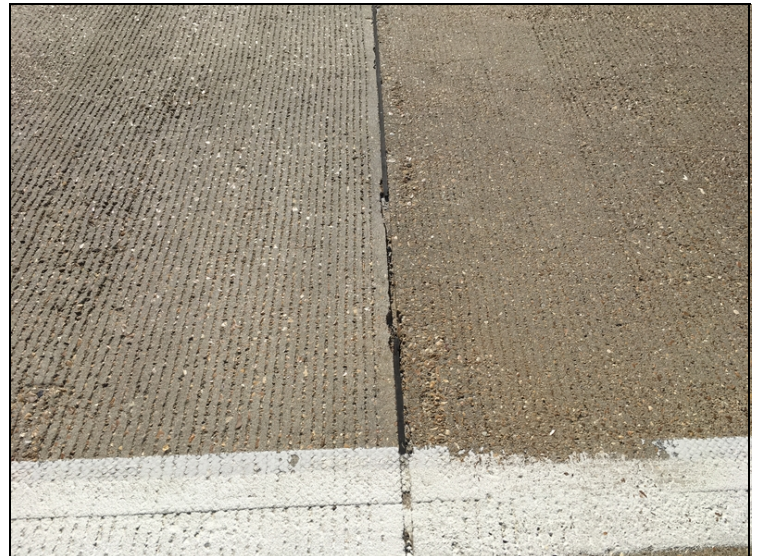
Span 3	Missing for 3'	Span 13	Missing for 8'
Span 5	Missing for 5'	Span 14	Missing for 14'
Span 7	Missing for 9'	Span 15	Missing for 12'
Span 12	Missing for 9'	Span 16	Missing for 2'

Typical missing and deteriorated saw joints in various locations throughout the structure.

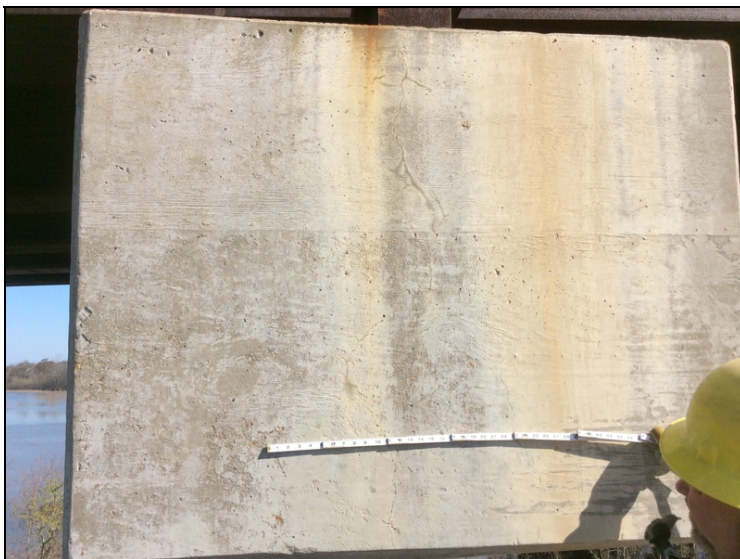
Bt. 2, Lt: Vertical efflorescence crack on end of cap.
Bt. 4, Rt: Minor horizontal crack on end of cap.
Bt. 5, Lt. & Rt: Minor map cracking on end of cap.
Bt. 7, Lt. & Rt: Vertical crack on end of cap.
Bt. 8, Rt: Map cracking on end of cap.
Bt. 12, Bk: Five efflorescence cracks in the cap. Horizontal crack on right end of cap.
Bt. 12, Lt: Minor efflorescence cracking at the cold joint on end of cap.
Bt. 15, Lt: Minor efflorescence cracking at the cold joint on end of cap.
Bt. 15: Two short vertical hairline cracks in cap on the ahead face.
Bt. 12&15: Minor debris on cap.

Bent 7 rt. End of cap: small vertical cracking in the ends of the caps

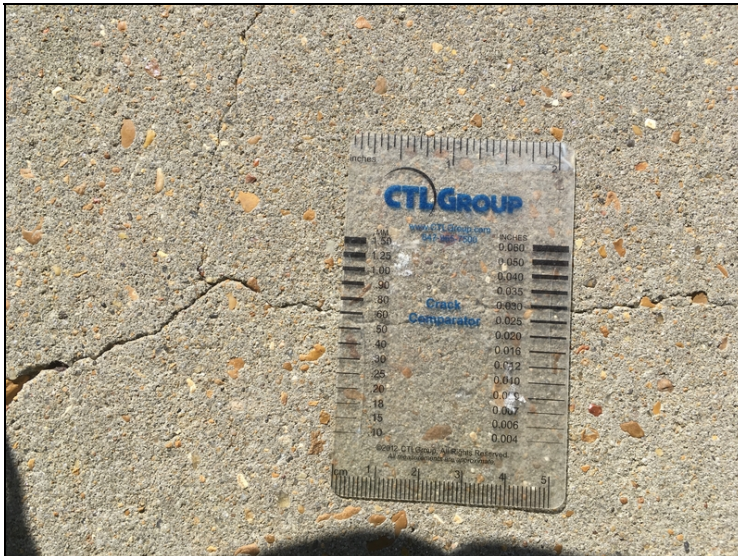
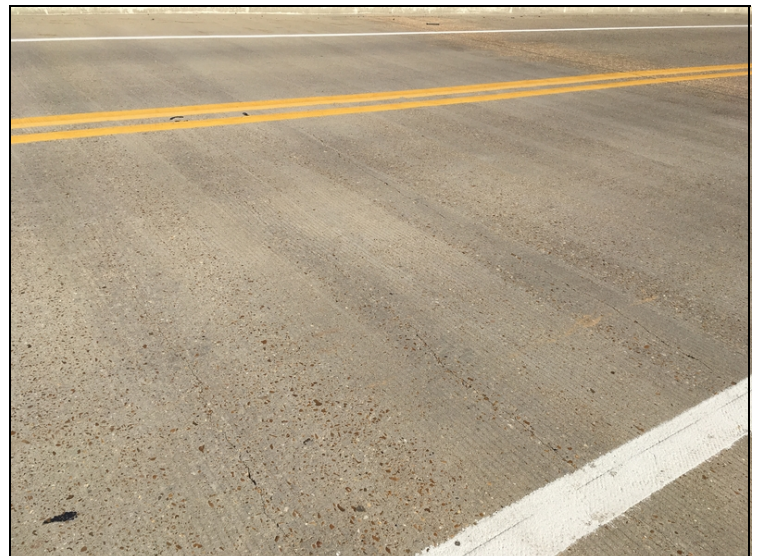
(12)	1/21/2020 - MFF & JRT						
	-Driving surface has transverse cracking at various spacing throughout the driving surface along with some longitudinal cracking at random locations. Spans 12 thru 14 have seal-able map cracking. (No spalls or delaminated areas at this inspection)						
	1/23/2017 - RWF & KRM - Isolated areas of light/medium sealable longitudinal and transverse cracking typical. Minor areas of diamond grinding in the driving surface. The overhangs have transverse cracks with efflorescence throughout the bridge.						
107	Steel Open Girder/Beam	LF	16500	15407	93	1000	0
1000	Corrosion	LF	1083	0	83	1000	0
1020	Connection	LF	10	0	10	0	0
515	Steel Protective Coating	SF	258711	257462	0	1249	0
3430	Oxide Film Degradation Color/Texture Adherence(Steel Protective Coatings)	SF	83	0	0	83	0
3440	Effectiveness (Steel Protective Coatings)	SF	1166	0	0	1166	0

Moderate debris in the gutter lines from snow and ice removal.

Typical transverse cracking at various spacing throughout the driving surface.
